Holtavirkjun Hydroelectric Project

Ground Investigation Report (GIR)

Title: Holtavirkjun Hydroelectric Project. Ground Investigation Report (GIR)

Abstract: In this report soil investigation carried out for Holtavirkjun is described.

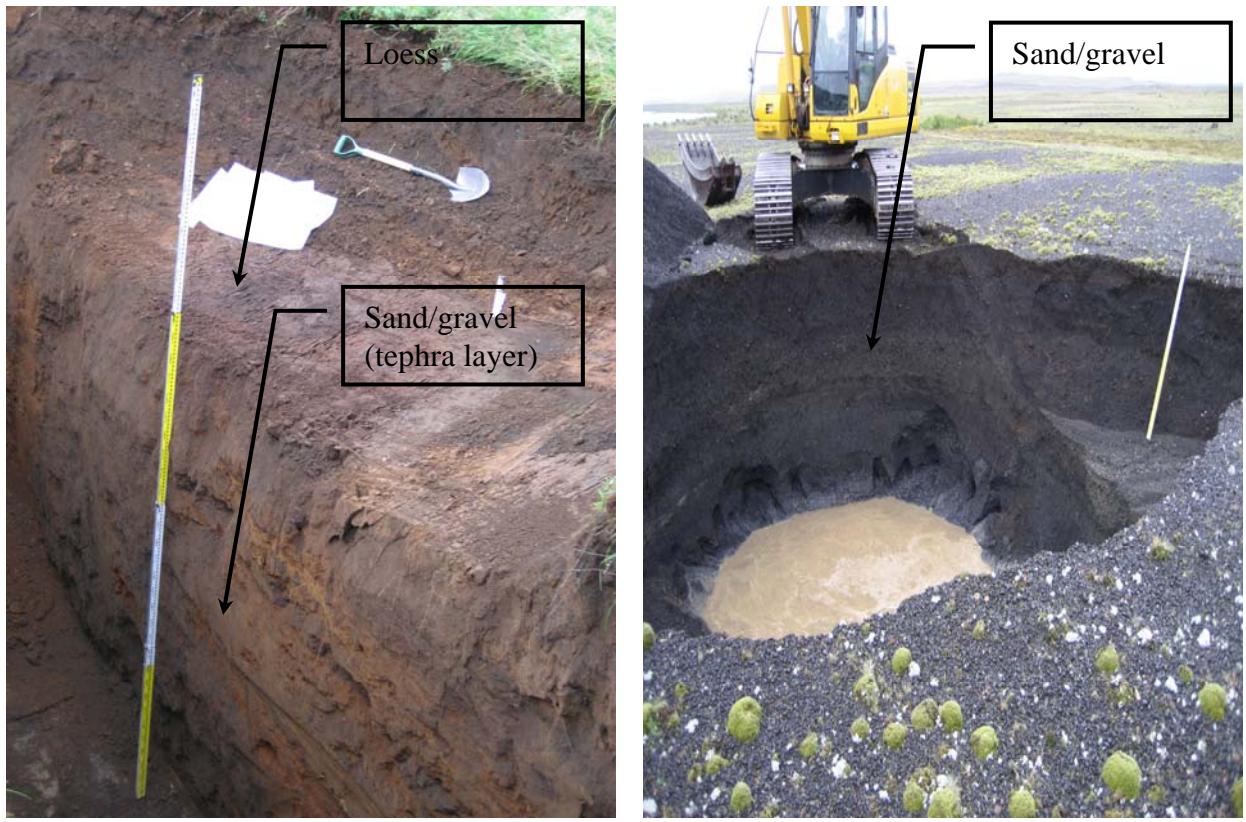
Most of the test pits were excavated down to the top of the underlying scoria and the soil thickness according to the test pits varies between 0,1 m and 6,0 m. At the test pits where the depth to the underlying scoria and bedrock is unknown it is noted in Appendix A. Typical test pits in loess and sandy gravel are shown in Figure 1 and 2.

a) Test pit number L19A (at the dam site)

b) Test pit number L21E

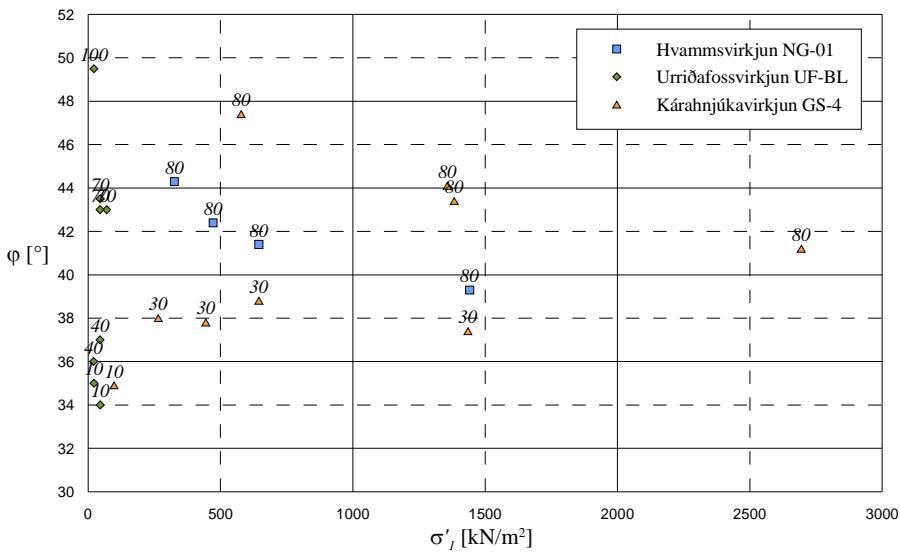
Figure 4.4. Triaxial test results (Dr indicated by a number)

No new static triaxial tests were supplemented in year 2006. It was evaluated that results from earlier testing at similar loess from Hvammsvirkjun [03], Urriðafossvirkjun [20] and Kárahnjúkavirkjun [02] Projects were sufficient to design the small dams and dikes in Holtavirkjun. Summary of the test results is shown in Table 4.3 and Figure 4.4.

Coefficient of consolidation c_v was found to be 30 cm²/min for NG-01. For sample from GS-4 it was 39 cm²/min if compacted and 121 cm²/min if loose. For UF-BL the coefficient was 1 cm²/min measured in oedometer tests.

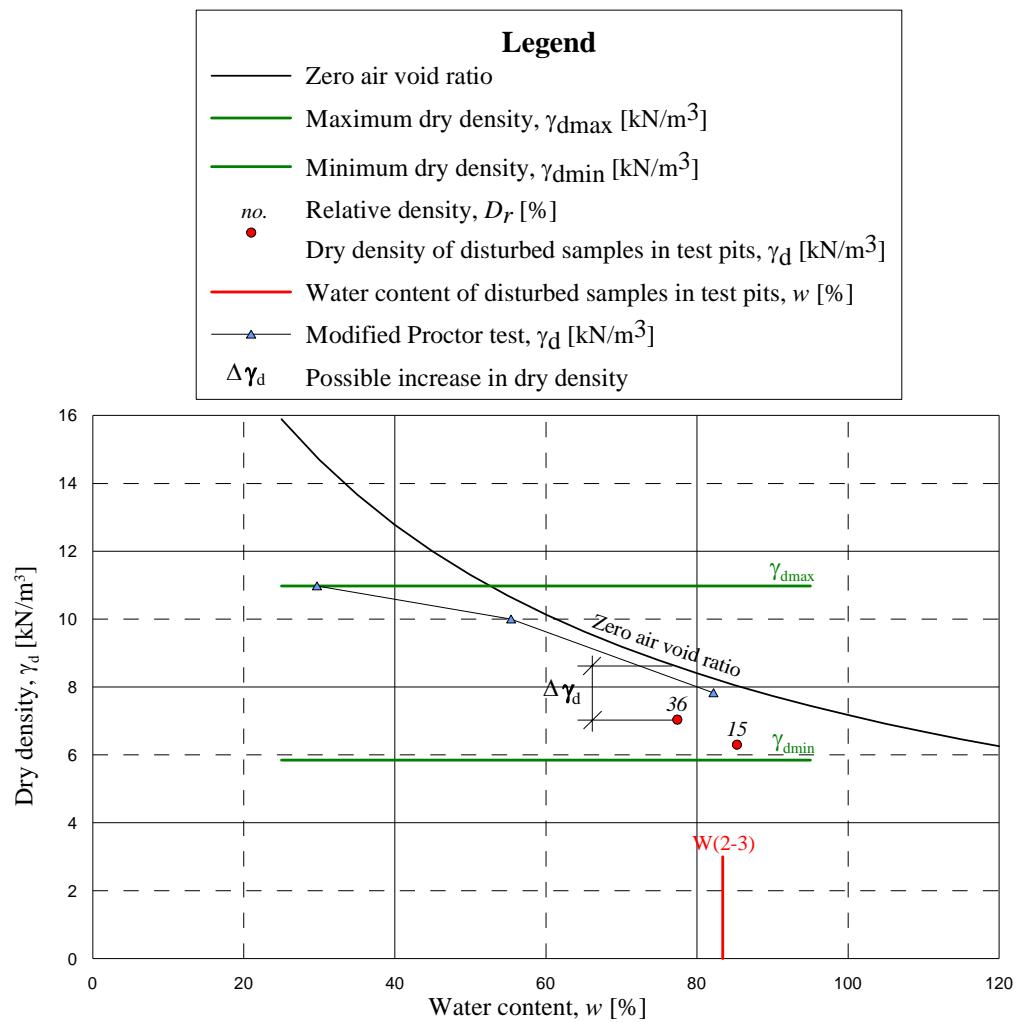
Figure 4.7. Schematic descriptions of the symbols

Selected samples from the test pits were used for measurement of the dry density and relative density. Highest dry density can not be measured according to ASTM standard because of high fines content. Therefore max dry density was selected as dry density at water content 30% and compaction according to Modified Proctor. Schematic descriptions of the symbols are shown in Figure 4.7. Results of the density measurements are shown in Table 4.9.

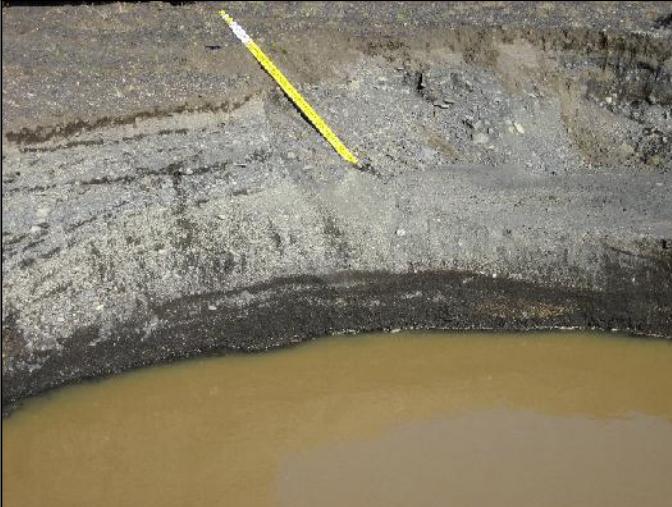
Photo:

Elev. [m.a.s.l.]	Depth [m]	Description	Depth [m]	Soil Profile	G.w.t. [m]	Bottom [m]	Sample [m]
		Sand & gravel - with organic layers					
-56	1,0	Sand & gravel from 0,2 m	1,0				0,7-0,9
-55	2,0	Groundwater table at 1,4 m [22.09.'06]	2,0				
-54	2,5	Bottom at 2,5 m	2,5				
-54	3,0	Bedrock not found	3,0				
-53	4,0		4,0				
-52	5,0		5,0

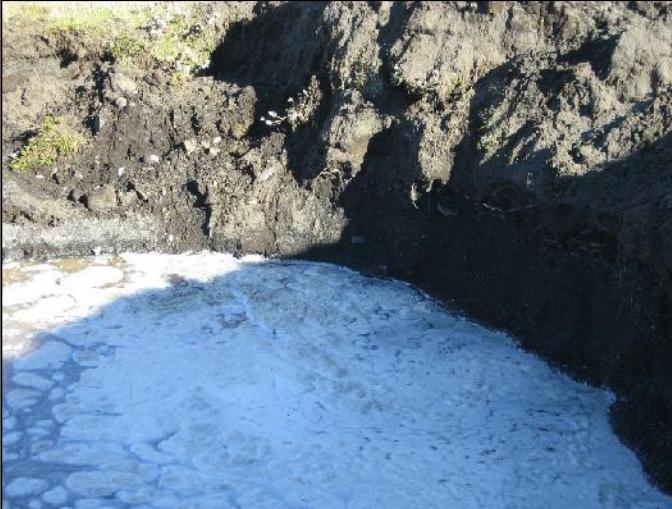
Photo:

Elev. [m.a.s.l.]	Depth [m]	Description	Depth [m]	Soil Profile	G.w.t. [m]	Bottom [m]	Sample [m]
		Sand & gravel - with organic layers					
-55	1,0	Sand & gravel from 0,6 m Groundwater table at 1,1 m [22.09.'06]	1,0	1,0			
-54	2,0	Bottom at 2,2 m	2,0	2,0			
-53	3,0	Bedrock not found	3,0				
-52	4,0		4,0				
-51	5,0		5,0

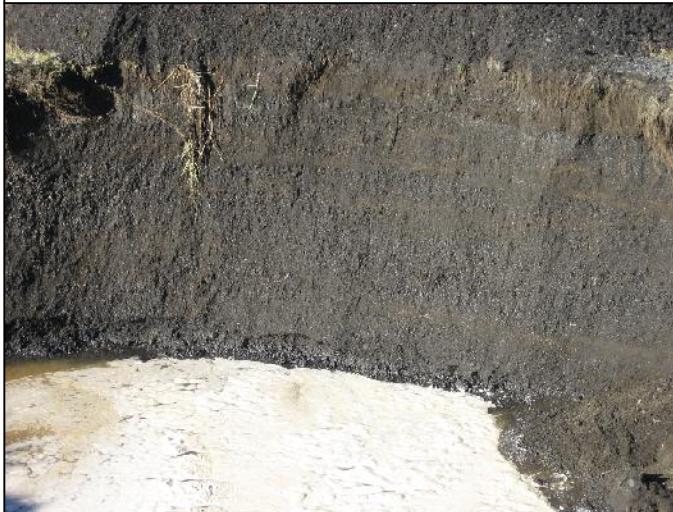
Photo:

Elev. [m.a.s.l.]	Depth [m]	Description	Depth [m]	Soil Profile	G.w.t. [m]	Bottom [m]	Sample [m]
-57		Sand & gravel - with organic layers Piezometer installed					
-56	1,0		1,0				1,1-1,2
-55	2,0		2,0				
-54	3,0	Bottom at 2,6 m Bedrock not found	3,0				
-53	4,0		4,0				
-52	5,0		5,0

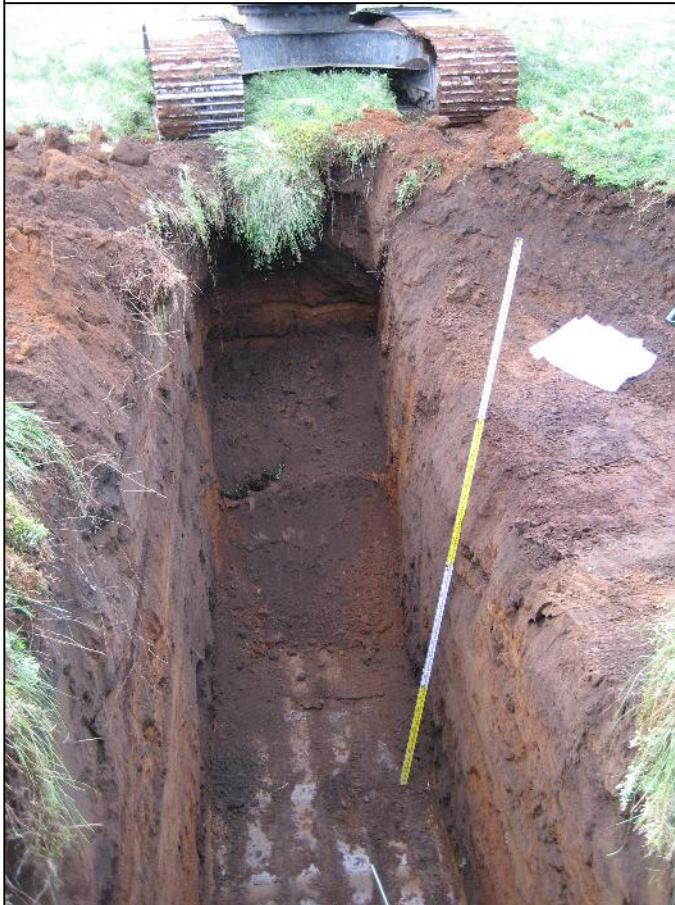
Photo:

Elev. [m.a.s.l.]	Depth [m]	Description	Depth [m]	Soil Profile	G.w.t. [m]	Bottom [m]	Sample [m]
74	1,0		1,0				1,2-1,4
73	2,0	Loess	2,0				
72	3,0		3,0				2,5-2,7
71	4,0	Sandstone at 4,0 m	4,0				
70	5,0		5,0				
69

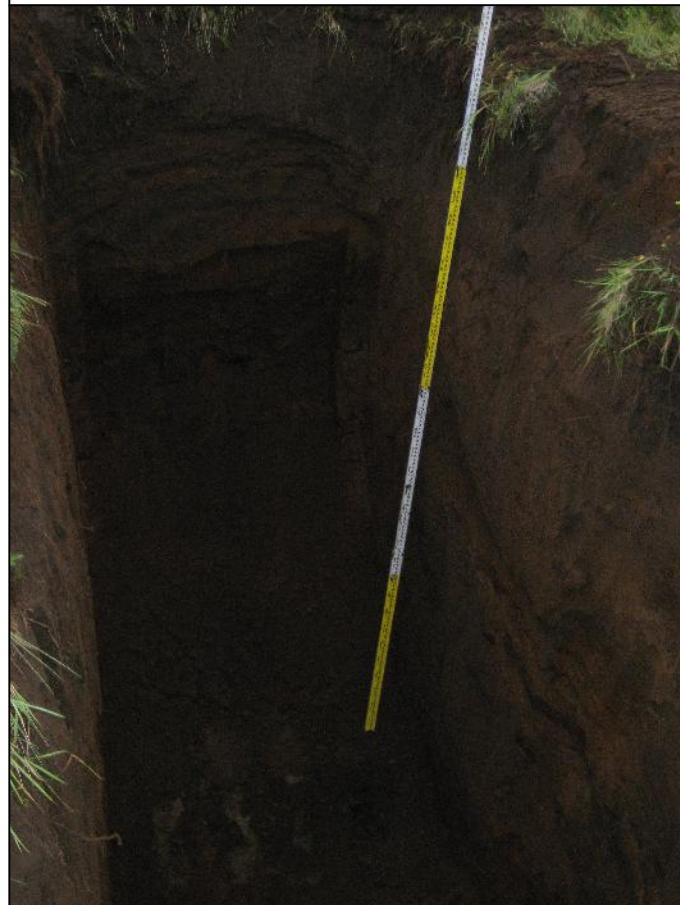
Photo:

Elev. [m.a.s.l.]	Depth [m]	Description	Depth [m]	Soil Profile	G.w.t. [m]	Bottom [m]	Sample [m]
74	1,0		1,0				1,0-1,2
73	2,0	Loess	2,0				2,0-2,2
72	3,0		3,0				
71	4,0	Sandstone at 3,4 m	4,0				
70	5,0		5,0				
69

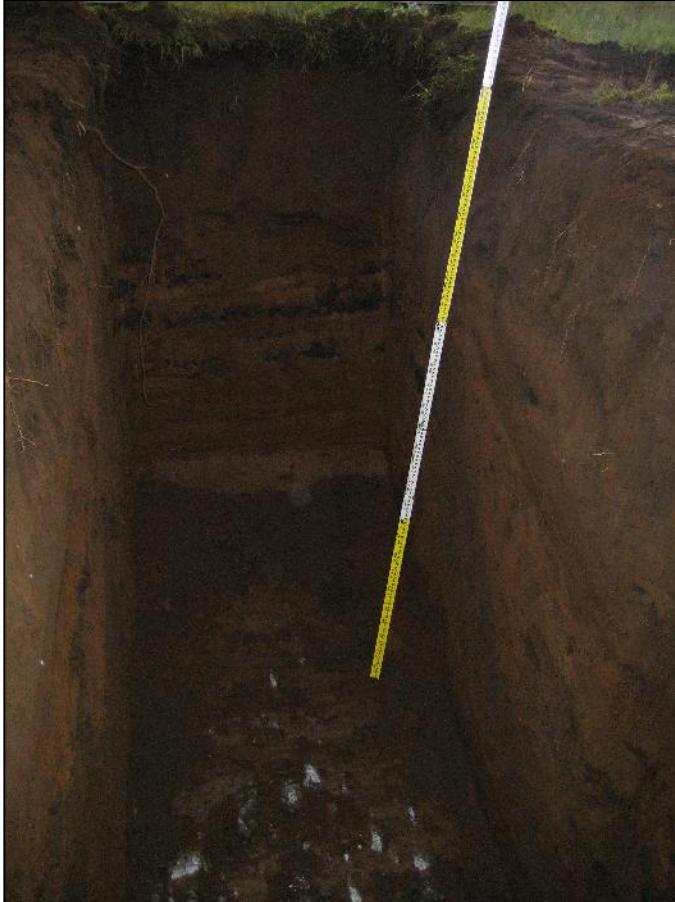
Photo:

Elev. [m.a.s.l.]	Depth [m]	Description	Depth [m]	Soil Profile	G.w.t. [m]	Bottom [m]	Sample [m]
76		Loess					
75	1,0	Loess - with thin sand layers from 0,8 m	1,0				1,0-1,2
74	2,0		2,0				2,0-2,2
73	3,0	Sandstone at 3,0 m	3,0				
72	4,0		4,0				
71	5,0		5,0

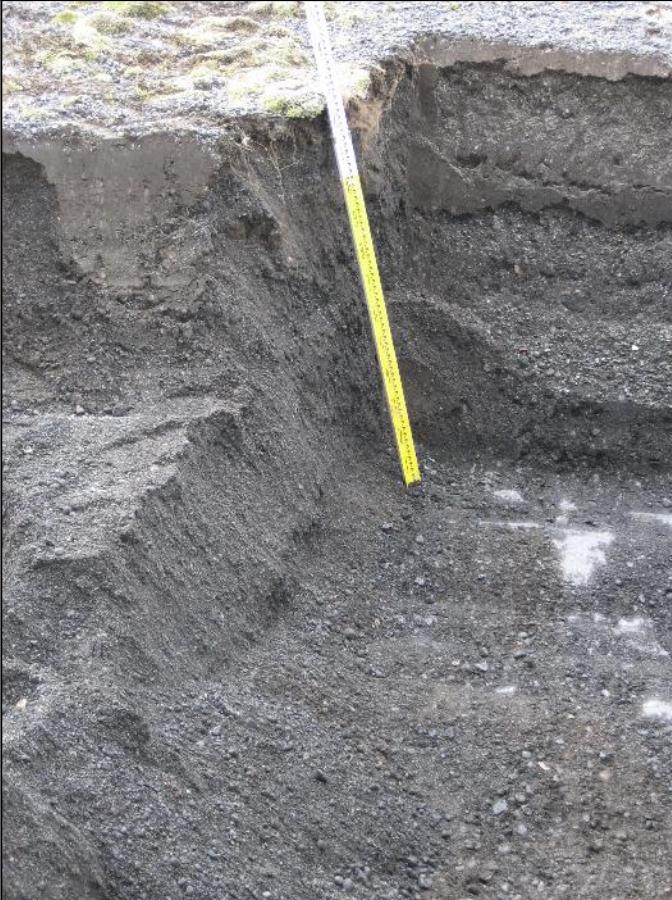
Photo:

Elev. [m.a.s.l.]	Depth [m]	Description	Depth [m]	Soil Profile	G.w.t. [m]	Bottom [m]	Sample [m]
- 71		Sand & gravel - with organic layers					
		Sand & gravel from 0,4 m					0,6-0,8
- 70	1,0	Lava at 1,2 m	1,0				
- 69	2,0		2,0				
- 68	3,0		3,0				
- 67	4,0		4,0				
- 66	5,0		5,0

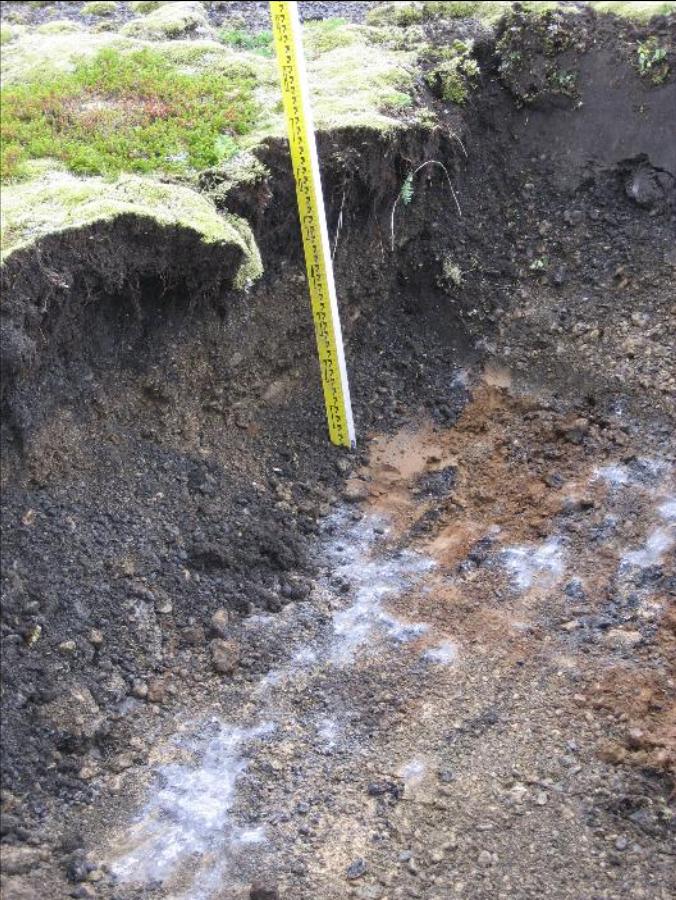
Photo:

Elev. [m.a.s.l.]	Depth [m]	Description	Depth [m]	Soil Profile	G.w.t. [m]	Bottom [m]	Sample [m]
		Sand & gravel - with organic layers					
70	1,0	Lava at 0,7 m	1,0				
69	2,0		2,0				
68	3,0		3,0				
67	4,0		4,0				
66	5,0		5,0				
65

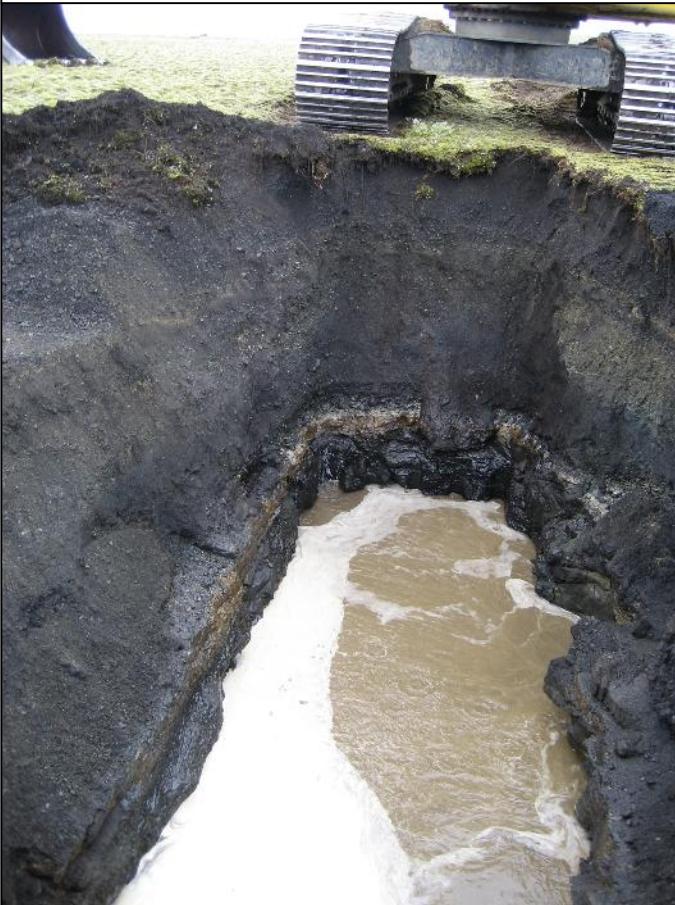
Photo:

Elev. [m.a.s.l.]	Depth [m]	Description	Depth [m]	Soil Profile	G.w.t. [m]	Bottom [m]	Sample [m]
-70							
-69	1,0	Sand & gravel Piezometer installed Groundwater table at 1,2 m [18.09.'06]	1,0				1,0-1,2
-68	2,0		2,0				2-3
-67	3,0		3,0				
-66	4,0		4,0				
-65	5,0	Bottom at 5,0 m Bedrock not found	5,0

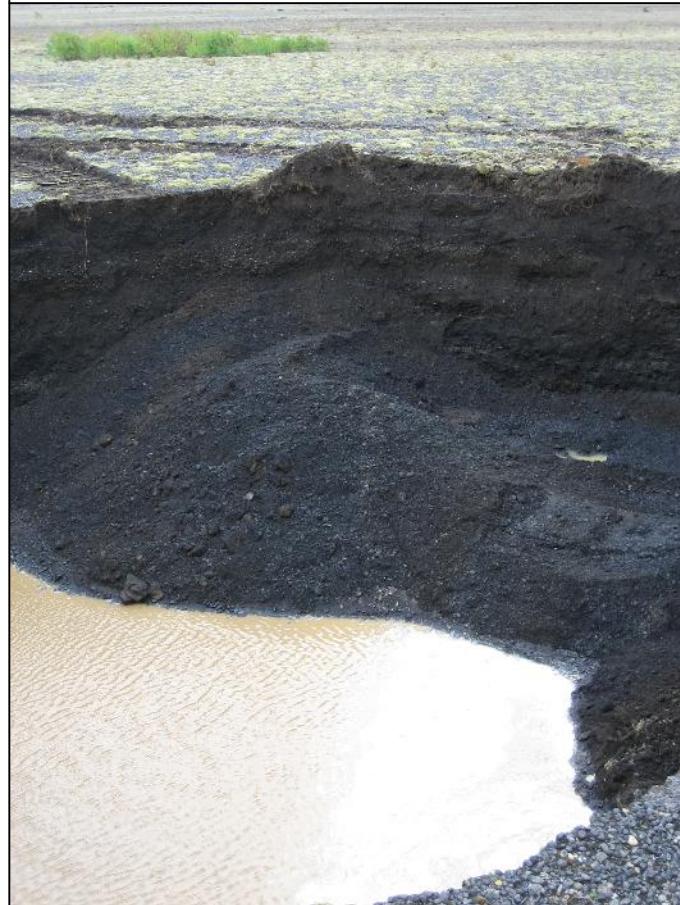
Photo:

Elev. [m.a.s.l.]	Depth [m]	Description	Depth [m]	Soil Profile	G.w.t. [m]	Bottom [m]	Sample [m]
		Sand & gravel - with organic layers Piezometer installed					
-70	1,0		1,0				1,0-1,2
-69	2,0	Groundwater table at 1,5 m [14.09.'06]	2,0				2,0-2,2
-68	3,0	Sand & gravel from 1,0 m	3,0				
-67	4,0	Bottom at 4,2 m Bedrock not found	4,0				
-65	5,0		5,0

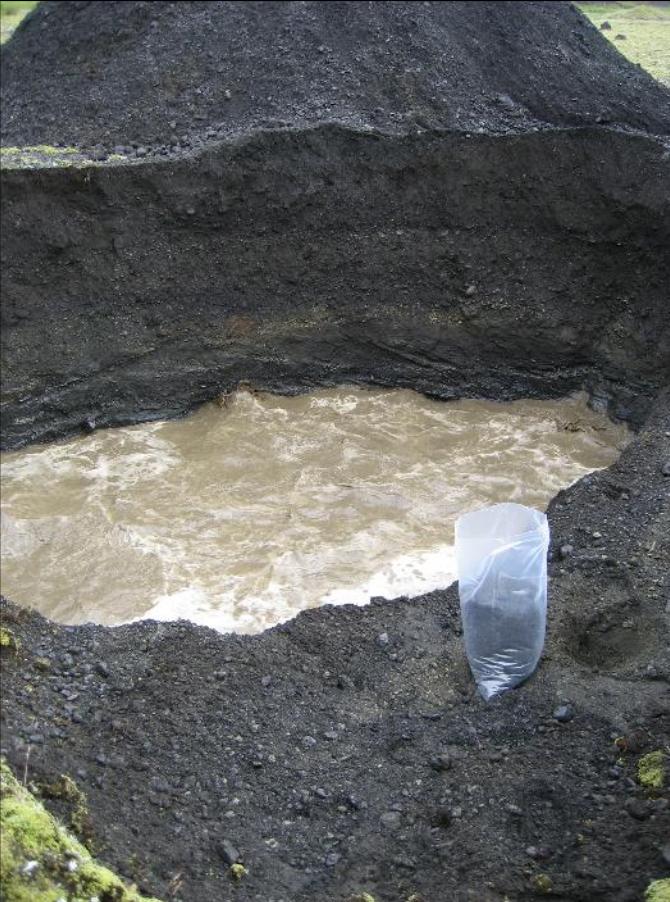
Photo:

Elev. [m.a.s.l.]	Depth [m]	Description	Depth [m]	Soil Profile	G.w.t. [m]	Bottom [m]	Sample [m]
		Sand & gravel - with organic layers Piezometer installed					
-69	1,0	Groundwater table at 0,95 m [14.09.'06]	1,0		1,0		1,0-1,3
-68	2,0	Sand & gravel from 0,7 m	2,0				
-67	3,0	Bottom at 3,4 m	3,0				
-66	4,0	Bedrock not found	4,0				
-65	5,0		5,0

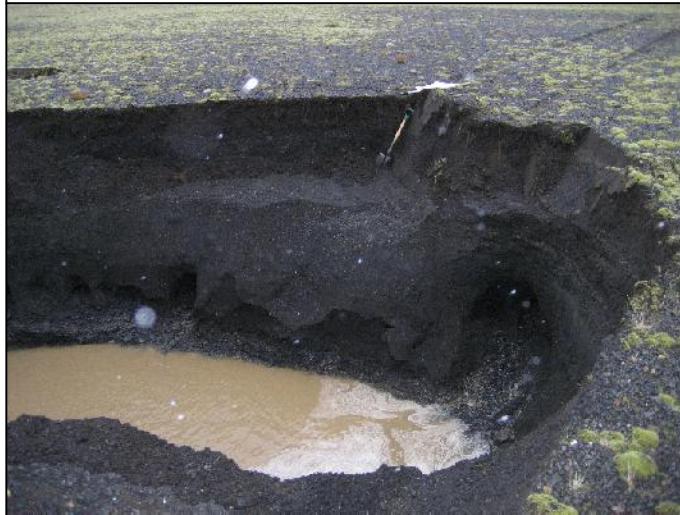
Photo:

Elev. [m.a.s.l.]	Depth [m]	Description	Depth [m]	Soil Profile	G.w.t. [m]	Bottom [m]	Sample [m]
-70		Sand & gravel - with organic layers Piezometer installed					
-69	1,0	Groundwater table at 0,92 m [19.09.'06]	1,0				
-69	2,0	Sand & gravel from 0,5 m	2,0				1,3-1,5
-68	3,0		3,0				
-67	3,3	Bottom at 3,3 m	3,3				
-67	4,0	Bedrock not found	4,0				
-66	5,0		5,0				
-65

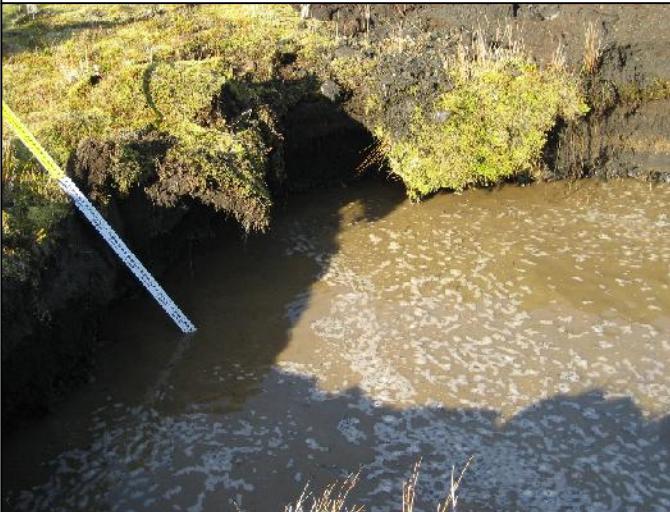
Photo:

Elev. [m.a.s.l.]	Depth [m]	Description	Depth [m]	Soil Profile	G.w.t. [m]	Bottom [m]	Sample [m]
60		Sand & gravel - with organic layers					0,6-0,7
59	1,0	Groundwater table at 0,8 m [23.09.'06]	1,0				
58	2,0	Sand & gravel from 0,8 m	2,0				
58	2,3	Sandstone at 2,3 m	2,3				
57	3,0		3,0				
56	4,0		4,0				
55	5,0		5,0

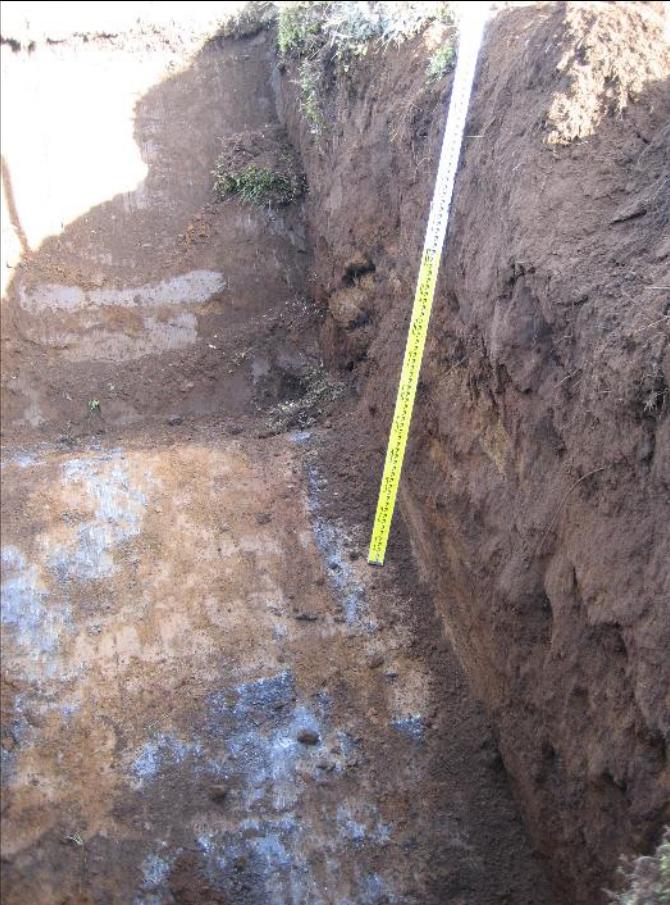
Photo:

Elev. [m.a.s.l.]	Depth [m]	Description	Depth [m]	Soil Profile	G.w.t. [m]	Bottom [m]	Sample [m]
- 72		Loess					
- 71	1,0	Loess - with thin sand layers from 0,6m	1,0				1,0-1,2
- 70	2,0	Scoria/Lava at 1,6m	2,0				
- 69	3,0		3,0				
- 68	4,0		4,0				
- 67	5,0		5,0

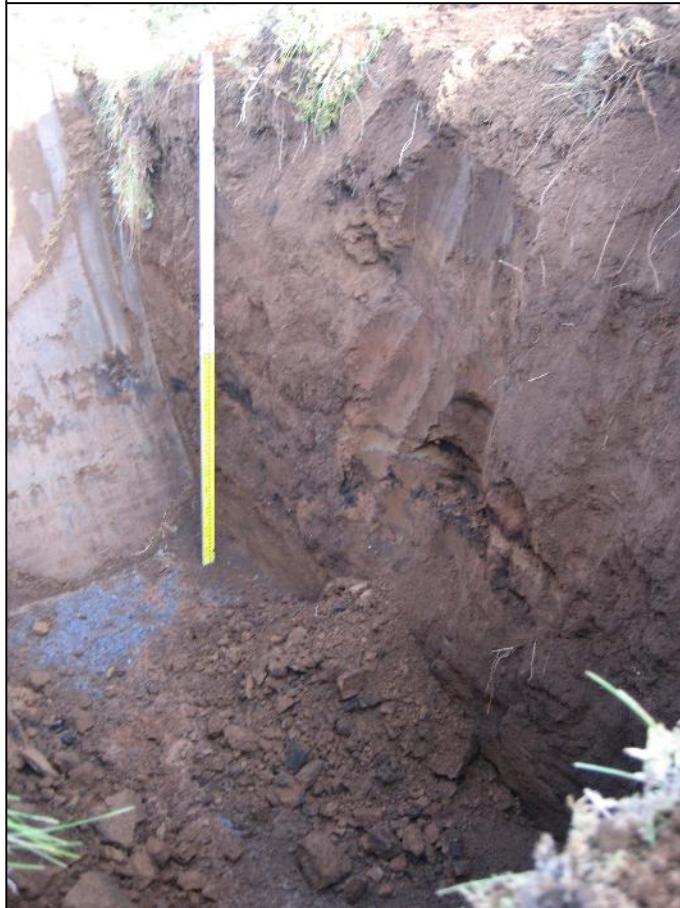
Photo:

Elev. [m.a.s.l.]	Depth [m]	Description	Depth [m]	Soil Profile	G.w.t. [m]	Bottom [m]	Sample [m]
71		Loess					
	1,0	Loess - with thin sand layers from 0,9 m	1,0	1,0			1,0-1,2
70							
	2,0	Scoria/Lava at 2,0 m	2,0	2,0			
69							
	3,0		3,0				
68							
	4,0		4,0				
67							
	5,0		5,0				
66

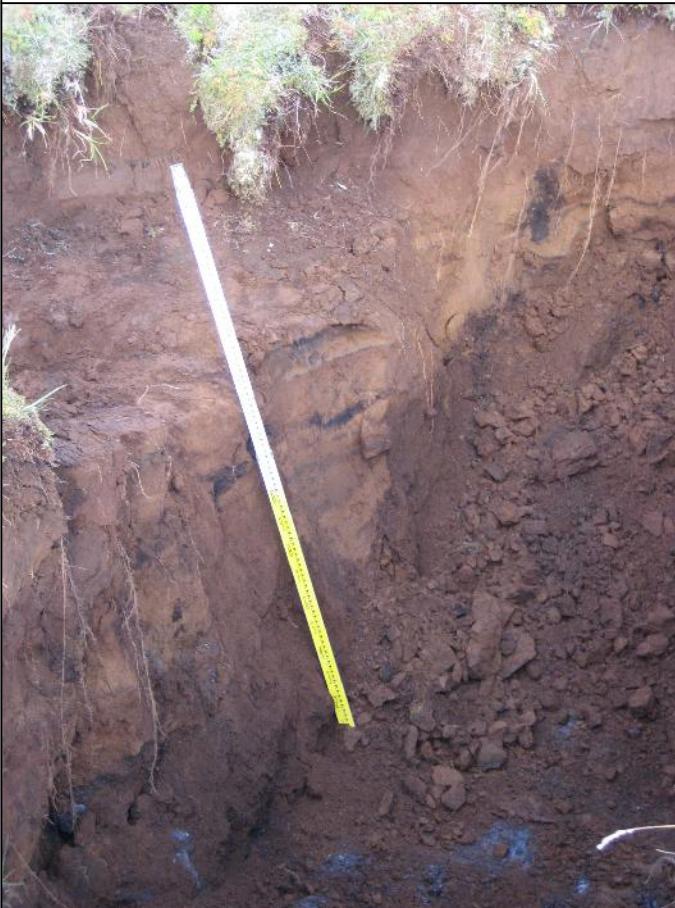
Photo:

Elev. [m.a.s.l.]	Depth [m]	Description	Depth [m]	Soil Profile	G.w.t. [m]	Bottom [m]	Sample [m]
70		Loess					
69	1,0	Loess - with thin sand layers from 0,8 m	1,0				1,0-1,2
68	2,0	Scoria/Lava at 2,4 m	2,0				
67	3,0		3,0				
66	4,0		4,0				
65	5,0		5,0

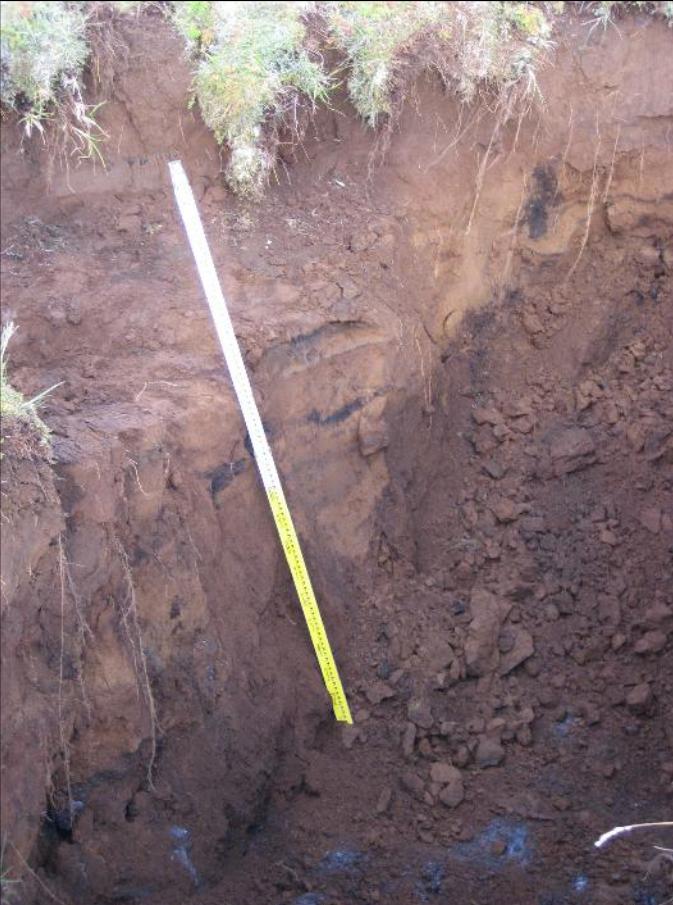
Photo:

Elev. [m.a.s.l.]	Depth [m]	Description	Depth [m]	Soil Profile	G.w.t. [m]	Bottom [m]	Sample [m]
		Loess					0,6-0,7
-71	1,0	Loess - with thin sand layers from 0,8 m	1,0				1,5-1,7
-70	2,0	Scoria/Lava at 2,0 m	2,0				
-69	3,0		3,0				
-68	4,0		4,0				
-67	5,0		5,0

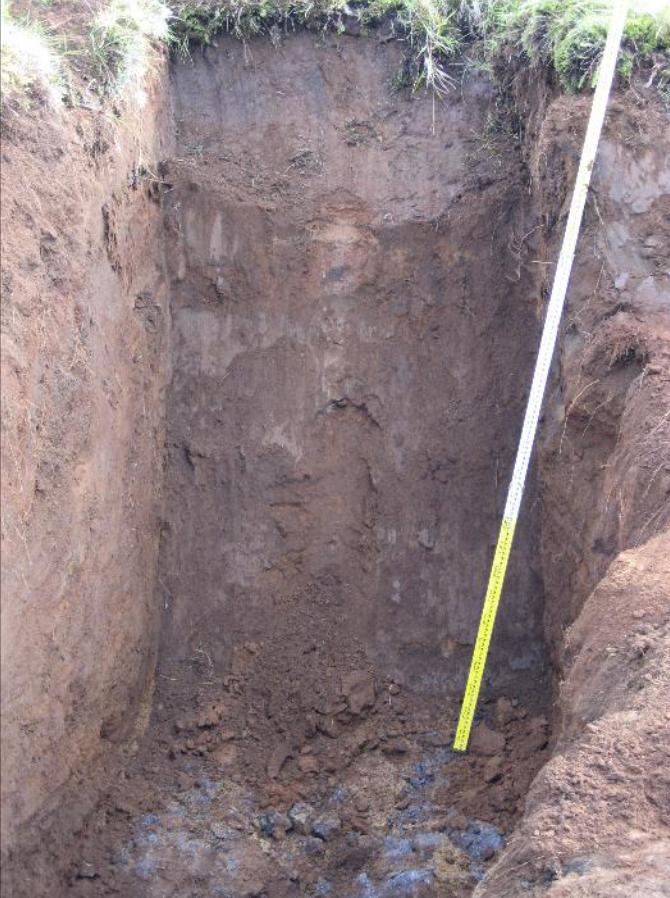
Photo:

Elev. [m.a.s.l.]	Depth [m]	Description	Depth [m]	Soil Profile	G.w.t. [m]	Bottom [m]	Sample [m]
-70	1,0	Loess	1,0				1,0-1,2
-69	2,0	Loess - with many thin sand layers from 1,5 m	2,0				2,0-2,2
-68	3,0	Scoria at 2,8 m	3,0				
-67	4,0		4,0				
-66	5,0		5,0				
-65

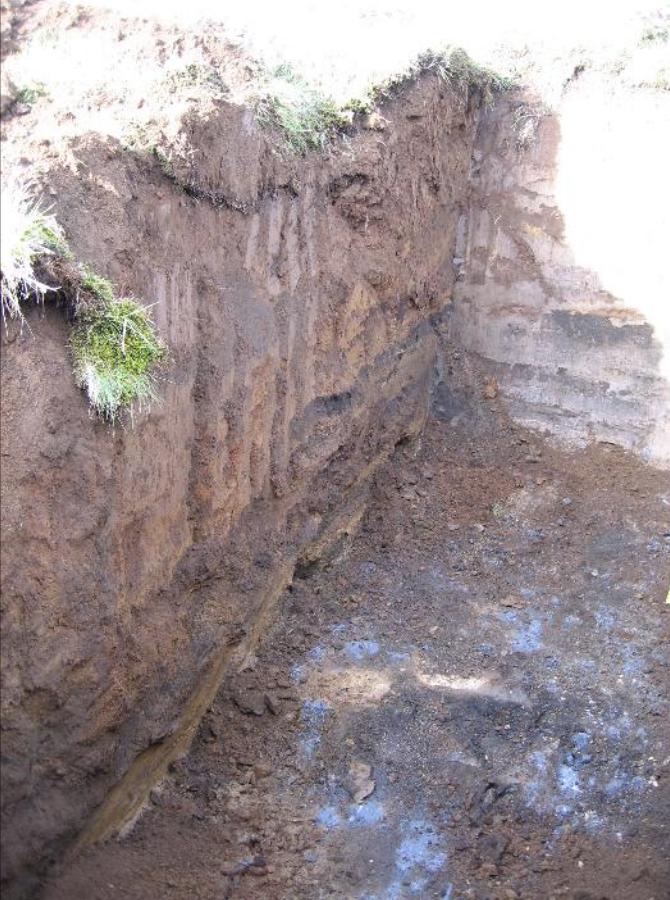
Photo:

Elev. [m.a.s.l.]	Depth [m]	Description	Depth [m]	Soil Profile	G.w.t. [m]	Bottom [m]	Sample [m]
		Loess					
-69	1,0	Loess - with thin sand layers from 0,9 m	1,0				1,0-1,2
-68	2,0	Scoria/Lava at 2,0 m	2,0				
-67	3,0		3,0				
-66	4,0		4,0				
-65	5,0		5,0

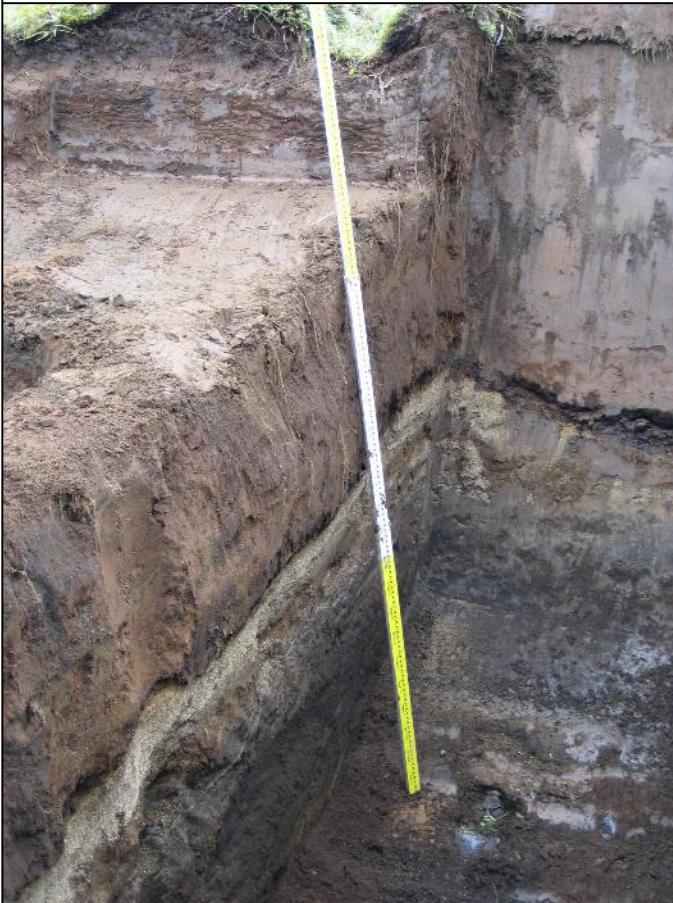
Photo:

Elev. [m.a.s.l.]	Depth [m]	Description	Depth [m]	Soil Profile	G.w.t. [m]	Bottom [m]	Sample [m]
-70		Loess					
-69	1,0		1,0	1,0			1,0-1,2
-68	1,0	Loess - with thin sand layers from 0,9 m	1,0				
-68	2,0	Sand & gravel - Tephra layer from 1,7 m to 1,9 m	2,0	2,0			2,0-2,1
-68	3,0	Scoria at 3,0 m	3,0	3,0			
-67							
-66	4,0		4,0				
-66	5,0		5,0

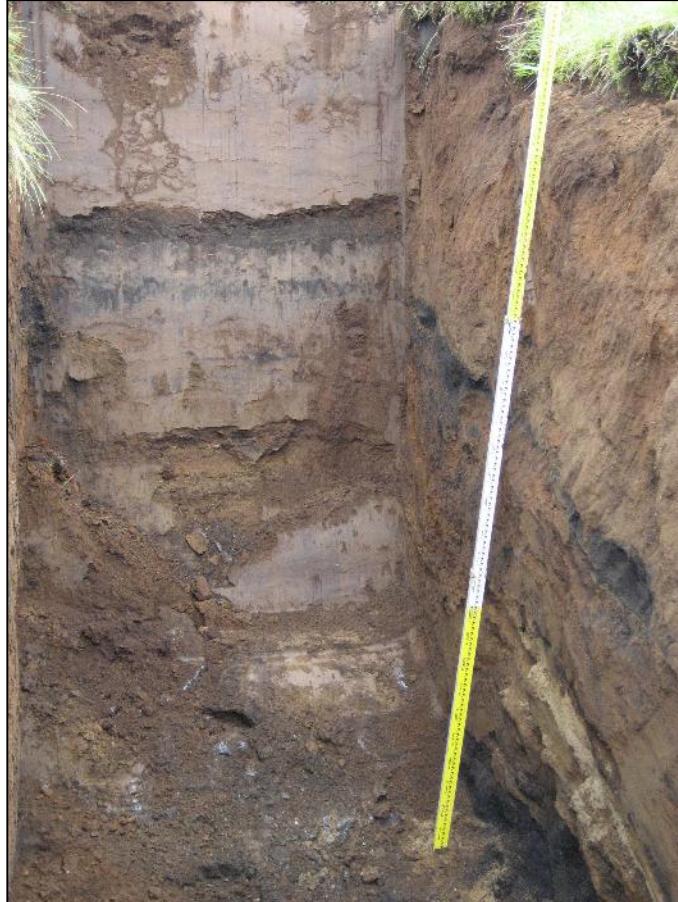
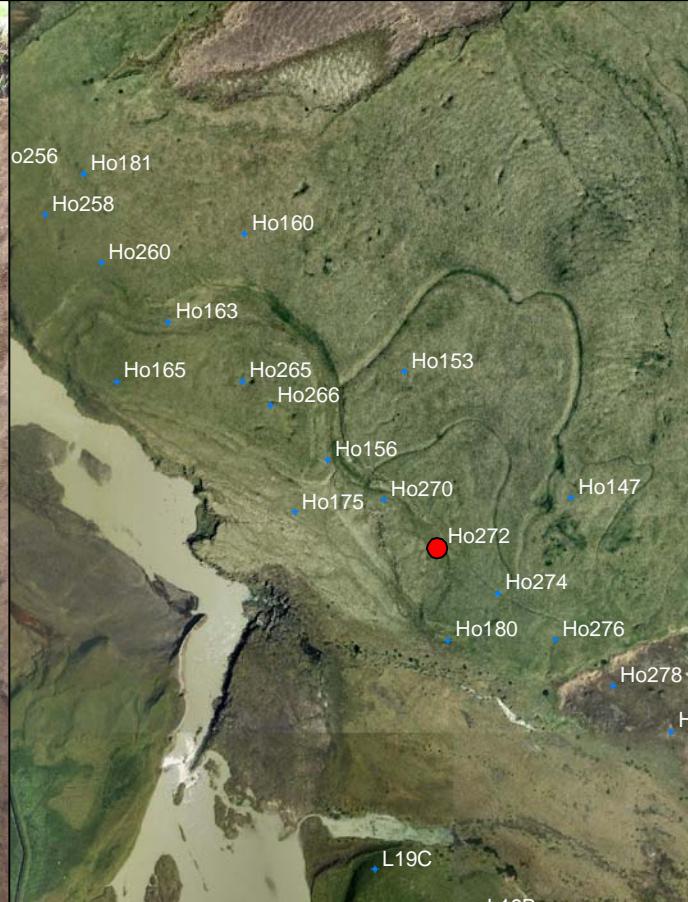
Photo:

Elev. [m.a.s.l.]	Depth [m]	Description	Depth [m]	Soil Profile	G.w.t. [m]	Bottom [m]	Sample [m]
		Loess					
-70	1,0		1,0				1,0-1,1
		Loess - with thin sand layers					
-69	2,0		2,0				1,8-2,0 2,0-2,2
		Sand & gravel - Tephra layer from 2,0 m to 2,2 m					
-68	3,0	Scoria at 3,0 m	3,0				
-67	4,0		4,0				
-66	5,0		5,0

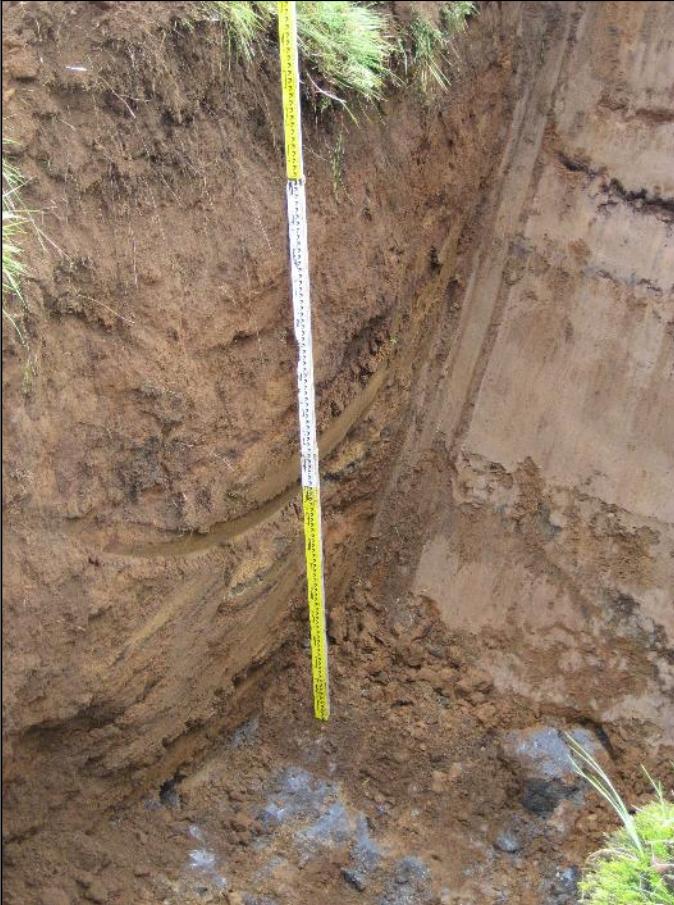
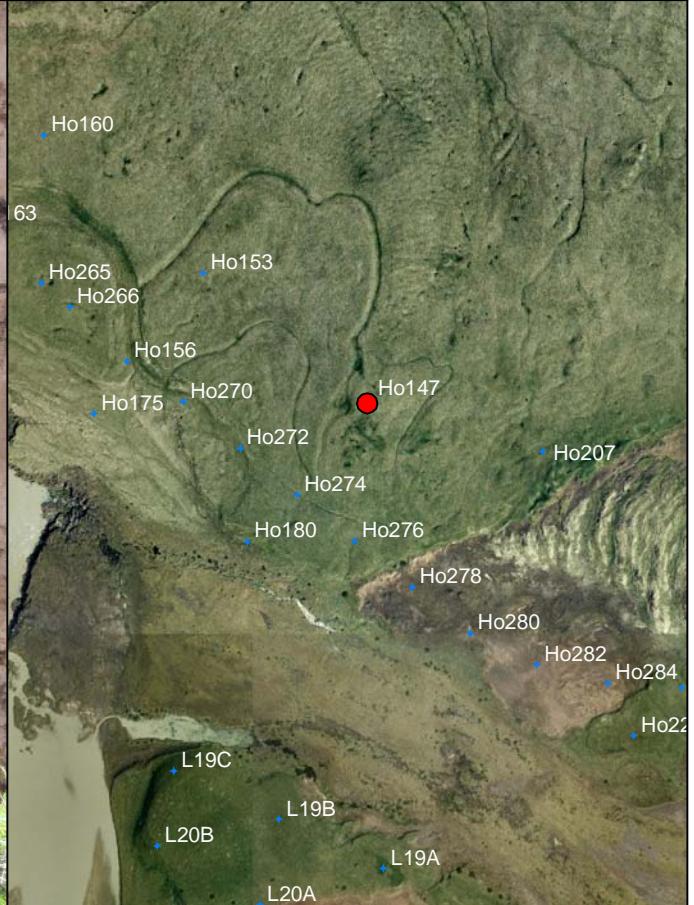
Photo:

Elev. [m.a.s.l.]	Depth [m]	Description	Depth [m]	Soil Profile	G.w.t. [m]	Bottom [m]	Sample [m]
- 72		Loess					0,6-0,7
- 71	1,0	Loess - with thin sand layers from 0,7 m	1,0				
- 70	2,0		2,0				2,0-2,2
- 69	3,0	Scoria at 2,5 m	3,0				
- 68	4,0		4,0				
- 67	5,0		5,0

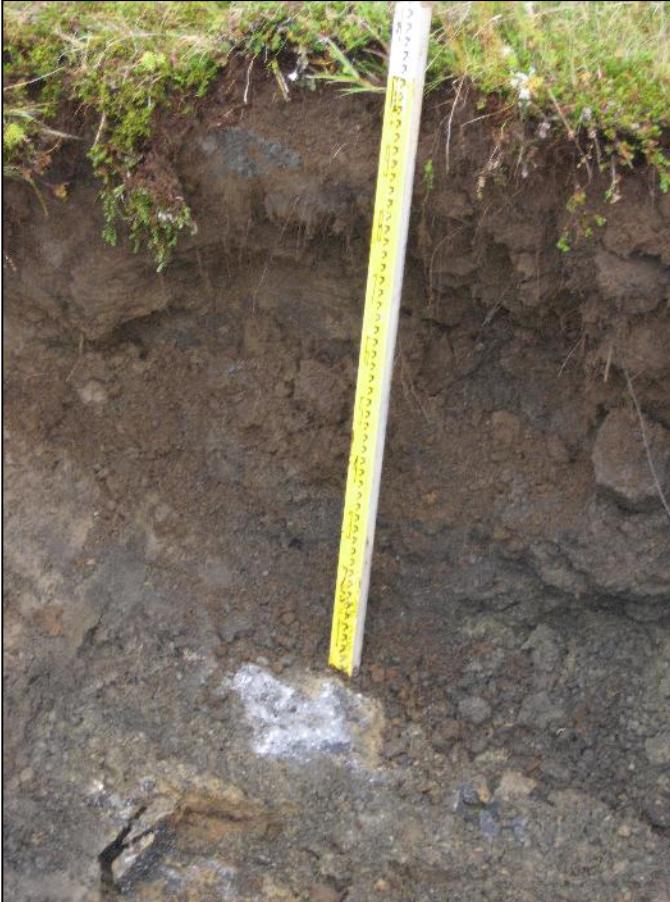
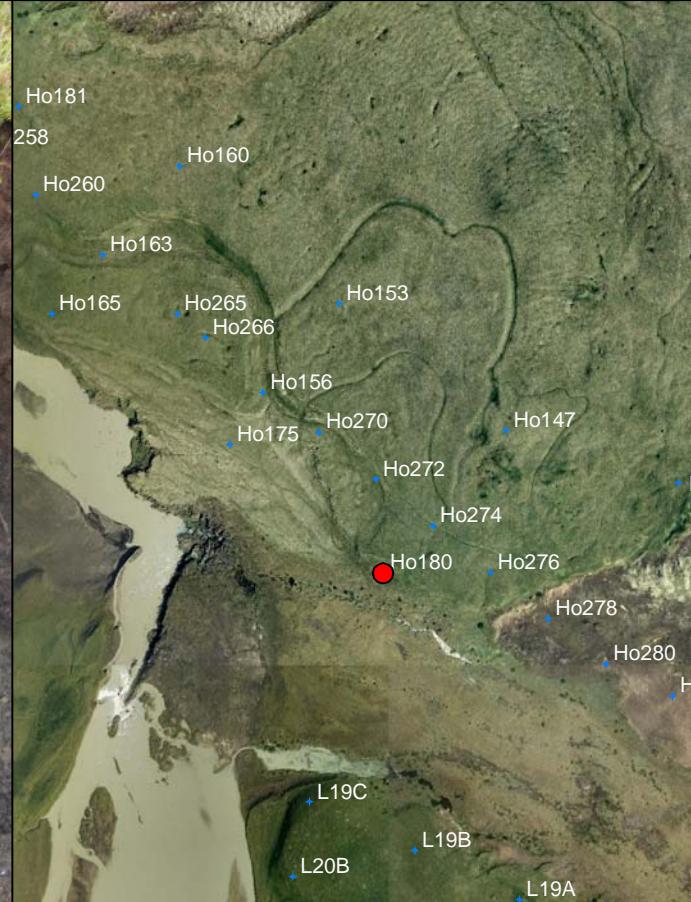
Photo:

Elev. [m.a.s.l.]	Depth [m]	Description	Depth [m]	Soil Profile	G.w.t. [m]	Bottom [m]	Sample [m]
-69		Sand & gravel - with organic layers					
-68	1,0	Scoria at 1,0 m	1,0				
-67	2,0		2,0				
-66	3,0		3,0				
-65	4,0		4,0				
-64	5,0		5,0

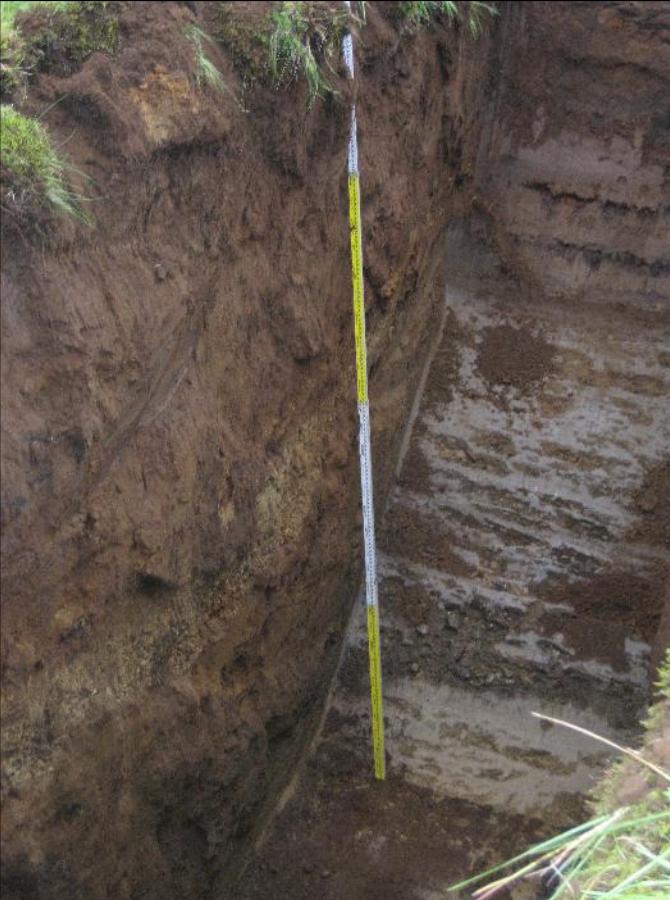
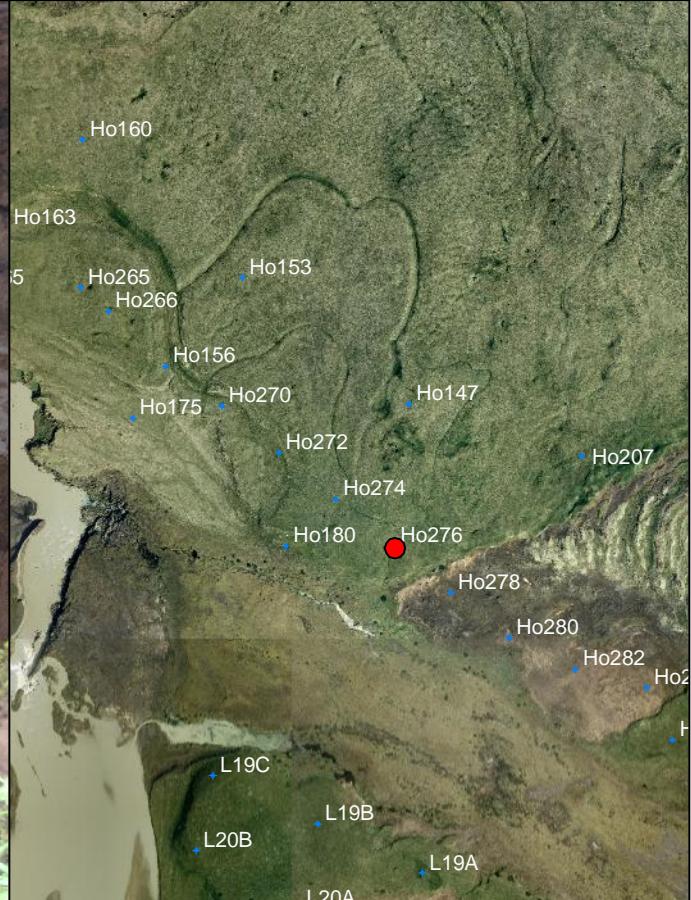
Photo:

Elev. [m.a.s.l.]	Depth [m]	Description	Depth [m]	Soil Profile	G.w.t. [m]	Bottom [m]	Sample [m]
71	1,0	Loess	1,0				
70	2,0	Sand & gravel - Tephra layer from 1,8 m to 2,0 m	2,0			1,8-2,0	
69	3,0	Loess - with thin sand layers from 2,0 m	3,0			3,0-3,2	
68	4,0	Scoria at 4,0 m	4,0				
67	5,0		5,0				
66

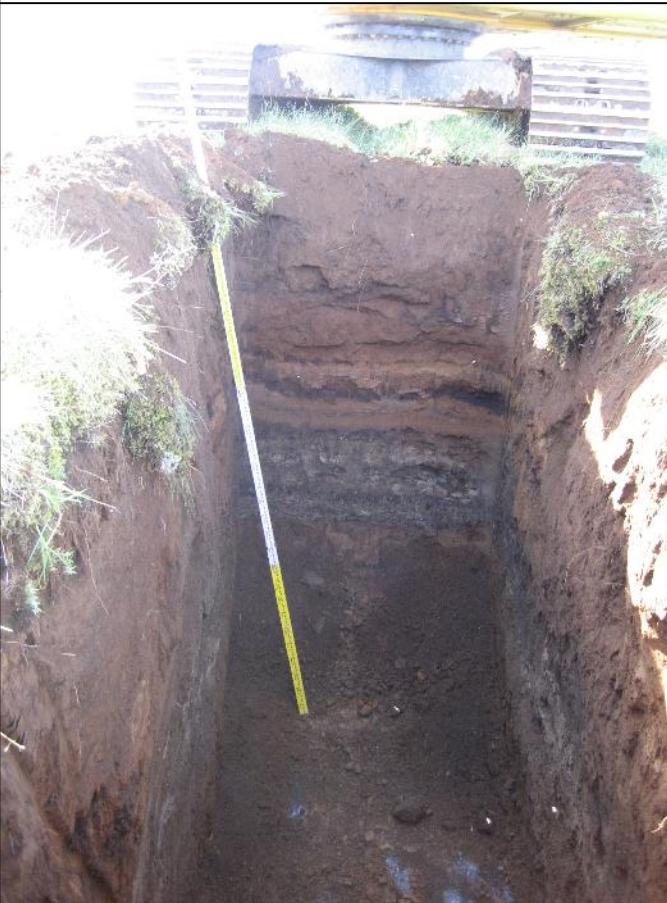
Photo:

Elev. [m.a.s.l.]	Depth [m]	Description	Depth [m]	Soil Profile	G.w.t. [m]	Bottom [m]	Sample [m]
		Loess					
-71	1,0		1,0				1,0-1,2
-70	2,0	Loess - with thin sand layers from 1,3 m	2,0				2,0-2,1
-69	3,0	Sand & gravel - Tephra layer from 2,1 m to 2,6 m	3,0				
-68	4,0	Scoria at 3,3 m	4,0				
-67	5,0		5,0

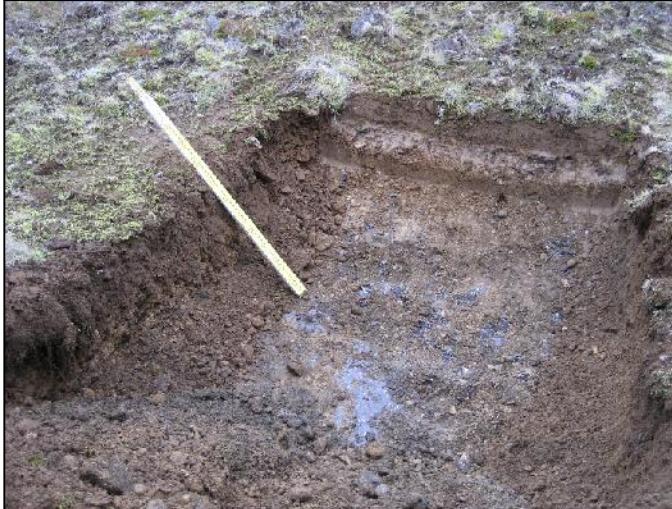
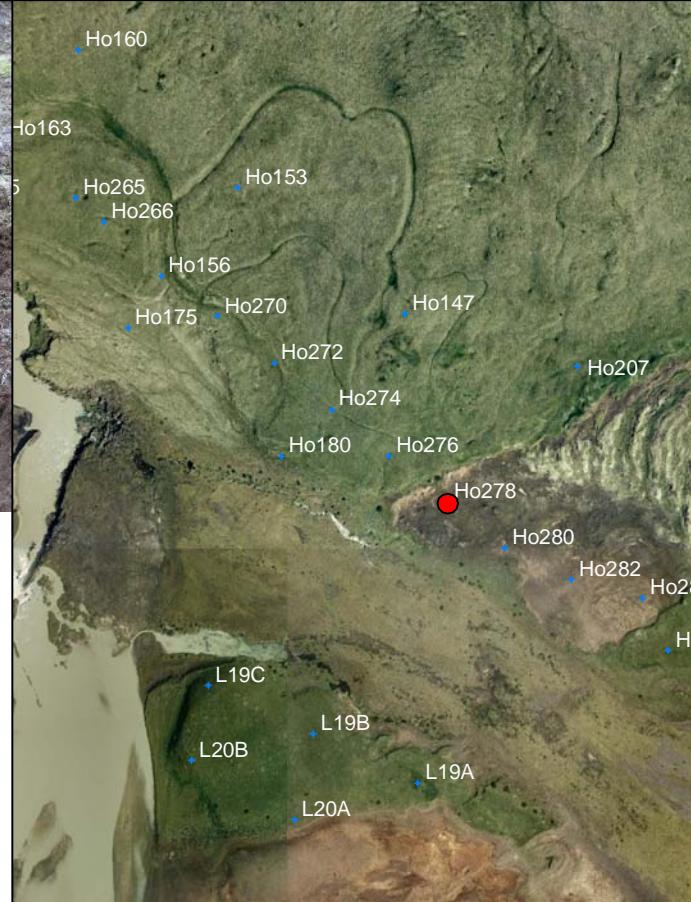
Photo:

Elev. [m.a.s.l.]	Depth [m]	Description	Depth [m]	Soil Profile	G.w.t. [m]	Bottom [m]	Sample [m]
		Sand & gravel - with organic layers					
		Scoria at 0,5 m					
-68	1,0		1,0				
-67	2,0		2,0				
-66	3,0		3,0				
-65	4,0		4,0				
-64	5,0		5,0
