Holtavirkjun Hydroelectric Project

Ground Investigation Report (GIR)

Title: Holtavirkjun Hydroelectric Project. Ground Investigation Report (GIR)

Abstract: In this report soil investigation carried out for Holtavirkjun is described.

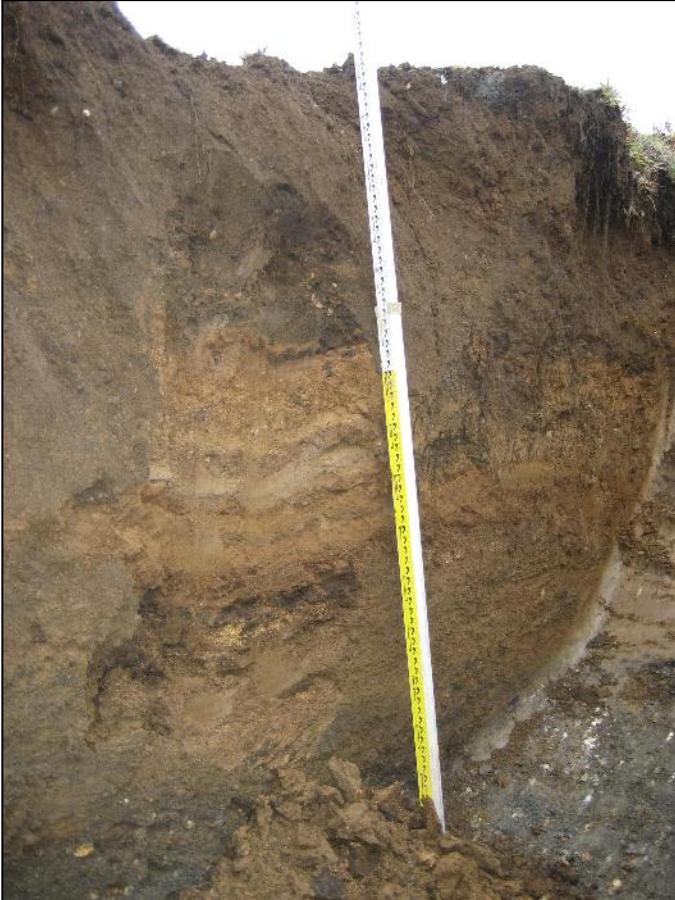
Photo:

Elev. [m.a.s.l.]	Depth [m]	Description	Depth [m]	Soil Profile	G.w.t. [m]	Bottom [m]	Sample [m]
		Loess					
-69	1,0	Loess - with thin sand layers from 0,8 m	1,0				1,0-1,1
-68	2,0	Scoria/Lava at 1,8 m	2,0				
-67	3,0		3,0				
-66	4,0		4,0				
-65	5,0		5,0

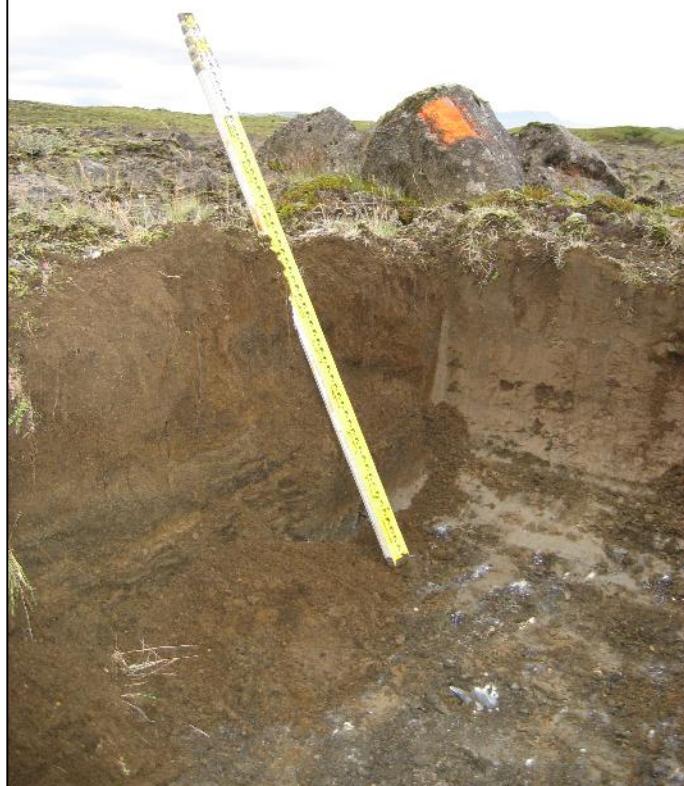
Photo:

Elev. [m.a.s.l.]	Depth [m]	Description	Depth [m]	Soil Profile	G.w.t. [m]	Bottom [m]	Sample [m]
69		Loess - with thin sand layers					
	1,0	Scoria/Lava at 0,7 m	1,0				
68							
	2,0		2,0				
67							
	3,0		3,0				
66							
	4,0		4,0				
65							
	5,0		5,0				
64

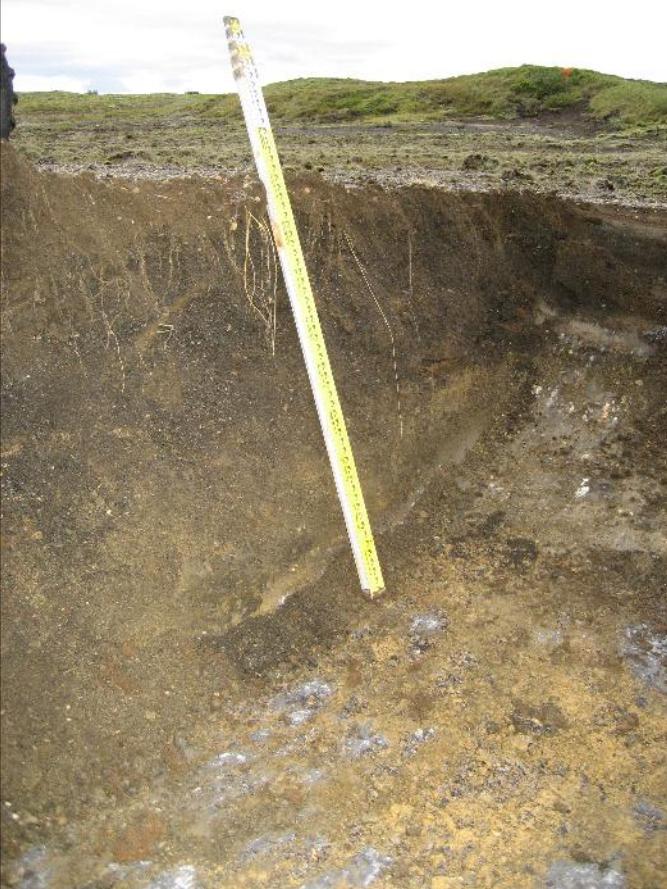
Photo:

Elev. [m.a.s.l.]	Depth [m]	Description	Depth [m]	Soil Profile	G.w.t. [m]	Bottom [m]	Sample [m]
		Sand & gravel - with organic layers					
69	1,0	Scoria/Lava at 0,9 m	1,0				
68	2,0		2,0				
67	3,0		3,0				
66	4,0		4,0				
65	5,0		5,0

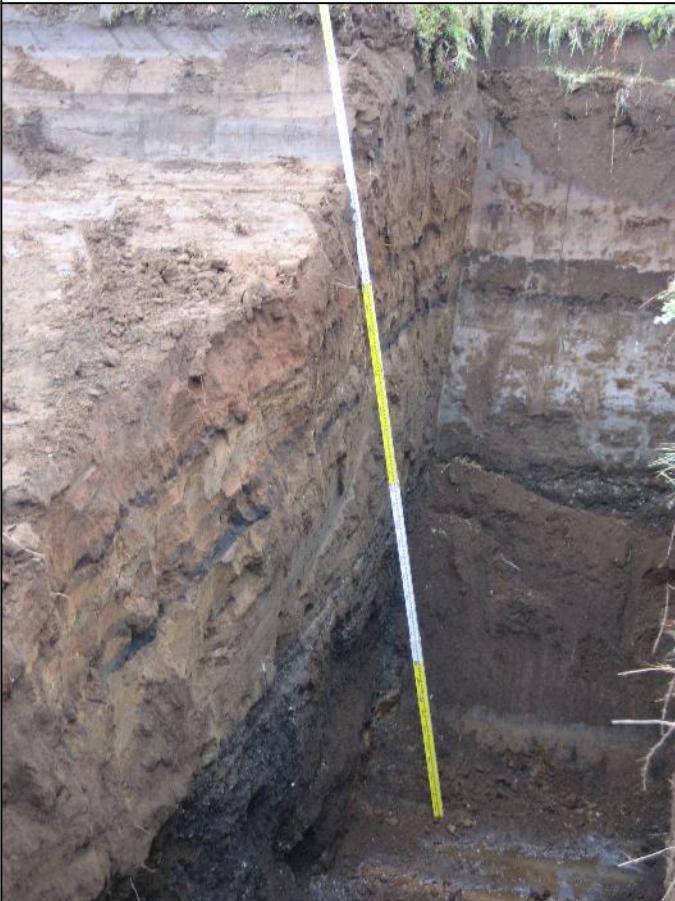
Photo:

Elev. [m.a.s.l.]	Depth [m]	Description	Depth [m]	Soil Profile	G.w.t. [m]	Bottom [m]	Sample [m]
72	1,0	Loess	1,0	1,0			0,8-1,0
71	2,0	Loess - with thin sand layers from 1,1 m	2,0	2,0			2,0-2,1
70	3,0	Sand & gravel from 2,3 m	3,0	3,0			2,6-2,7
69	4,0	Groundwater table at 3,5 m	4,0	4,0	3,5		
68	5,0	Scoria at 4,1 m	5,0				
67

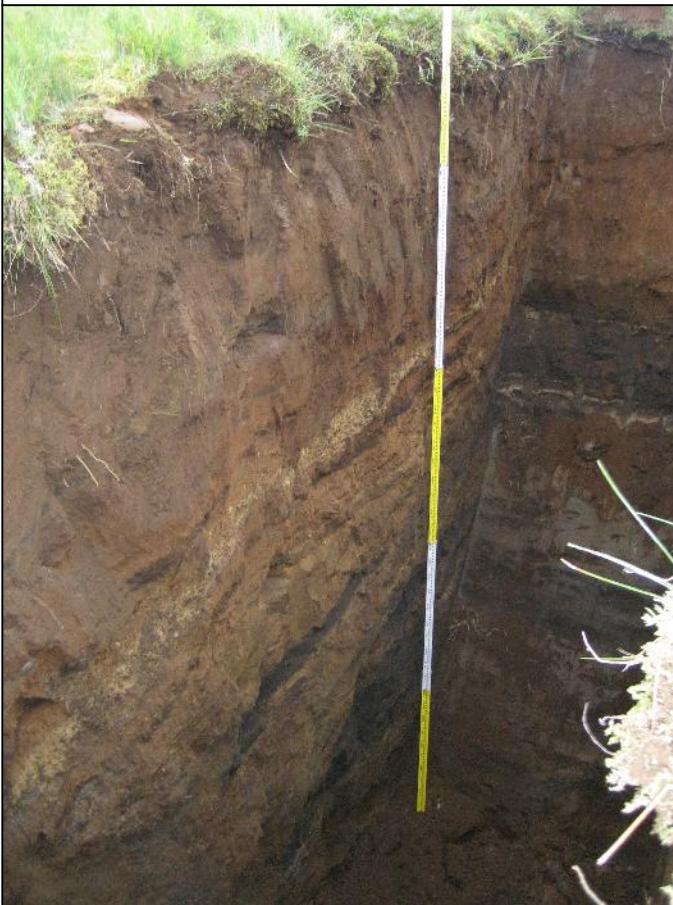
Photo:

Elev. [m.a.s.l.]	Depth [m]	Description	Depth [m]	Soil Profile	G.w.t. [m]	Bottom [m]	Sample [m]
72	1,0	Loess	1,0				1,0-1,2
71	1,3	Loess - with thin sand layers from 1,3 m Sand & gravel - Tephra layer from 1,4 m to 1,6 m	1,3				
71	2,0	Loess - with thin sand layers	2,0				2,0-2,2
70	2,3	Fine sand - Tephra layer from 2,3 m to 2,4 m	2,3				
70	2,8	Loess - with thin sand layers Fine sand - Tephra layer from 2,8 m to 3,0 m	2,8				
69	3,0	Loess - with thin sand layers from 3,0 m	3,0				
68	4,0	Scoria at 4,6 m	4,0				
68	5,0		5,0

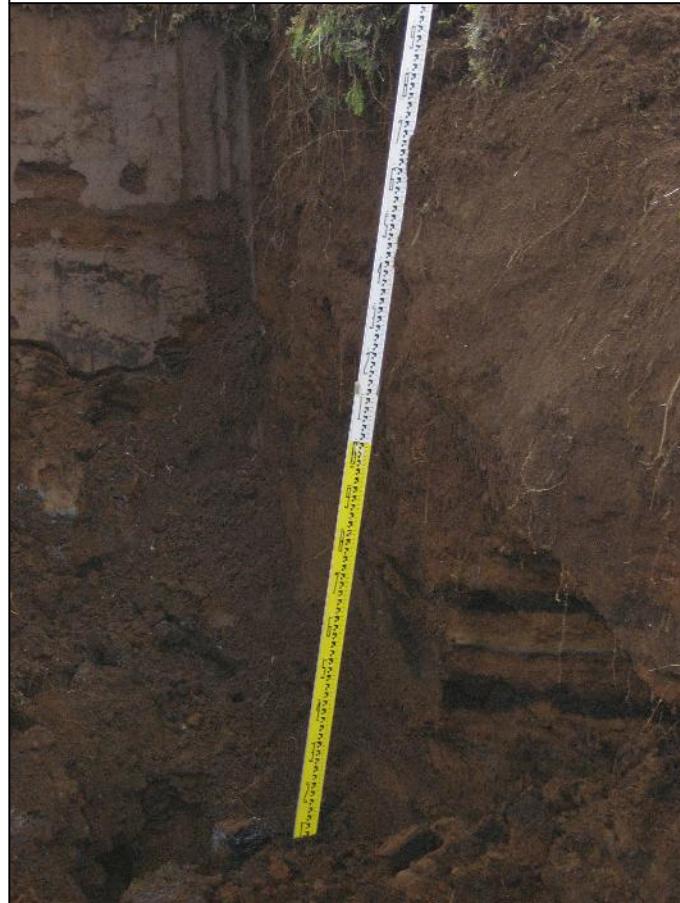
Photo:

Elev. [m.a.s.l.]	Depth [m]	Description	Depth [m]	Soil Profile	G.w.t. [m]	Bottom [m]	Sample [m]
		Loess					
-74	1,0		1,0				1,3-1,4
		Loess - with thin sand layers from 1,2 m					
-73	2,0	Scoria at 2,0 m	2,0				
-72	3,0		3,0				
-71	4,0		4,0				
-70	5,0		5,0

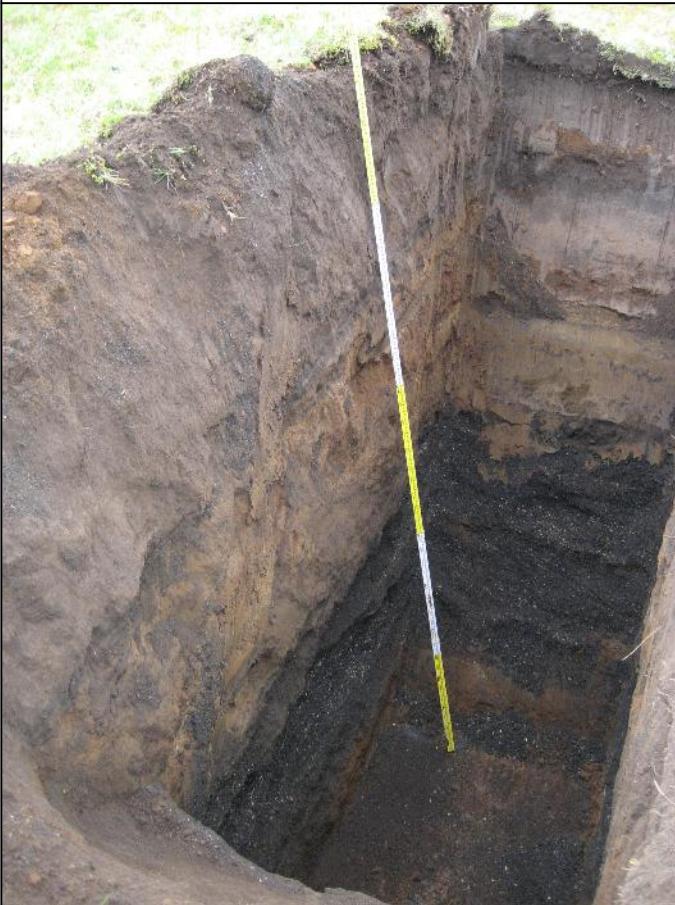
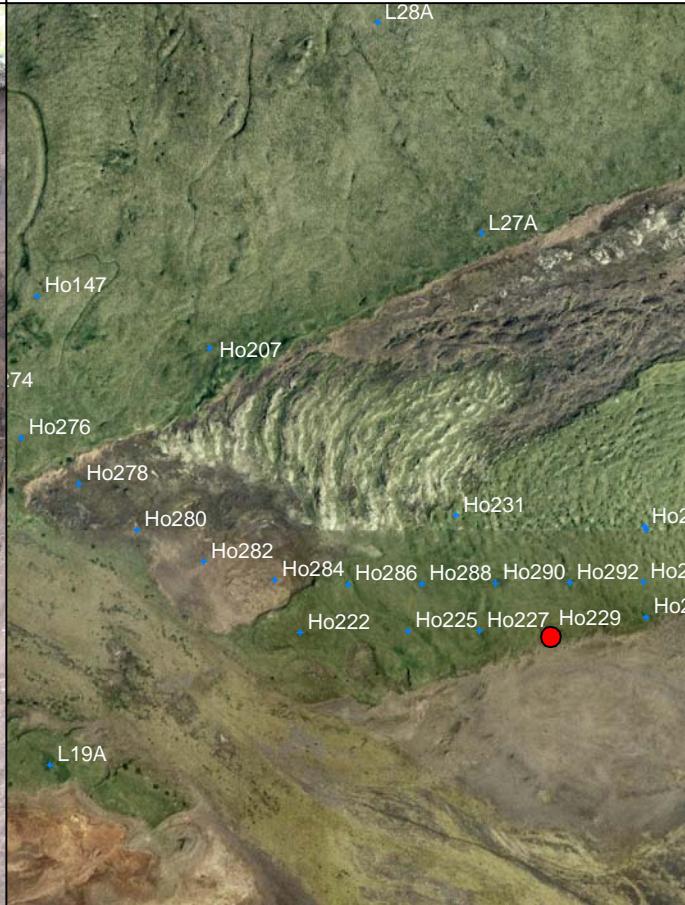
Photo:

Elev. [m.a.s.l.]	Depth [m]	Description	Depth [m]	Soil Profile	G.w.t. [m]	Bottom [m]	Sample [m]
-72	1,0	Loess	1,0				
-71	2,0	Loess - with thin sand layers from 1,0 m	2,0				
-70	3,0		3,0				
-69	4,0	Sand & gravel from 3,0 m	4,0				
-68	5,0	Scoria at 4,6 m	5,0

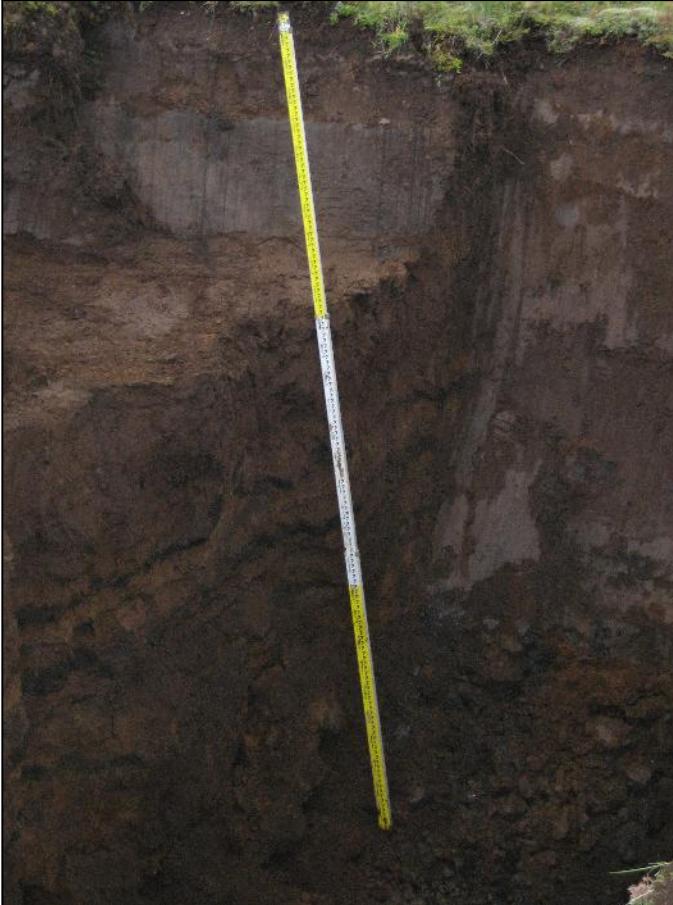
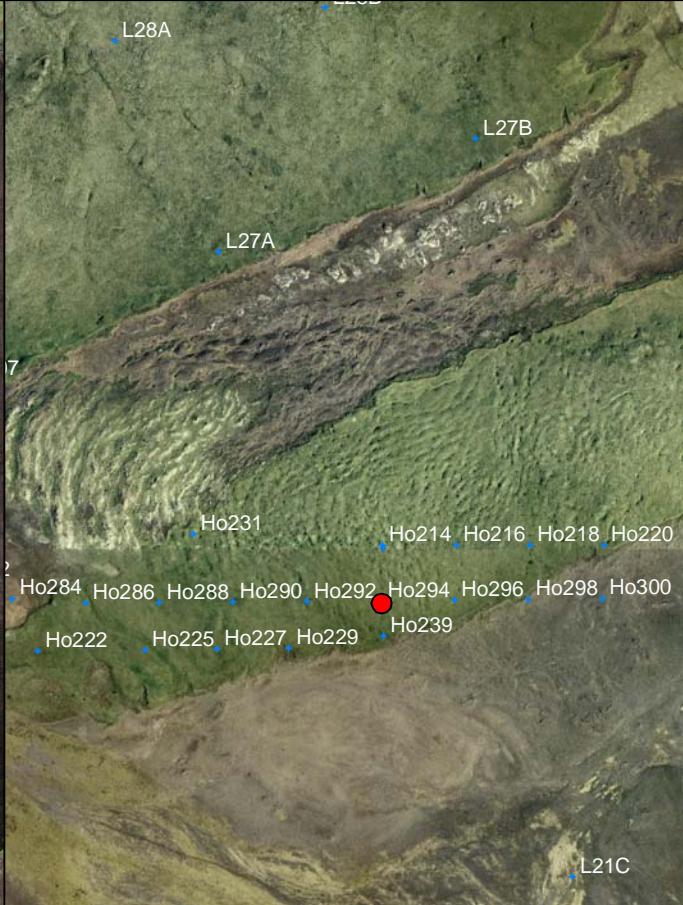
Photo:

Elev. [m.a.s.l.]	Depth [m]	Description	Depth [m]	Soil Profile	G.w.t. [m]	Bottom [m]	Sample [m]
		Loess					
-74	1,0		1,0				1,0-1,2
-73	2,0	Loess - with thin sand layers from 1,2 m	2,0				2,0-2,2
-72	3,0	Scoria at 3,0 m	3,0				
-71	4,0		4,0				
-70	5,0		5,0

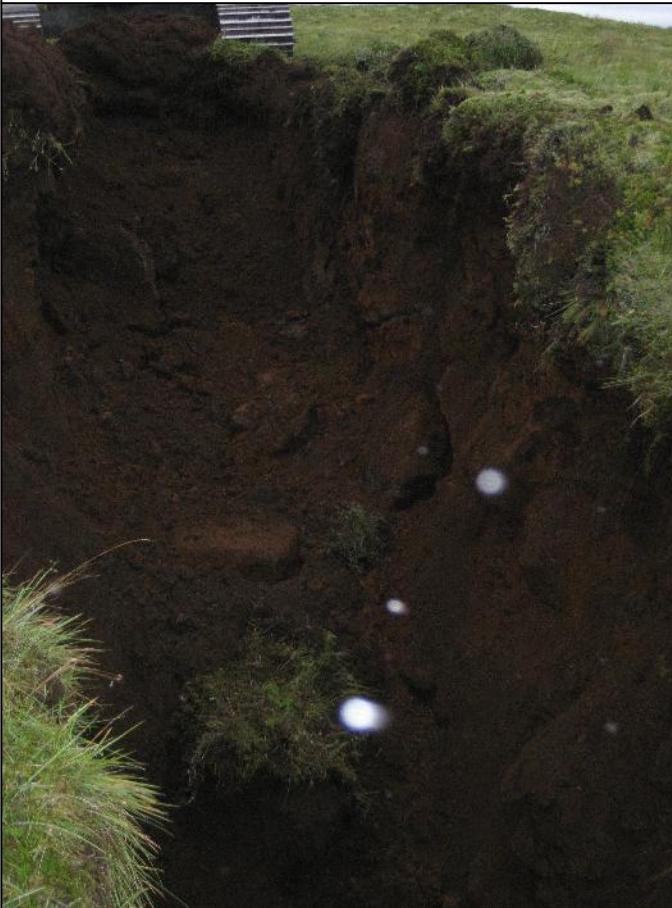
Photo:

Elev. [m.a.s.l.]	Depth [m]	Description	Depth [m]	Soil Profile	G.w.t. [m]	Bottom [m]	Sample [m]
- 74		Loess					
- 73	1,0	Loess - with thin sand layers	1,0				
- 72	2,0	Scoria at 1,5 m	2,0				
- 71	3,0		3,0				
- 70	4,0		4,0				
- 69	5,0		5,0

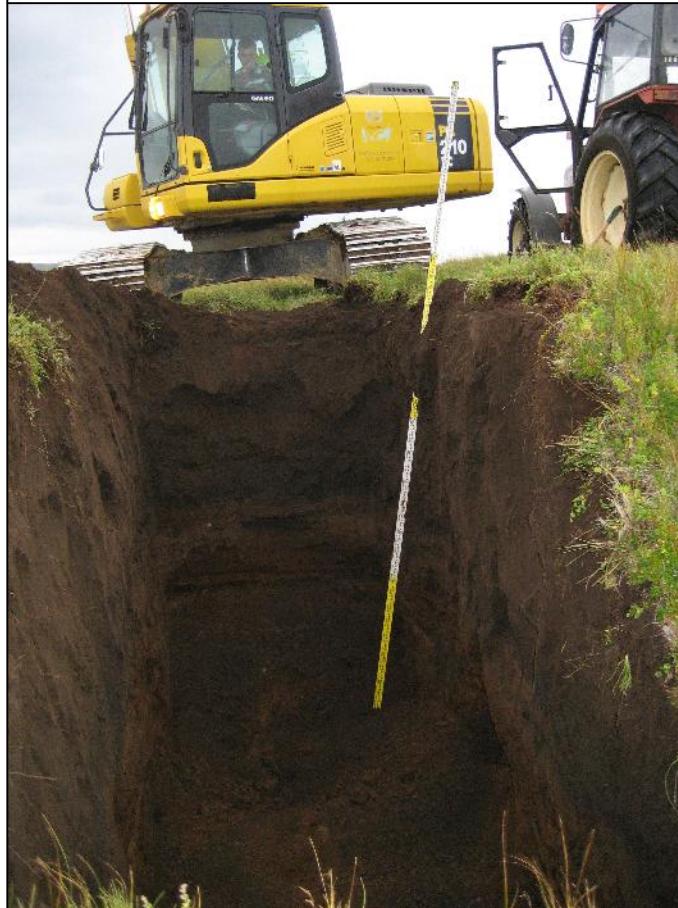
Photo:

Elev. [m.a.s.l.]	Depth [m]	Description	Depth [m]	Soil Profile	G.w.t. [m]	Bottom [m]	Sample [m]
74	1,0	Loess	1,0				1,0-1,1
73	2,0	Loess - with thin sand layers from 1,2 m	2,0				2,0-2,2
72	3,0	Scoria at 3,0 m	3,0				
71	4,0		4,0				
70	5,0		5,0

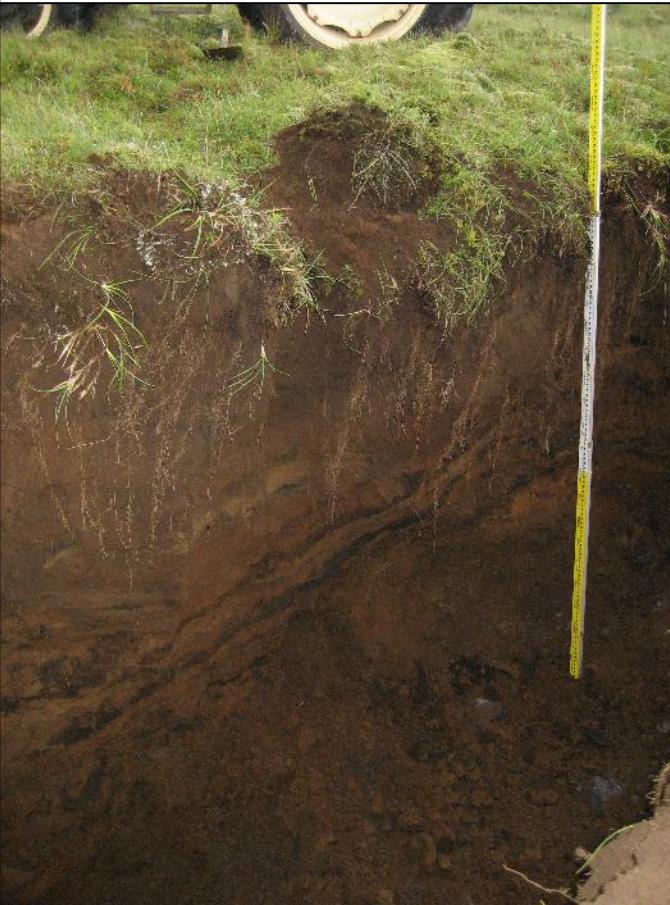
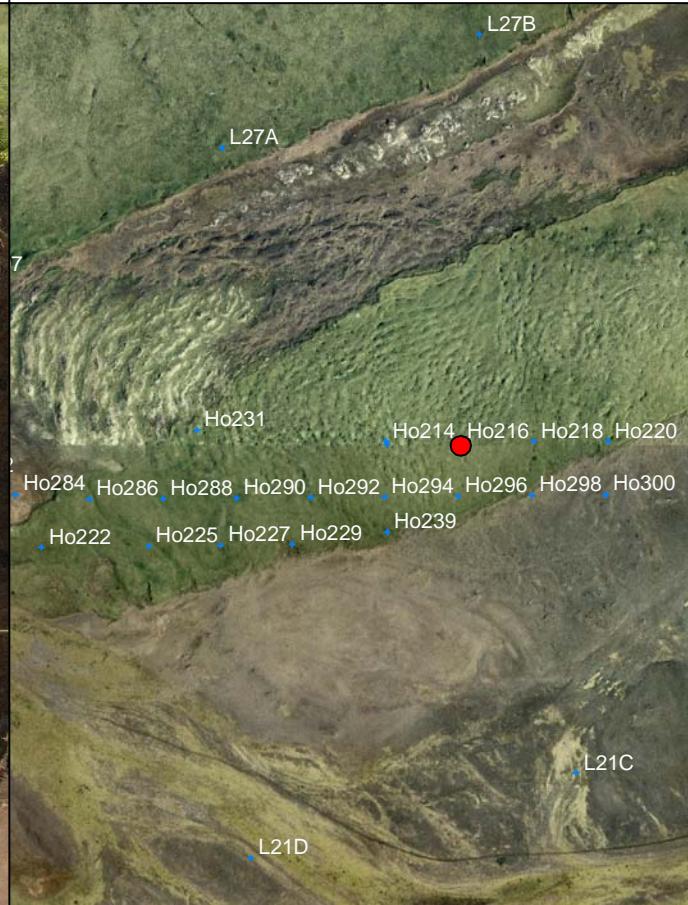
Photo:

Elev. [m.a.s.l.]	Depth [m]	Description	Depth [m]	Soil Profile	G.w.t. [m]	Bottom [m]	Sample [m]
		Loess					0,6-0,7
-73	1,0	Loess - with thin sand layers from 0,7 m	1,0				
-72	2,0	Scoria at 2,2 m	2,0				2,0-2,1
-71	3,0		3,0				
-70	4,0		4,0				
-69	5,0		5,0

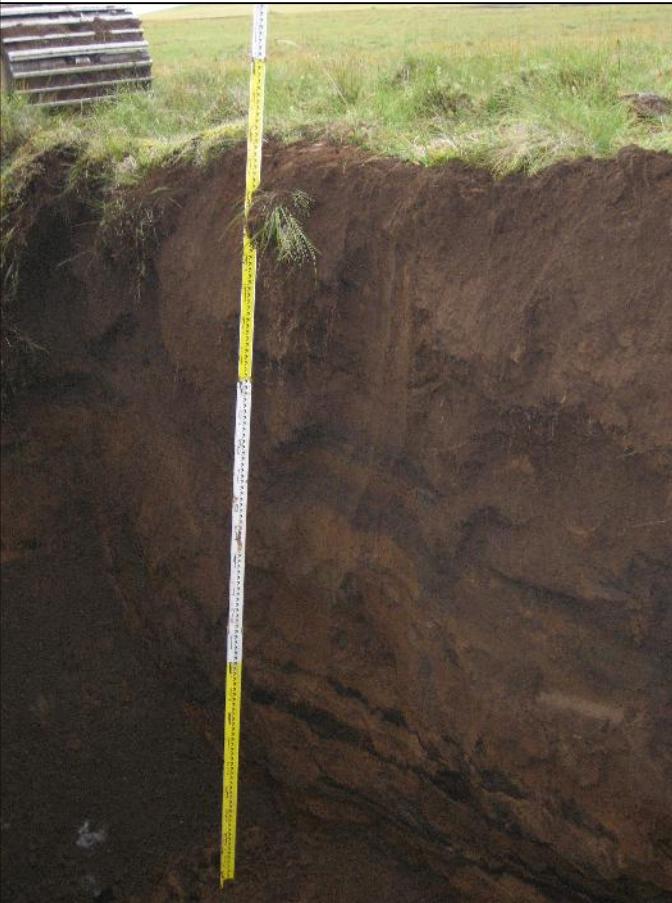
Photo:

Elev. [m.a.s.l.]	Depth [m]	Description	Depth [m]	Soil Profile	G.w.t. [m]	Bottom [m]	Sample [m]
- 74		Loess					
	1,0		1,0				
- 73		Loess - with thin sand layers from 0,6 m					1,5-1,7
	2,0		2,0				
- 72		Scoria at 2,6 m					
	3,0		3,0				
- 71							
	4,0		4,0				
- 70							
	5,0		5,0				
- 69

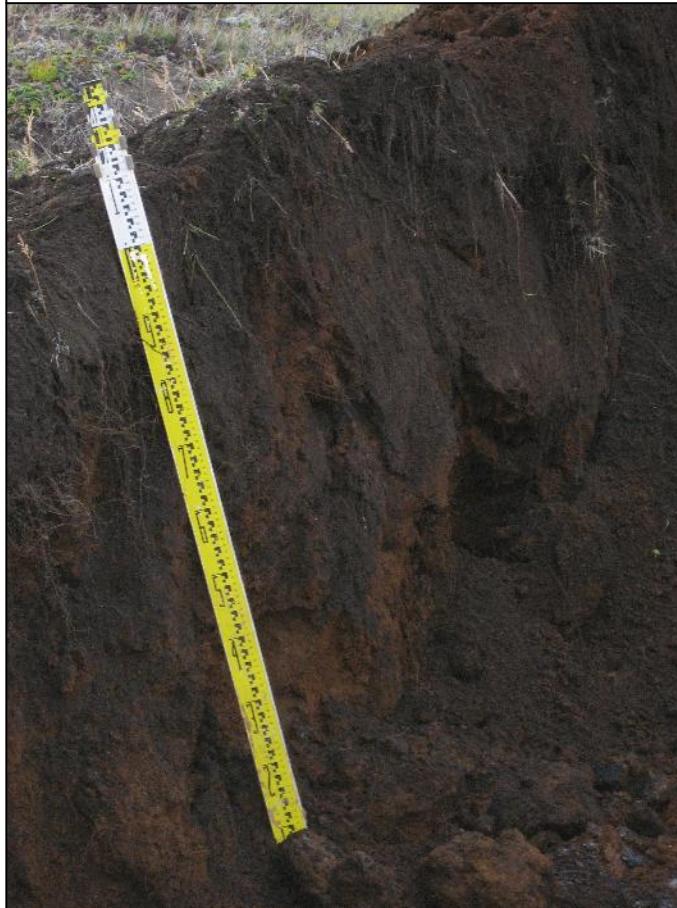
Photo:

Elev. [m.a.s.l.]	Depth [m]	Description	Depth [m]	Soil Profile	G.w.t. [m]	Bottom [m]	Sample [m]
		Sand & gravel - with organic layers					
-73	1,0	Scoria at 1,0 m	1,0				
-72	2,0		2,0				
-71	3,0		3,0				
-70	4,0		4,0				
-69	5,0		5,0

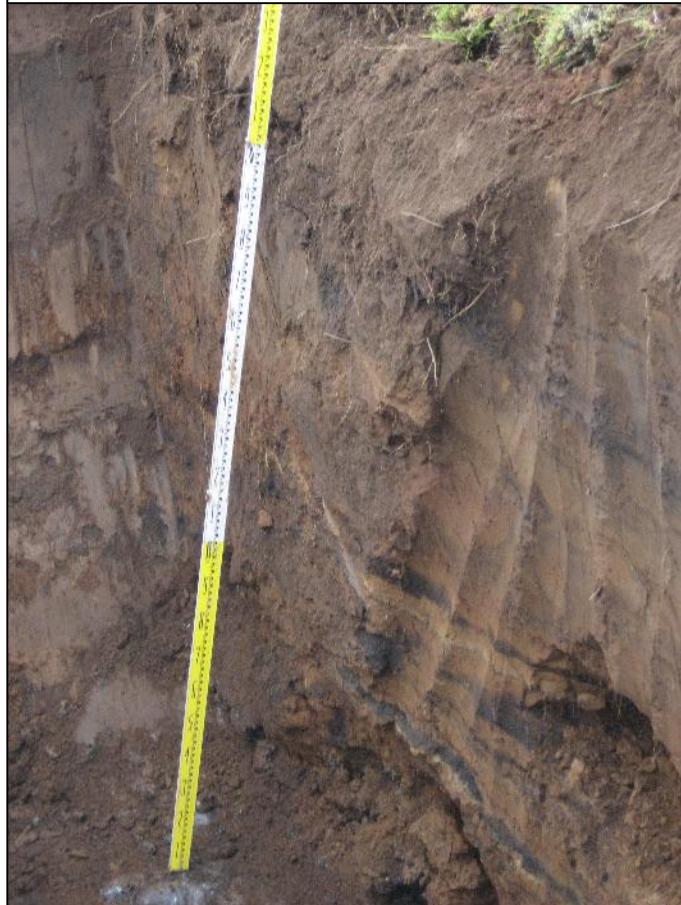
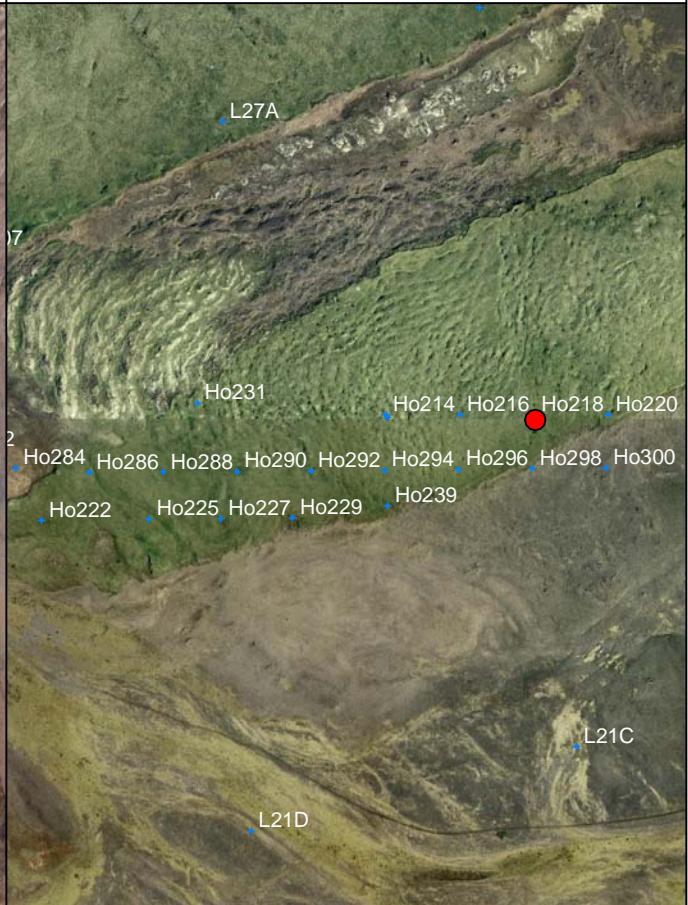
Photo:

Elev. [m.a.s.l.]	Depth [m]	Description	Depth [m]	Soil Profile	G.w.t. [m]	Bottom [m]	Sample [m]
-74	1,0	Loess	1,0				0,9-1,1
-73	2,0	Loess - with thin sand layers from 1,2 m	2,0				1,5-1,7
-72	3,0	Scoria at 2,5 m	3,0				
-71	4,0		4,0				
-70	5,0		5,0				
-69

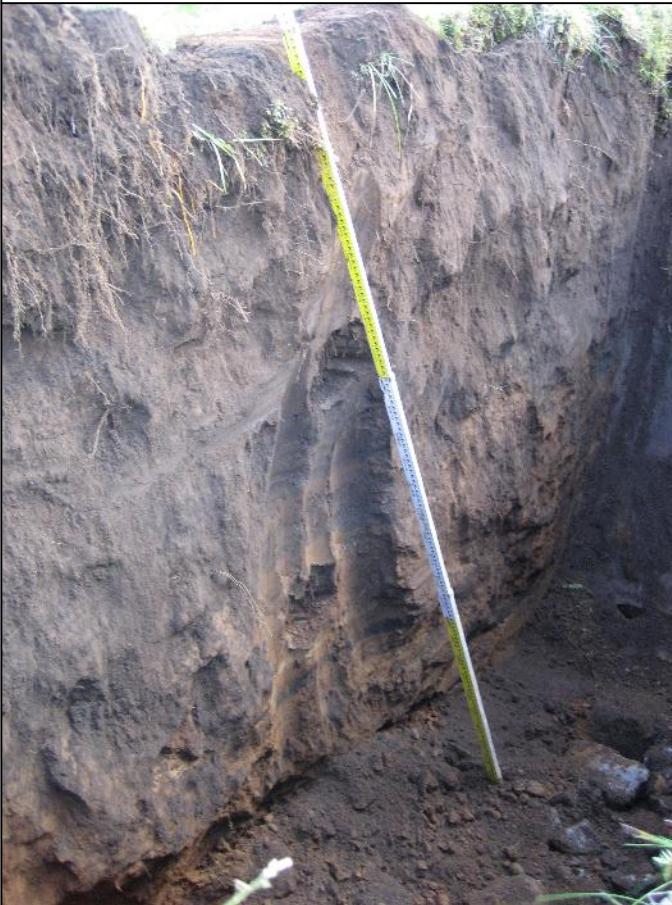
Photo:

Elev. [m.a.s.l.]	Depth [m]	Description	Depth [m]	Soil Profile	G.w.t. [m]	Bottom [m]	Sample [m]
		Loess					
-74	1,0		1,0				1,0-1,2
-73	2,0	Loess - with thin sand layers from 1,2 m	2,0				2,0-2,2
-72	3,0	Scoria at 3,1 m	3,0				
-71	4,0		4,0				
-70	5,0		5,0

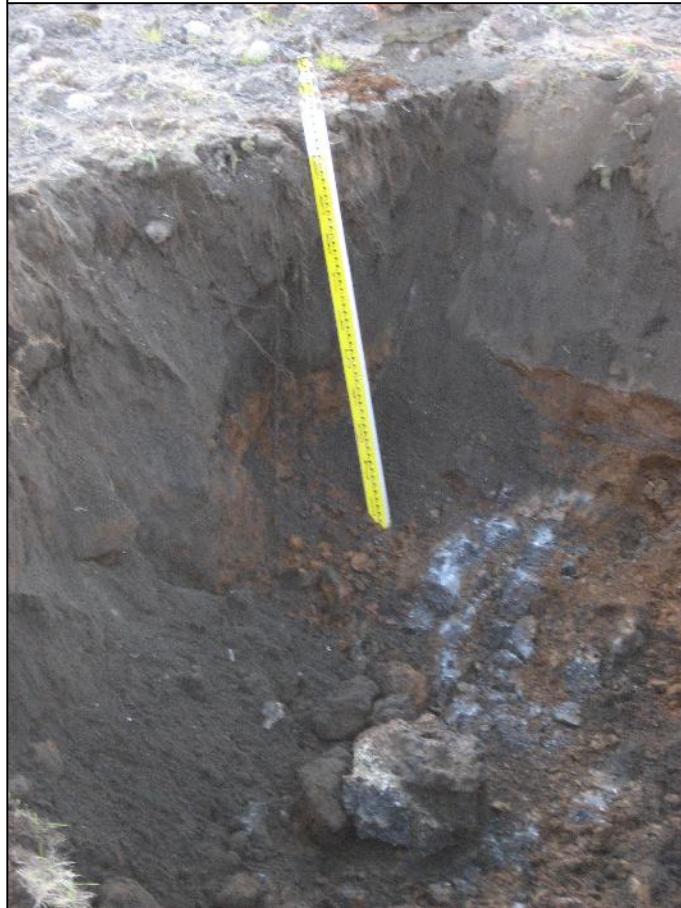
Photo:

Elev. [m.a.s.l.]	Depth [m]	Description	Depth [m]	Soil Profile	G.w.t. [m]	Bottom [m]	Sample [m]
-73		Sand & gravel - with organic layers					
	1,0	Scoria at 1,0 m	1,0				
-72							
	2,0		2,0				
-71							
	3,0		3,0				
-70							
	4,0		4,0				
-69							
	5,0		5,0				
-68

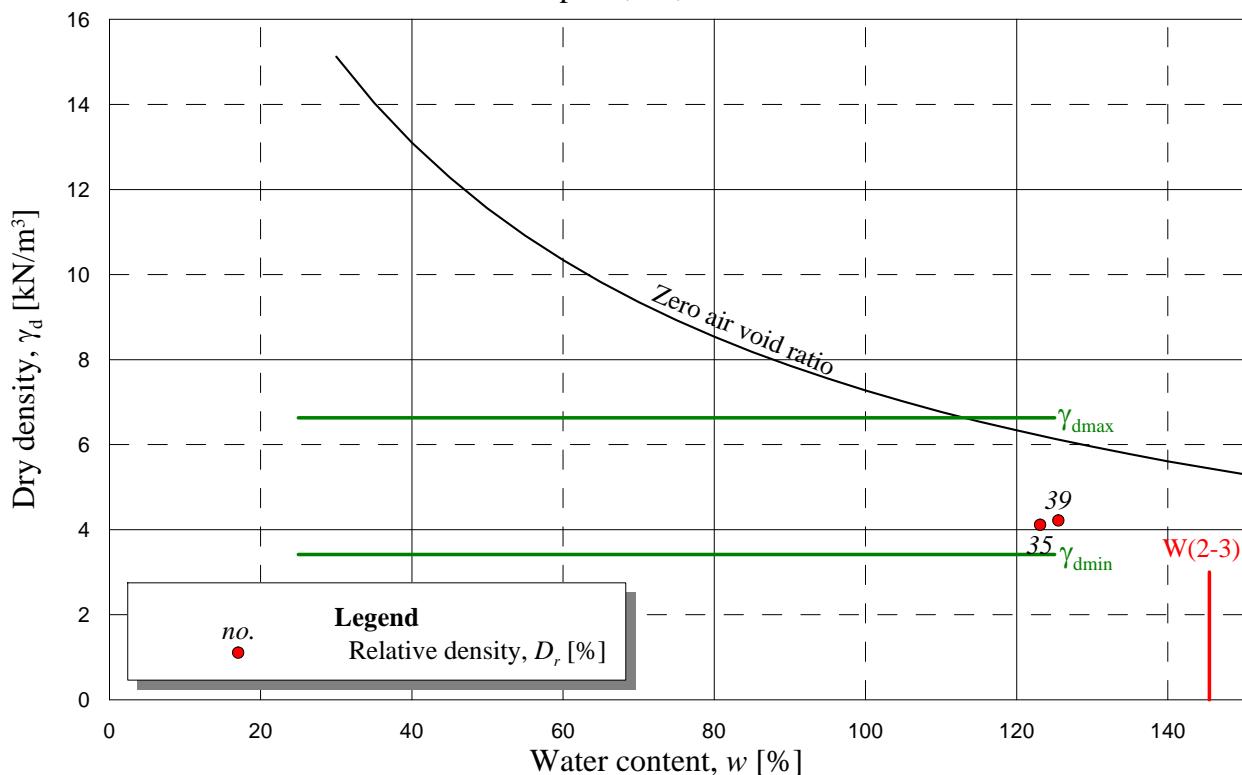
**HOLTAVIRKJUN
HYDROELECTRIC PROJECT
Water content and density tests
Test pit L28A**

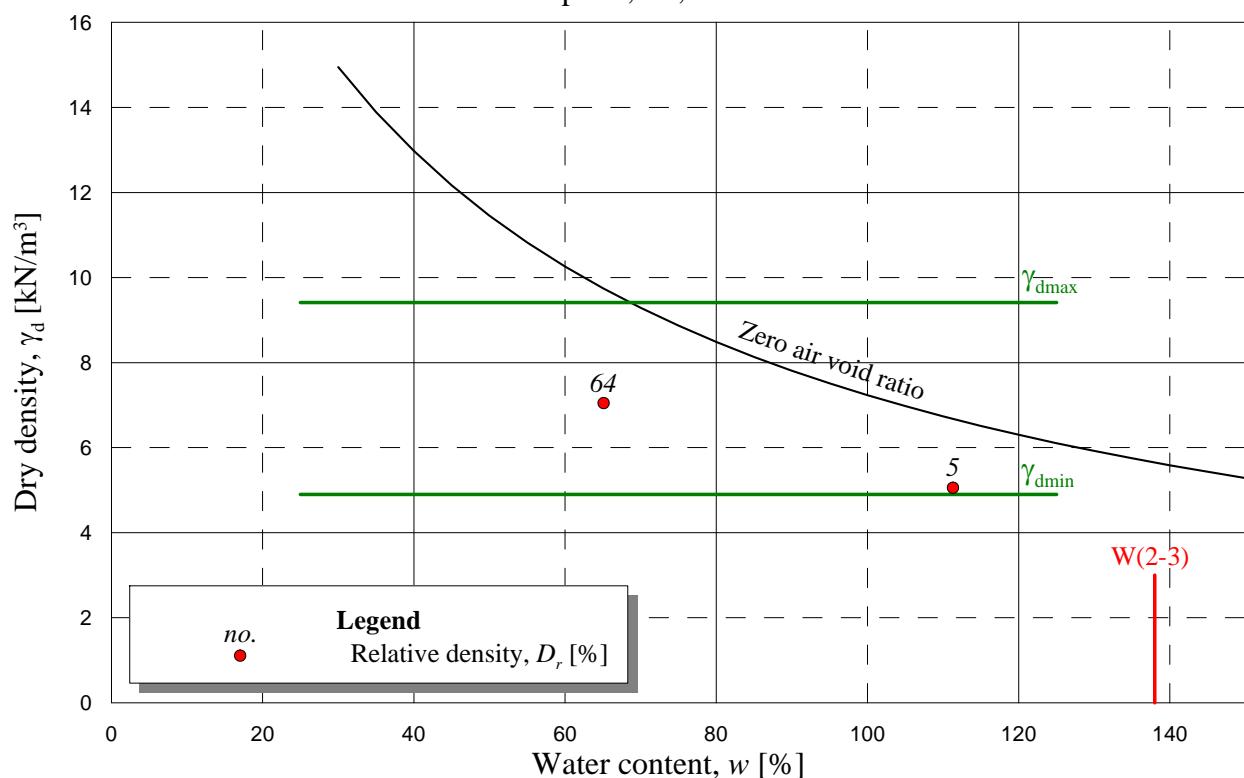
**HOLTAVIRKJUN
HYDROELECTRIC PROJECT
Water content and density tests
Test pit Ho265**

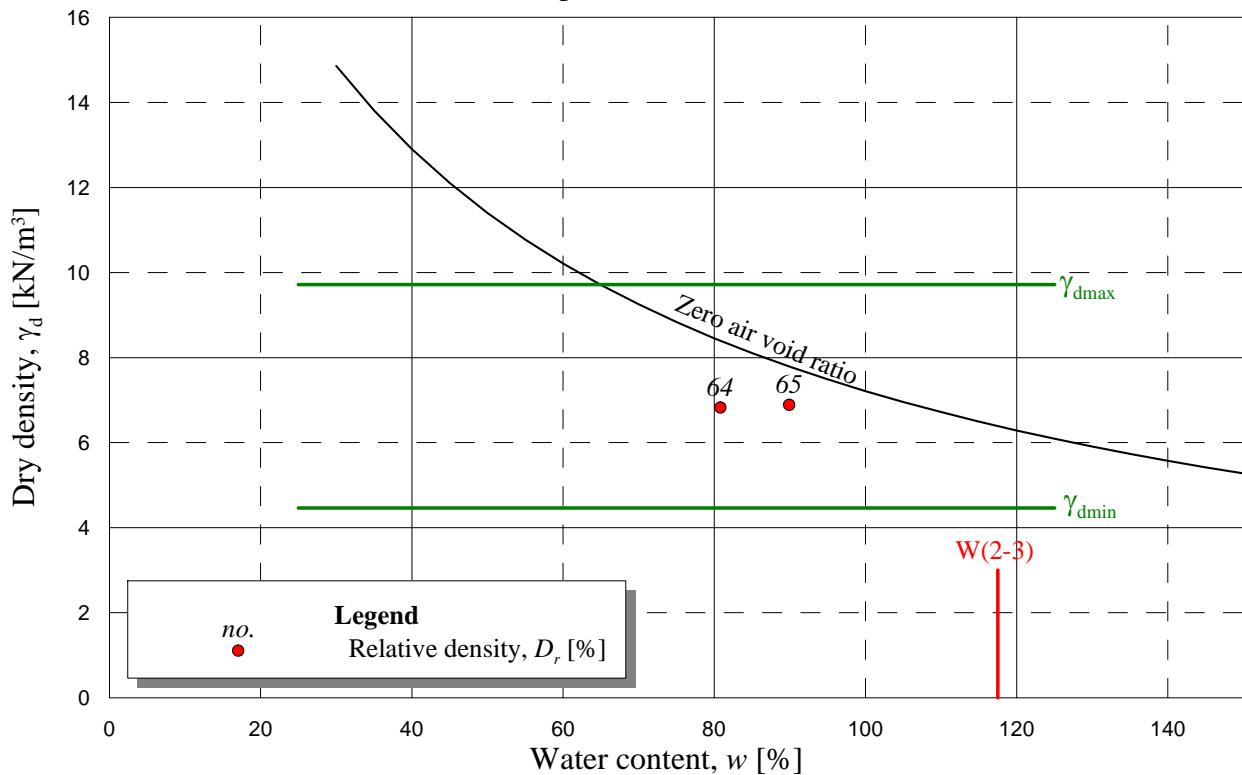
**HOLTAVIRKJUN
HYDROELECTRIC PROJECT
Water content and density tests
Test pit Ho286**

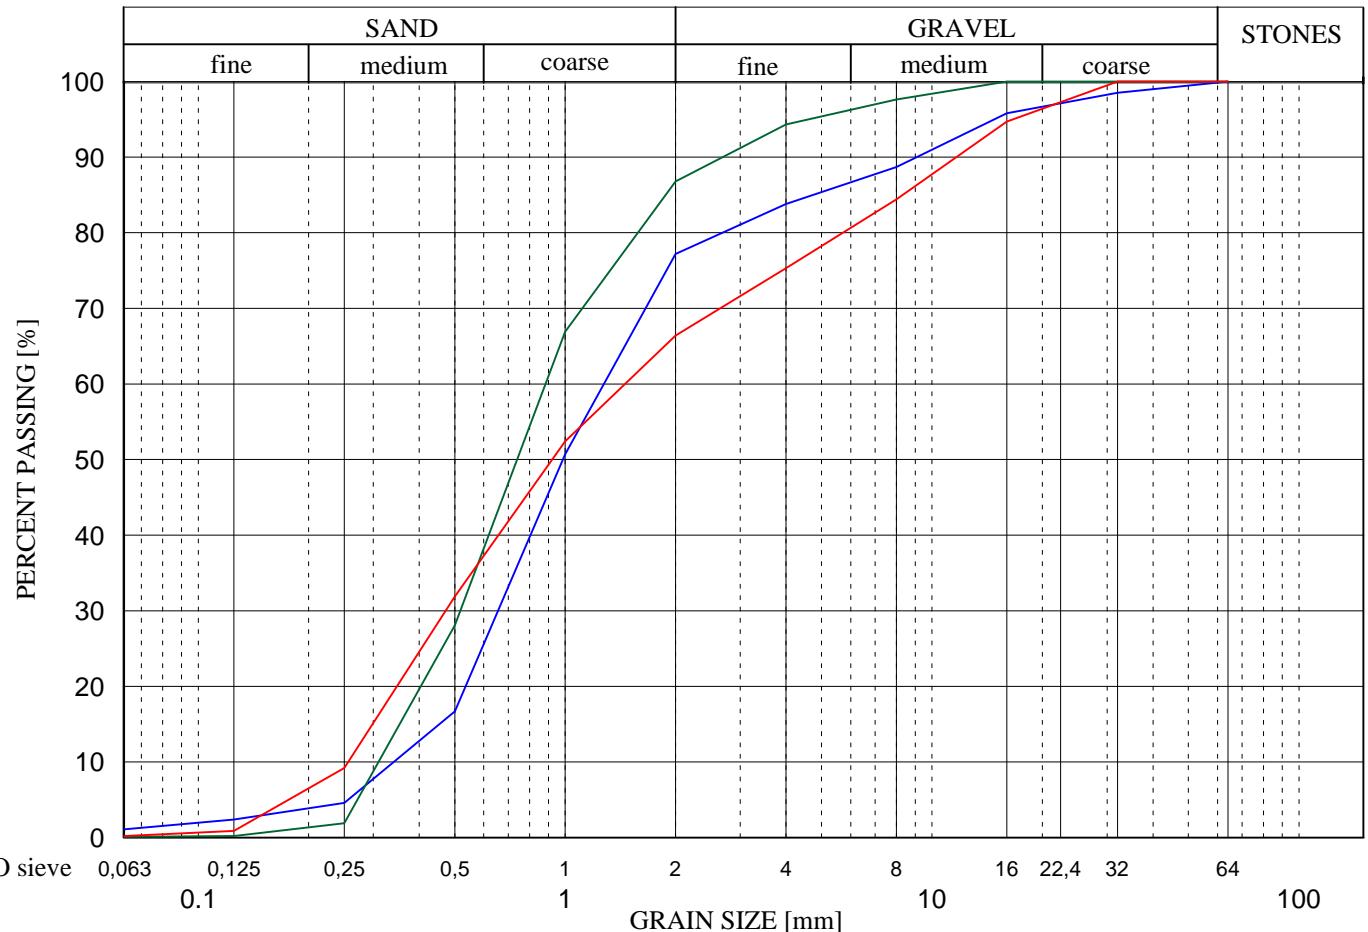
**HOLTAVIRKJUN
HYDROELECTRIC PROJECT**
Grain size distributions
Test pits L1A, L1B & L1C

Sieve no.	0,063	0,125	0,25	0,5	1	2	4	8	16	32	64
L1A, 1,1-1,3m	0	1	9	32	52	66	75	84	95	100	100
L1B, 1,1-1,3m	0	0	2	28	67	87	94	98	100	100	100
L1C, 0,7-0,9m	1	2	5	17	51	77	84	89	96	99	100

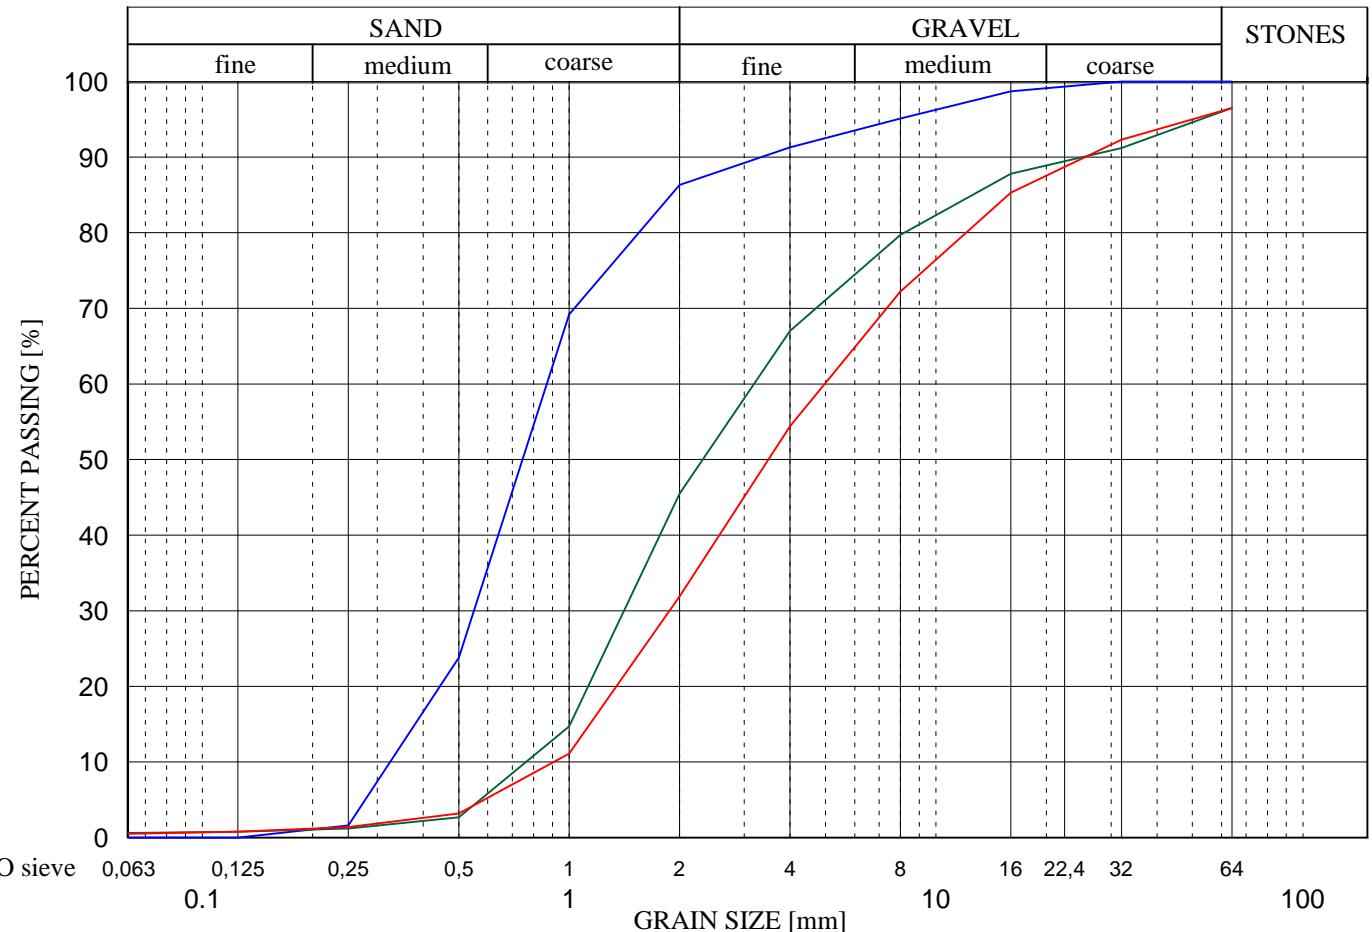
**HOLTAVIRKJUN
HYDROELECTRIC PROJECT**
Grain size distributions
Test pits S2A, S3A & S3B

Sieve no.	0,063	0,125	0,25	0,5	1	2	4	8	16	32	64
S2A, 1,1-1,3m	1	1	1	3	11	32	54	72	85	92	97
S3A, 1,0-1,2m	1	1	1	3	15	46	67	80	88	91	97
S3B, 1,0-1,2m	0	0	2	24	69	86	91	95	99	100	100

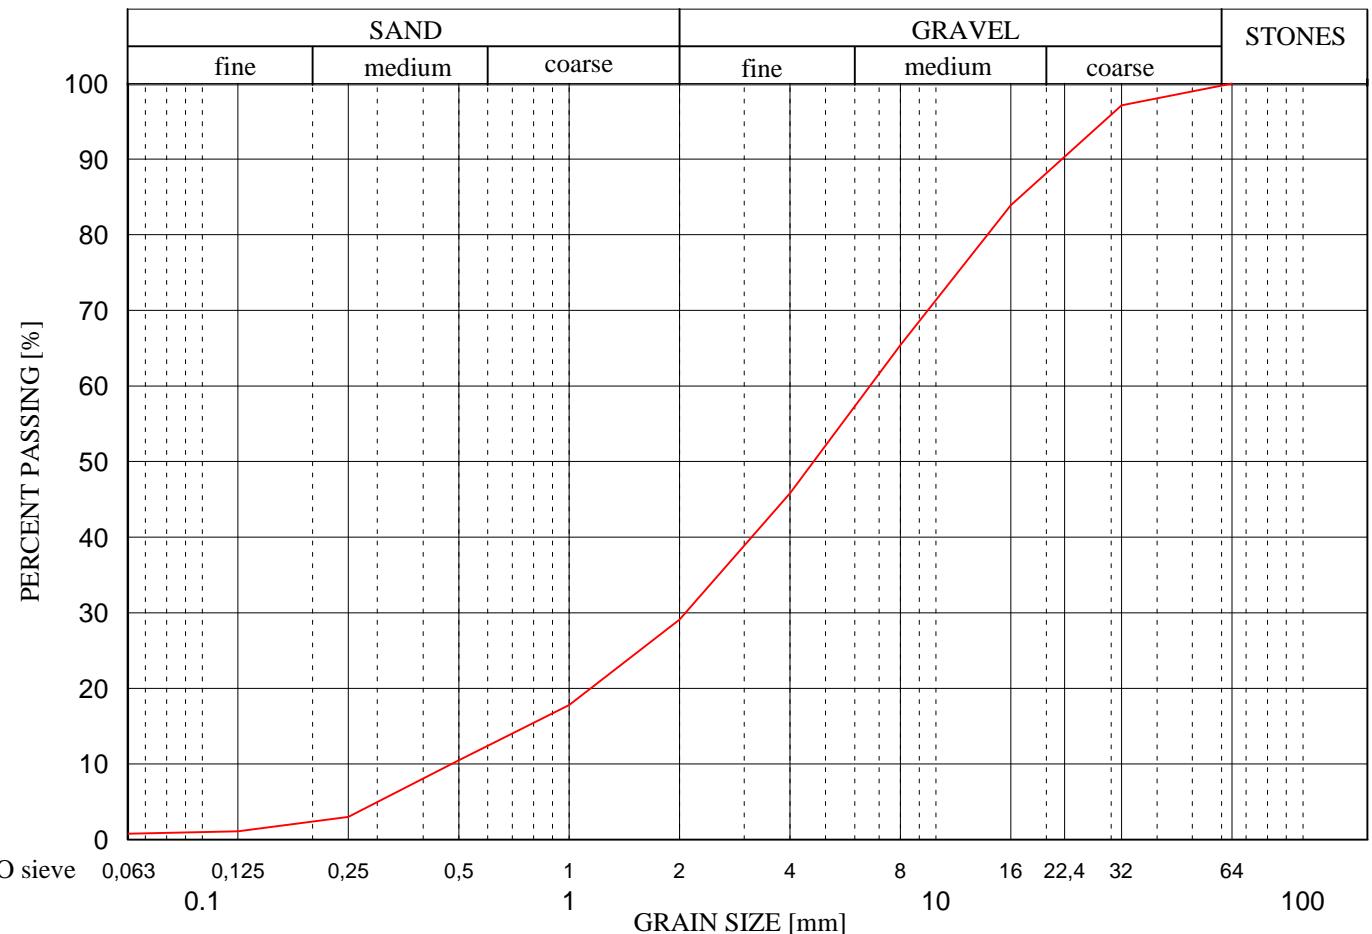
**HOLTAVIRKJUN
HYDROELECTRIC PROJECT**
Grain size distributions
Borrow area near Lækur

Sieve no.	0,063	0,125	0,25	0,5	1	2	4	8	16	32	64
Læk. 0,4-0,6m	1	1	3	11	18	29	46	65	84	97	100

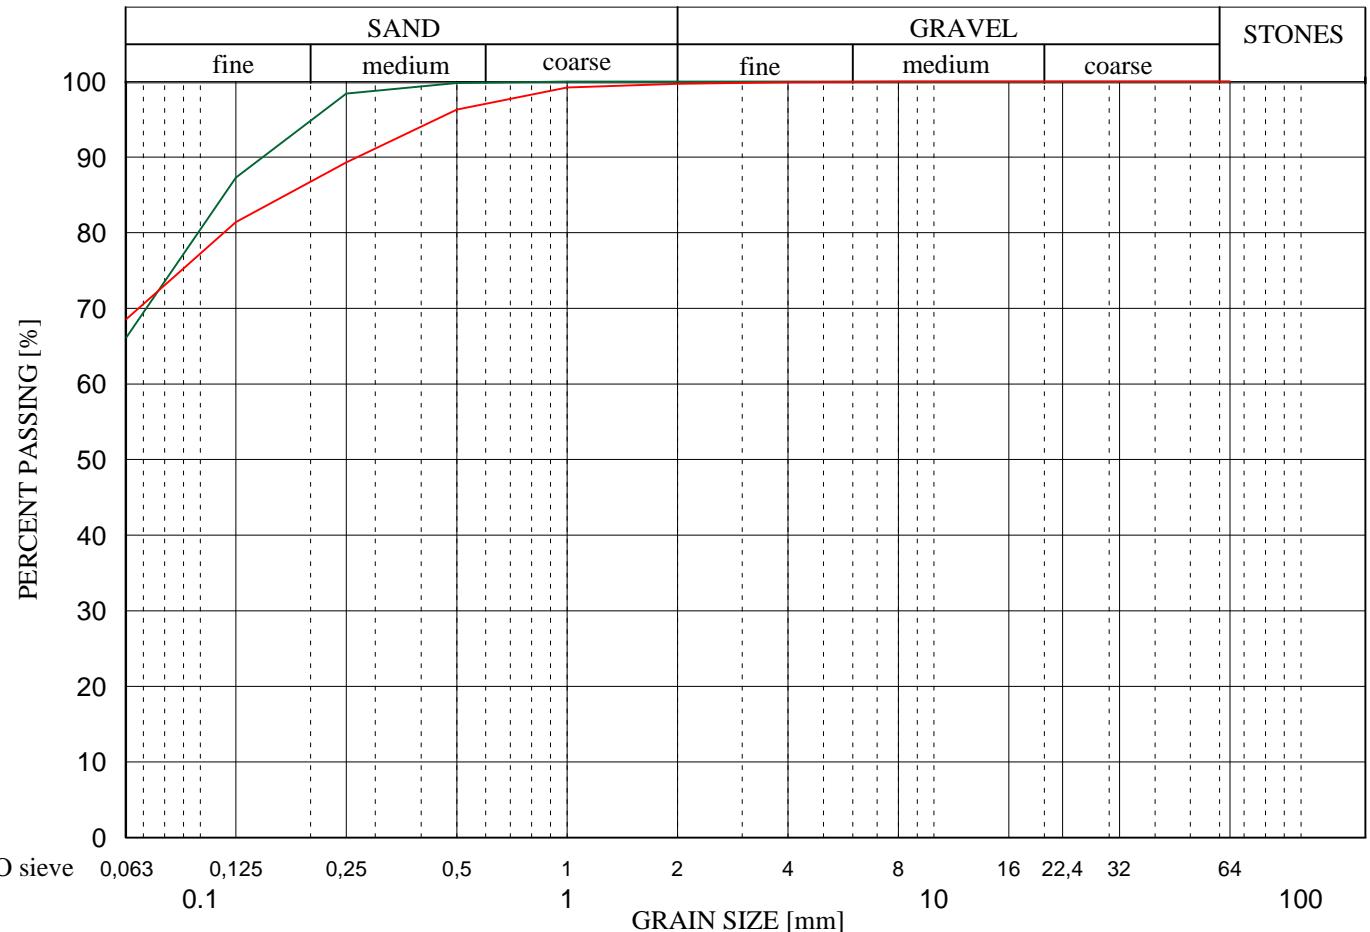
Grain size distributions Test pit L19A

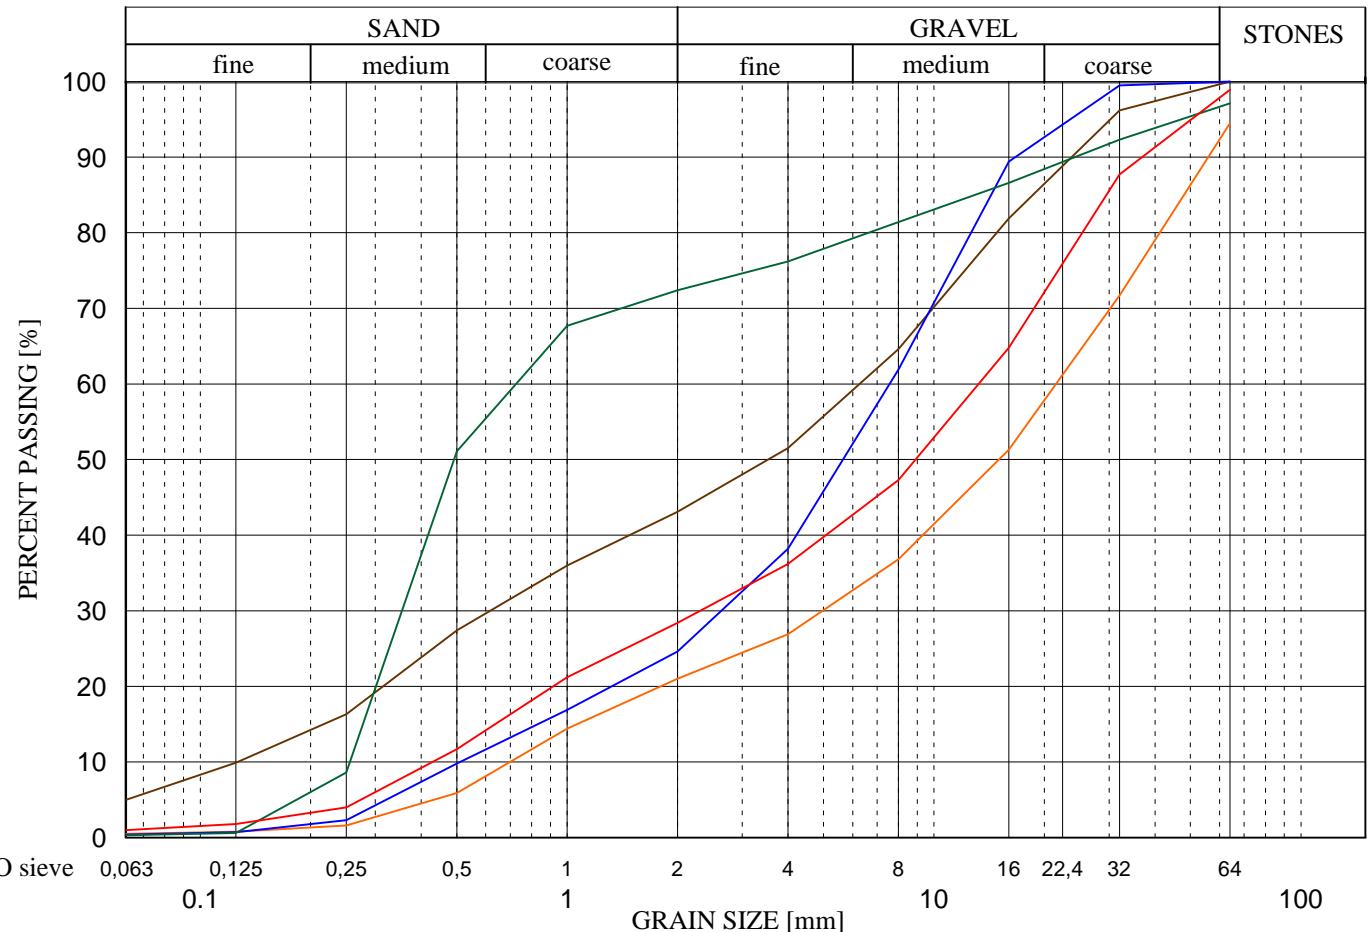
HOLTAVIRKJUN
HYDROELECTRIC PROJECT
Grain size distributions
Test pits L21A, L21B, L21D & L21E

Sieve no.	0,063	0,125	0,25	0,5	1	2	4	8	16	32	64
L21A, 1,0-1,2m	1	2	4	12	21	28	36	47	65	88	99
L21A, 2,0-2,2m	0	1	9	51	68	72	76	81	87	92	97
L21B, 0,6-0,8m	0	1	2	10	17	25	38	62	89	100	100
L21D, 0,4-0,6m	5	10	16	27	36	43	52	65	82	96	100
L21E, 1,1-1,2m	1	1	2	6	14	21	27	37	51	72	95
