Holtavirkjun Hydroelectric Project

Ground Investigation Report (GIR)

Title: Holtavirkjun Hydroelectric Project. Ground Investigation Report (GIR)

Abstract: In this report soil investigation carried out for Holtavirkjun is described.

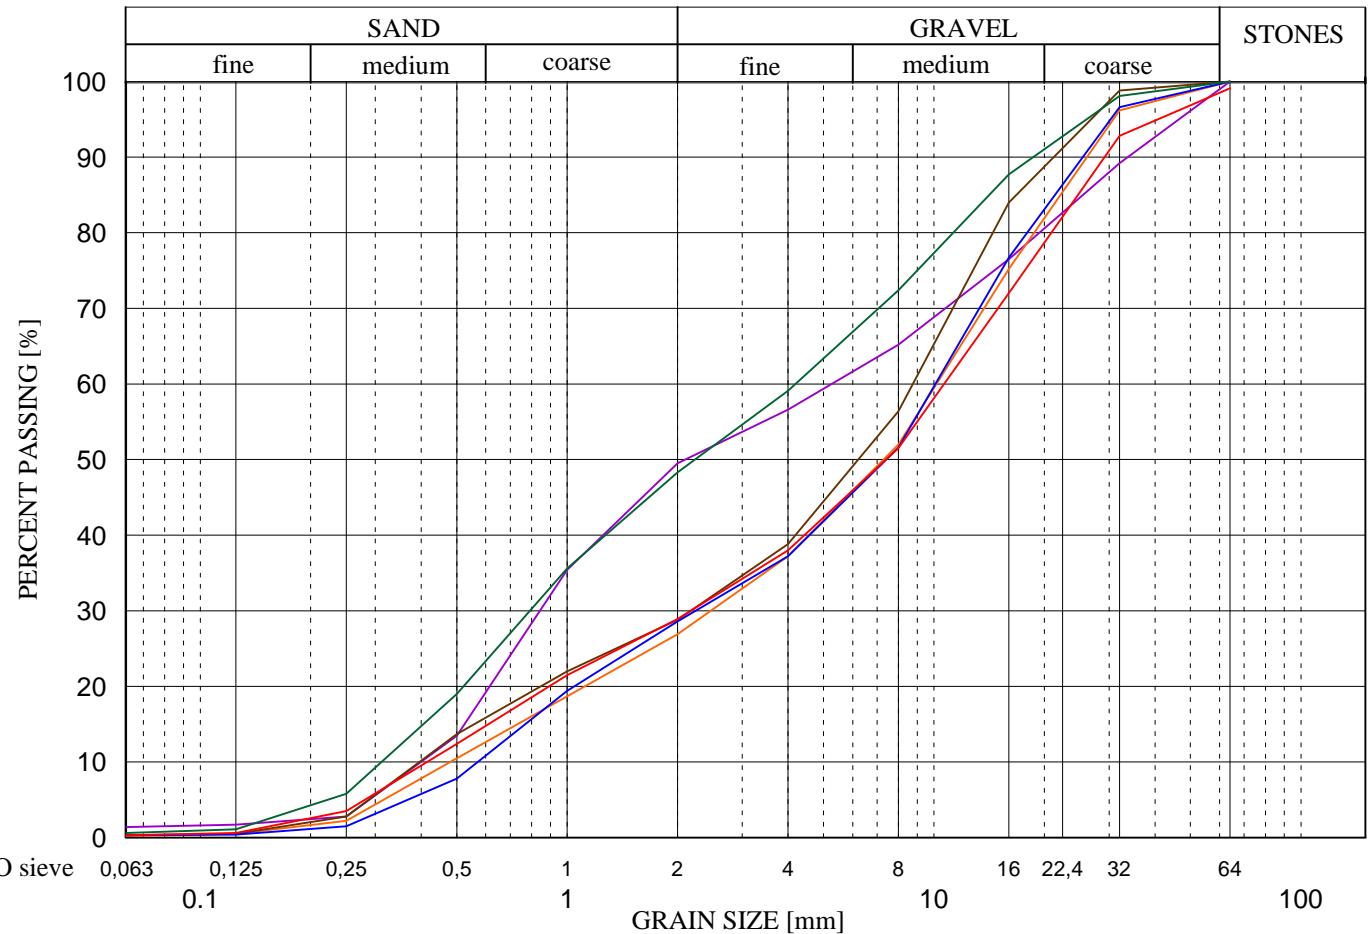
HOLTAVIRKJUN
HYDROELECTRIC PROJECT
Grain size distributions
Test pits L22A, L22B, L22C, L22D & L22E

Sieve no.	0,063	0,125	0,25	0,5	1	2	4	8	16	32	64
L22A, 1,0-1,2m	0	1	4	12	22	29	38	52	72	93	99
L22B, 1,0-1,2m	1	1	6	19	36	48	59	72	88	98	100
L22C 0,6-0,75m	0	0	2	8	19	29	37	52	77	97	100
L22D, 1,0-1,2m	0	1	3	14	22	29	39	56	84	99	100
L22D, 2,0-2,2m	0	1	2	11	19	27	37	52	75	96	100
L22E, 1,0-1,3m			2	11	19	27	37	52	75	96	100

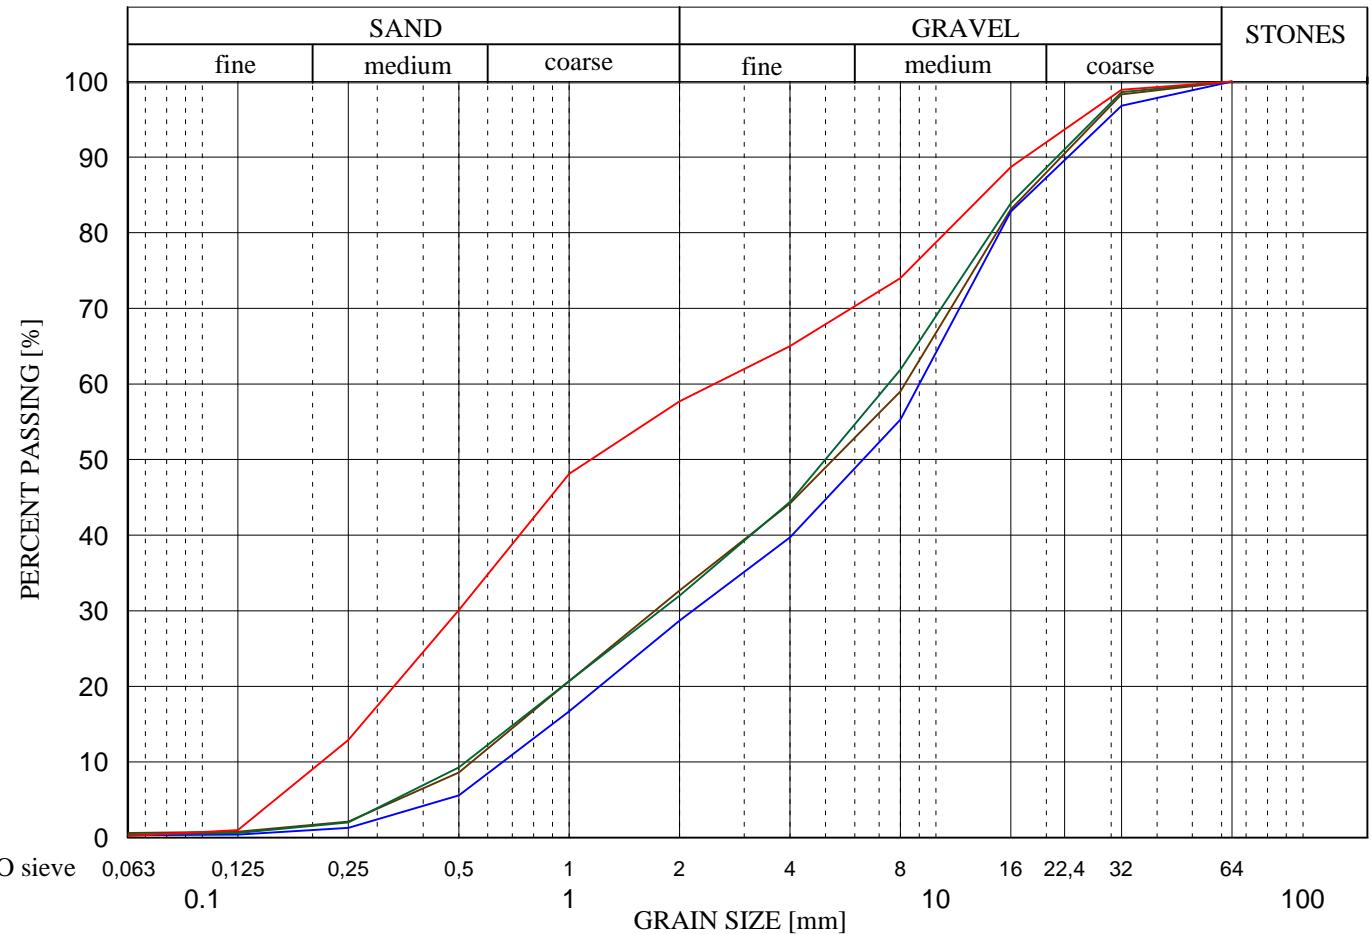
HOLTAVIRKJUN
HYDROELECTRIC PROJECT
Grain size distributions
Test pits L23A, L23B, L23C & L23D

Sieve no.	0,063	0,125	0,25	0,5	1	2	4	8	16	32	64
L23A, 1,1-1,3m	0	1	13	30	48	58	65	74	89	99	100
L23B, 1,0-1,3m	0	1	2	9	21	32	44	62	84	99	100
L23C 1,3-1,5m	0	0	1	6	17	29	40	55	83	97	100
L23D, 1,3-1,5m	1	1	2	9	21	33	44	59	83	98	100

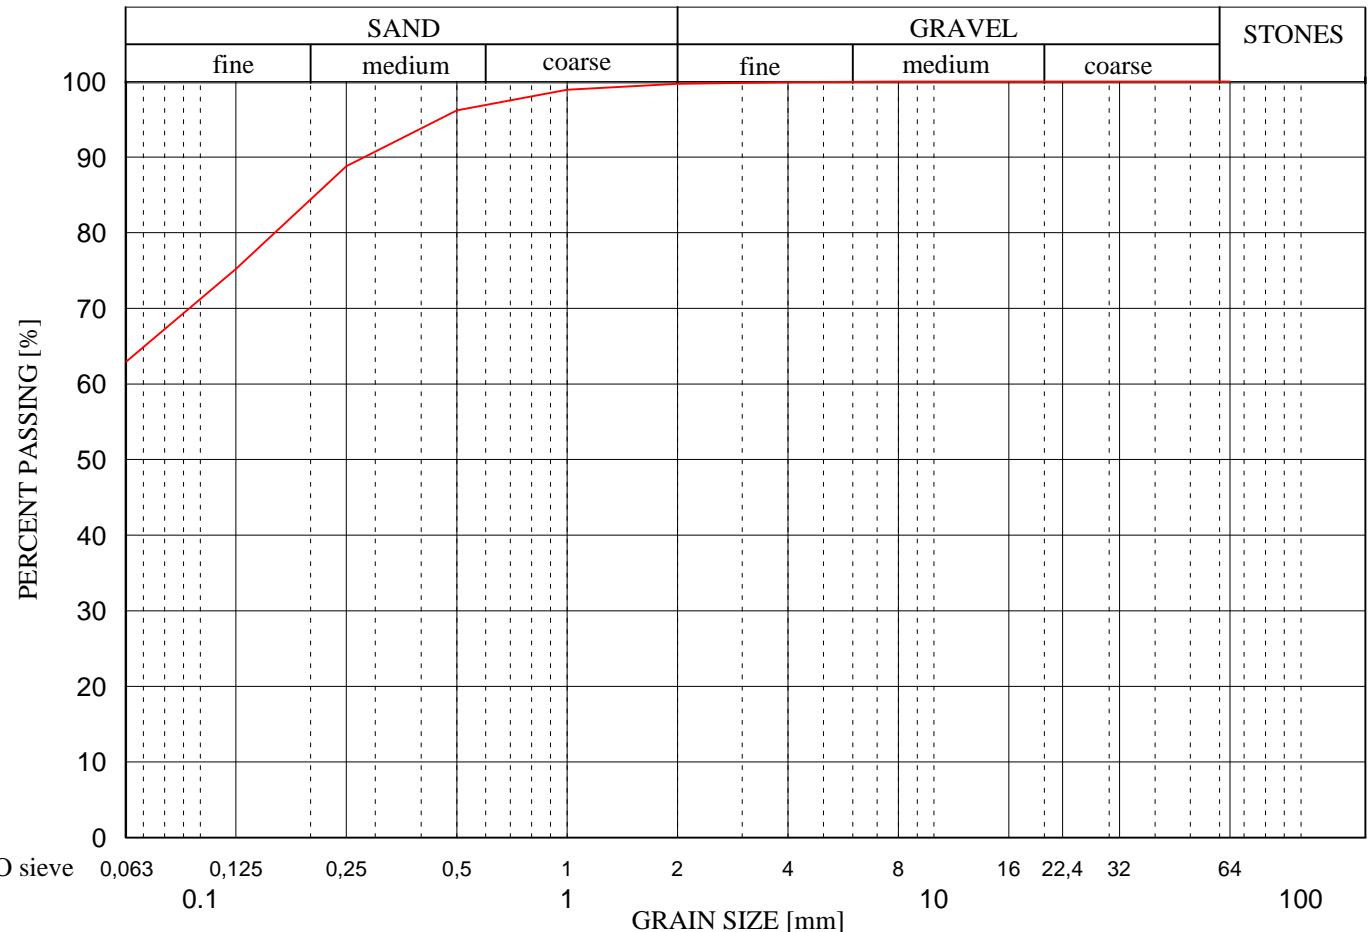
**HOLTAVIRKJUN
HYDROELECTRIC PROJECT**
Grain size distributions
Test pit L28A

Sieve no.	0,063	0,125	0,25	0,5	1	2	4	8	16	32	64
L28A, 1,0-1,5m	63	75	89	96	99	100	100	100	100	100	100

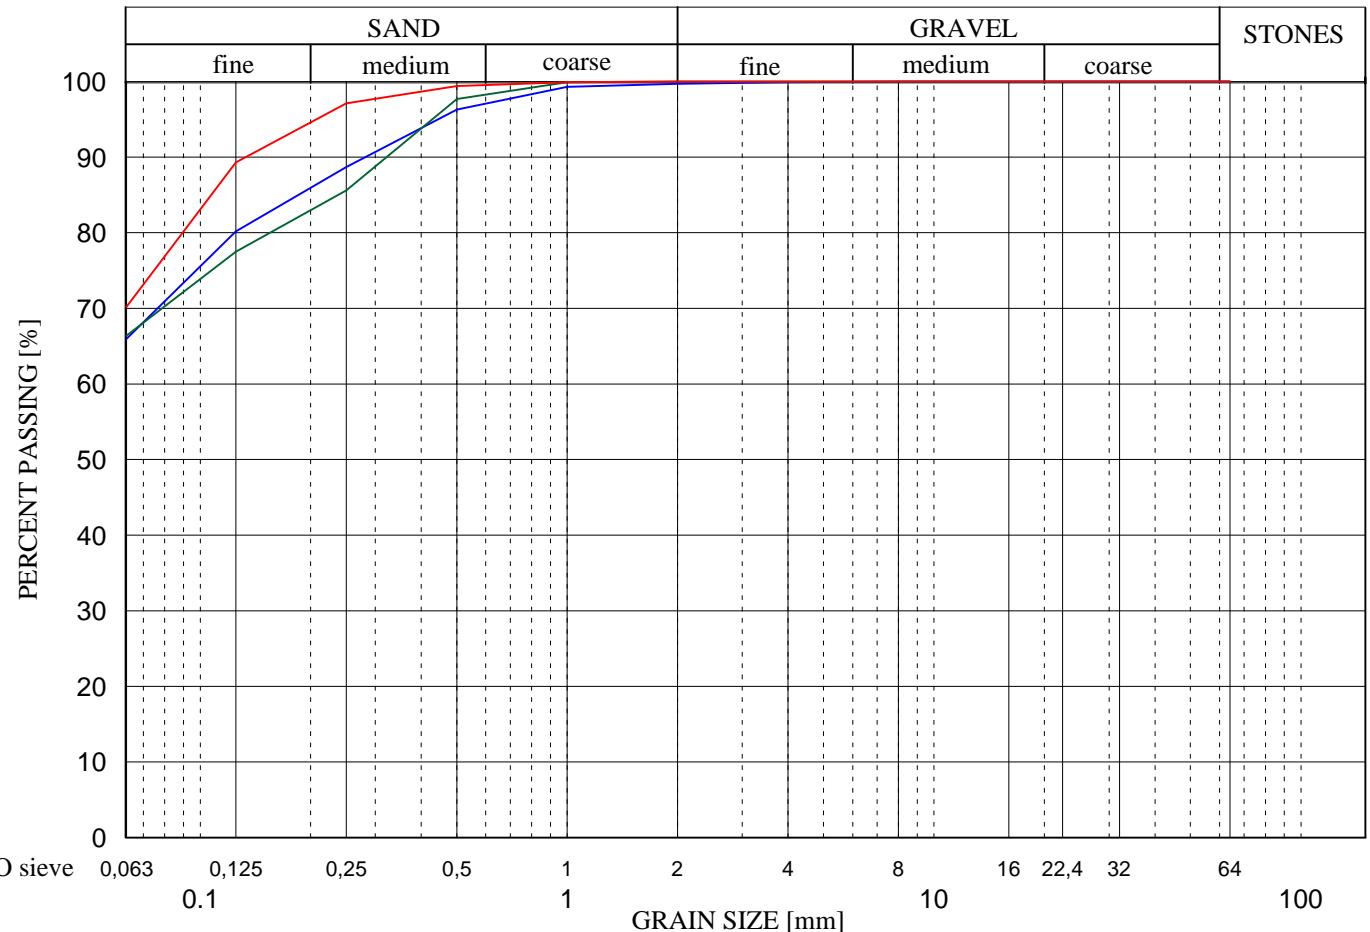
**HOLTAVIRKJUN
HYDROELECTRIC PROJECT**
Grain size distributions
Test pits Ho258 & Ho265

Sieve no.	0,063	0,125	0,25	0,5	1	2	4	8	16	32	64
258, 0,7-0,85m	70	89	97	99	100	100	100	100	100	100	100
258, 2,0-2,1m	66	78	86	98	100	100	100	100	100	100	100
265, 1,0-1,2m	66	80	89	96	99	100	100	100	100	100	100

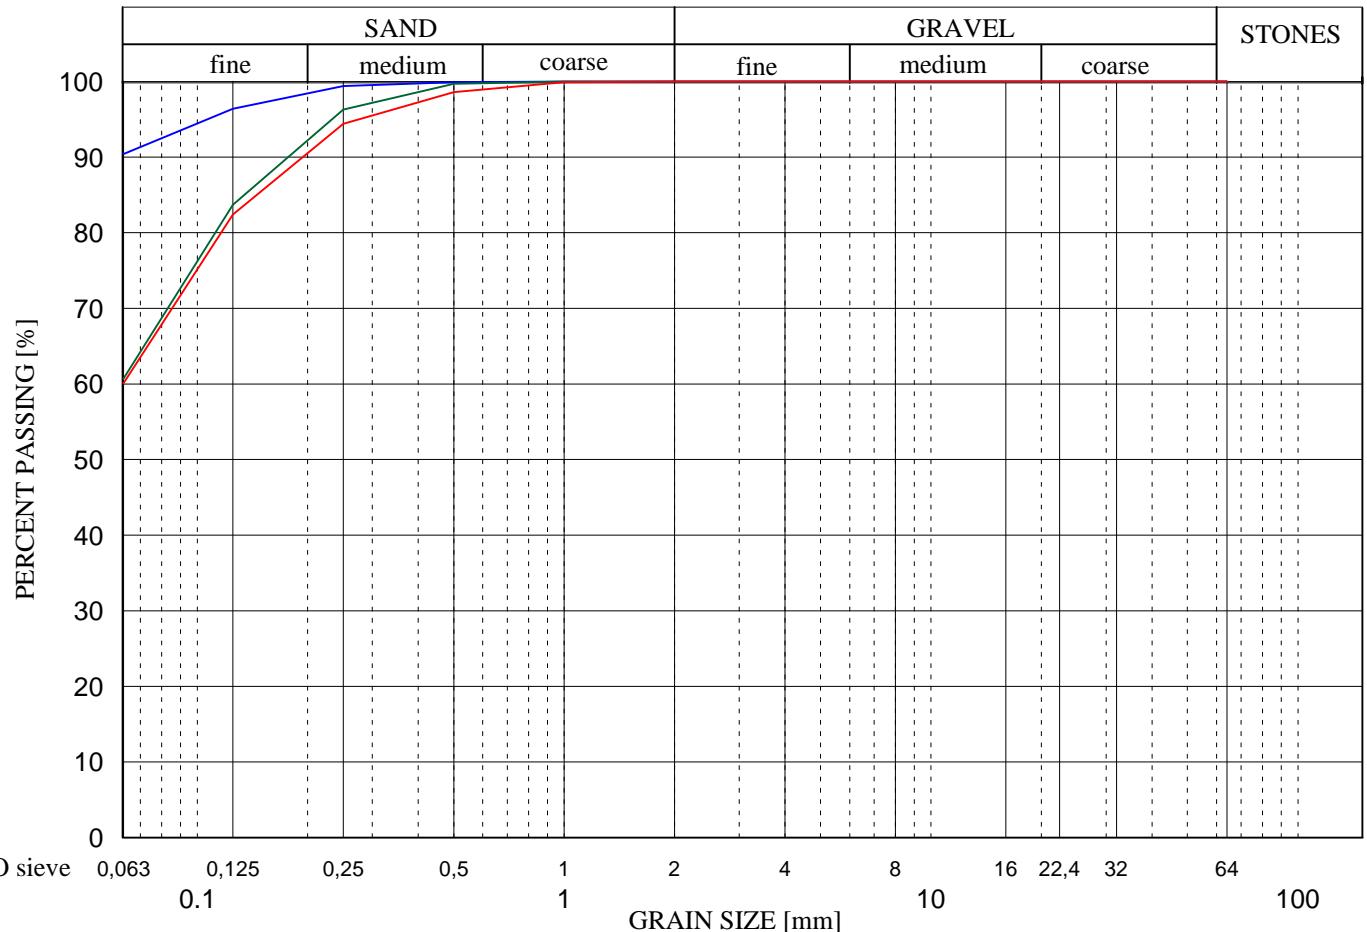
Grain size distributions Test pits Ho270 & Ho274

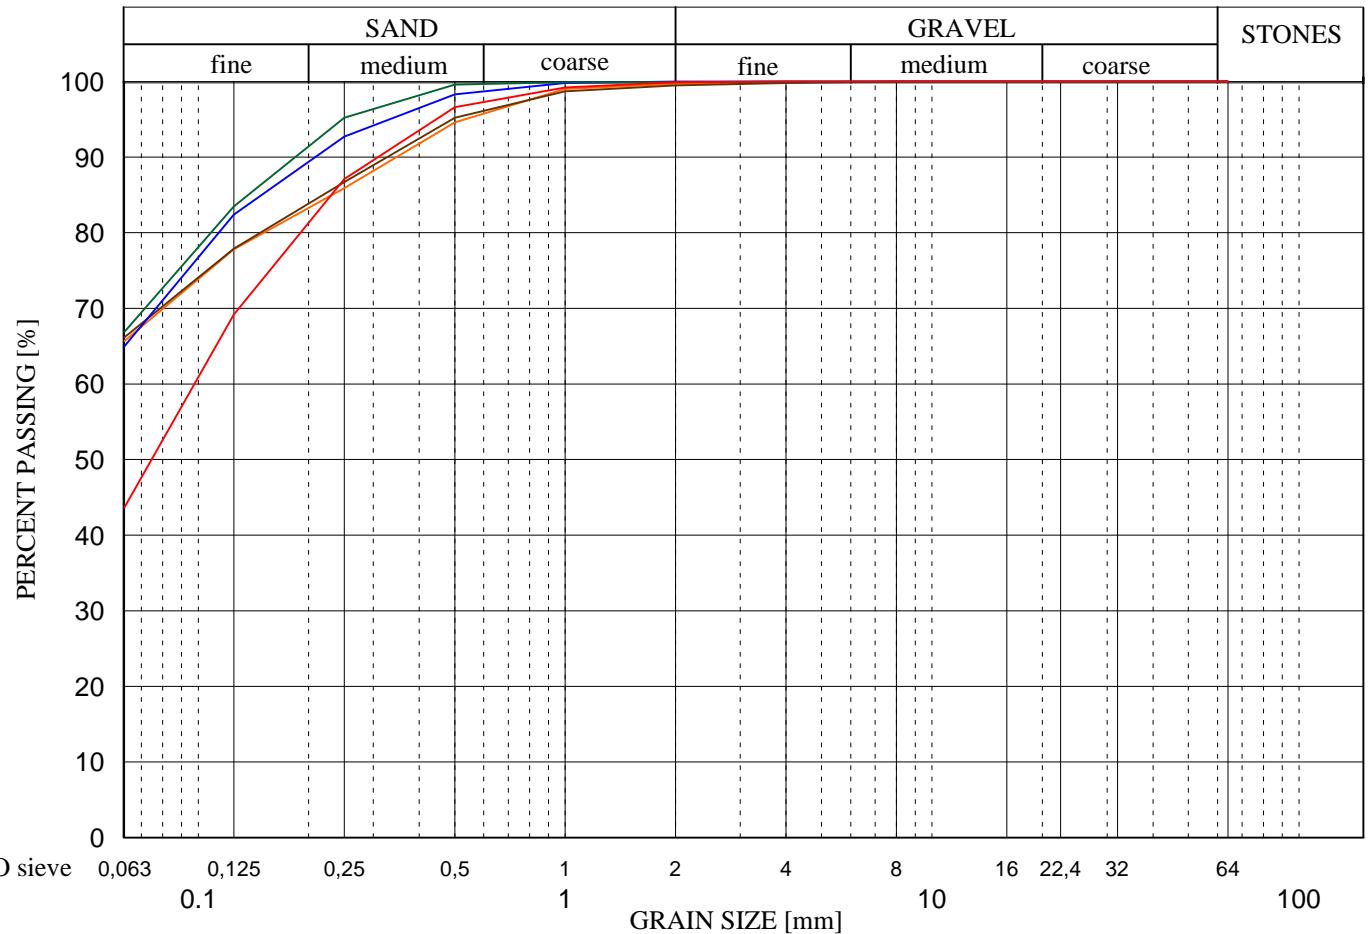
**HOLTAVIRKJUN
HYDROELECTRIC PROJECT**
Grain size distributions
Test pits Ho218, Ho286, Ho290 & Ho294

Sieve no.	0,063	0,125	0,25	0,5	1	2	4	8	16	32	64
218, 0,9-1,1m	44	69	87	97	99	100	100	100	100	100	100
218, 1,5-1,7m	67	84	95	100	100	100	100	100	100	100	100
286, 0,8-0,95m	65	82	93	98	100	100	100	100	100	100	100
290, 1,3-1,45	66	78	87	95	99	100	100	100	100	100	100
294, 1,0-1,2m	66	78	86	95	99	100	100	100	100	100	100
