# Krafla – Well K-41

Phase 3: Drilling for Production Part  
down to 1313 m

ÍSOR-2016/068

Title: Krafla – Well K-41. Phase 3: Drilling for Production Part down to 1313 m

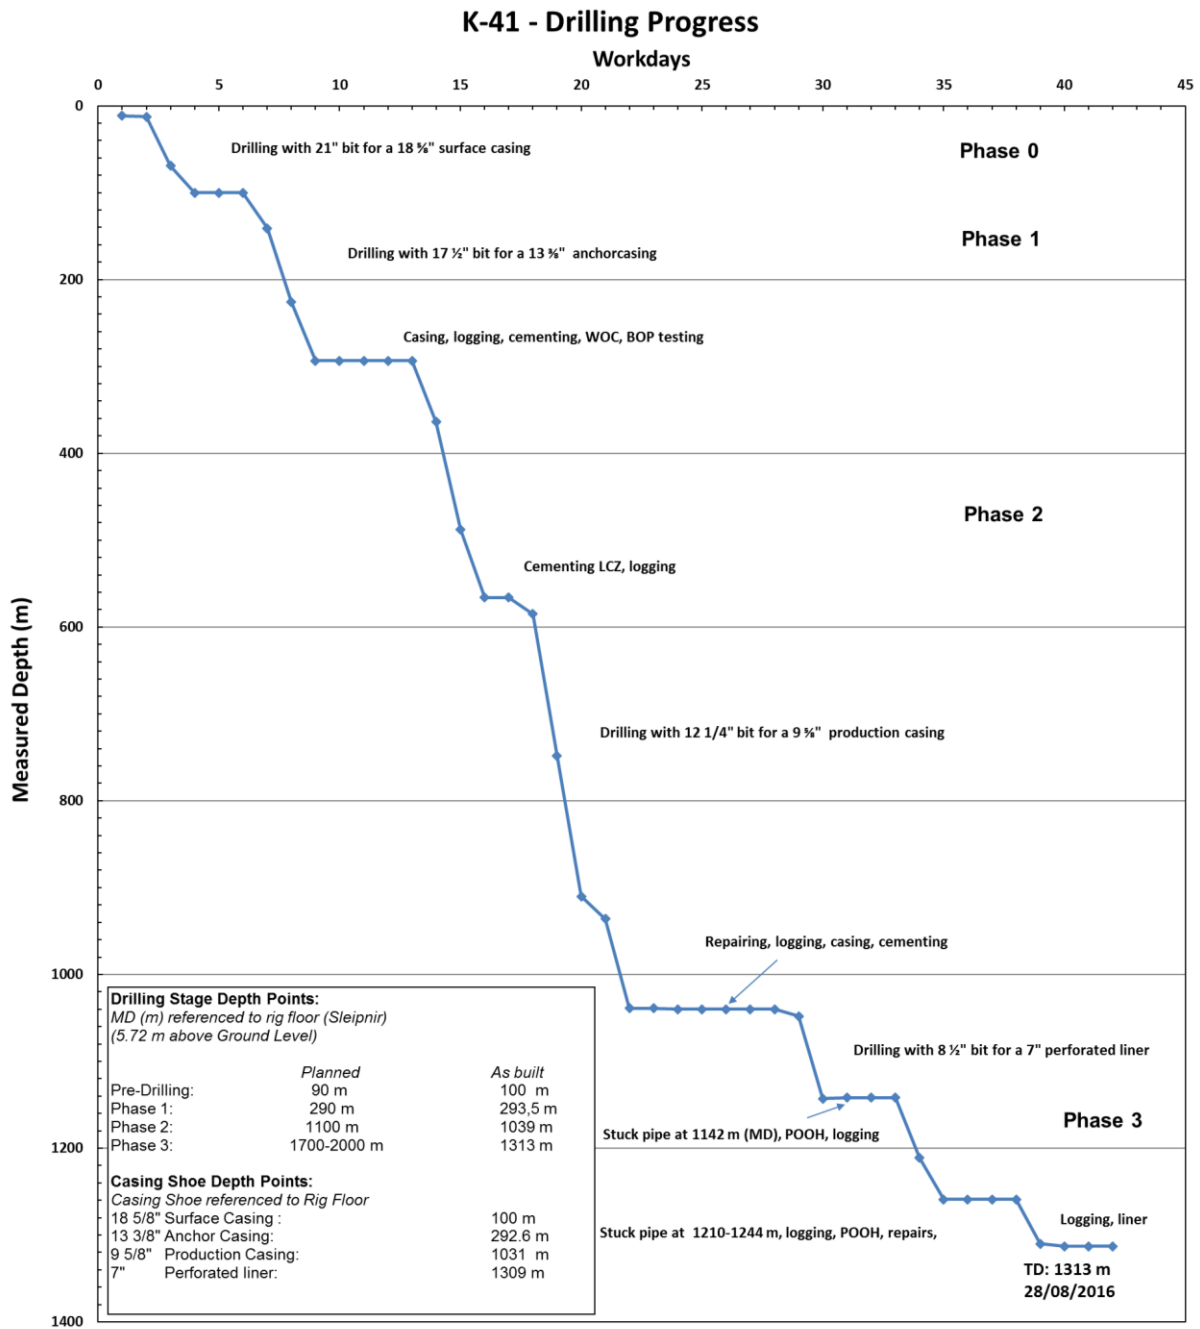
Figure 3. Drilling progress of well K-41.

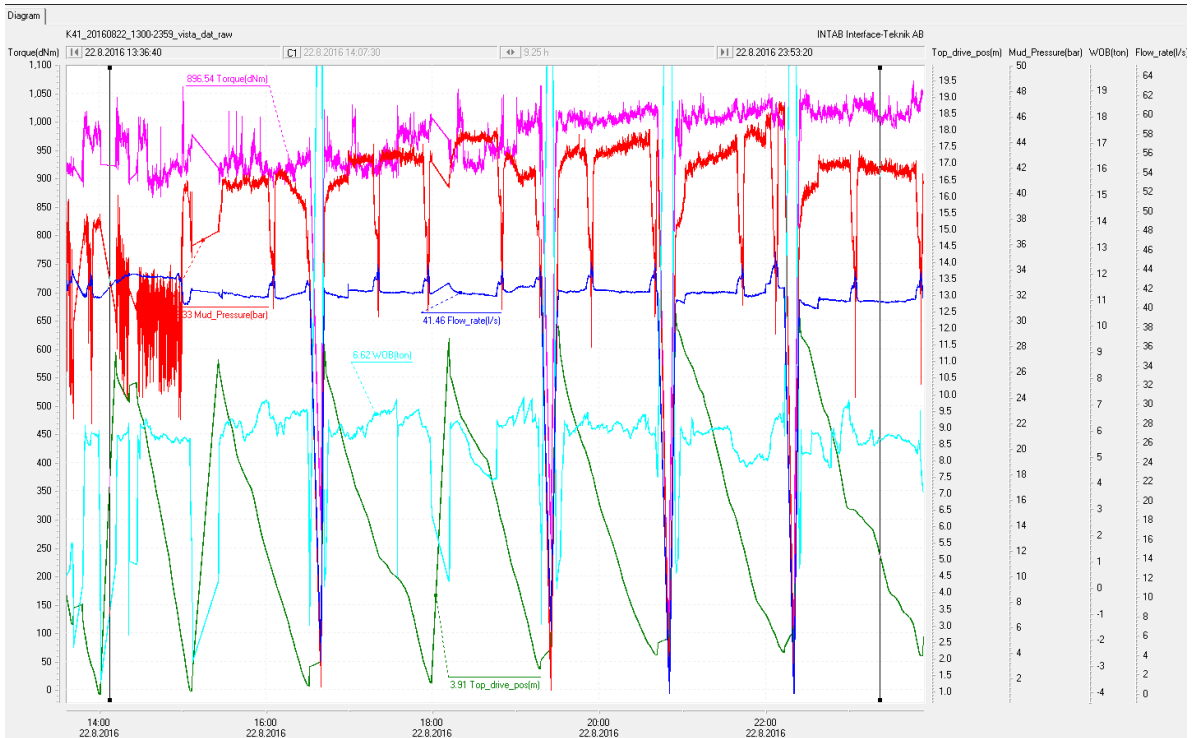
Figure 7. Key parameters during drilling on August 22<sup>nd</sup>.

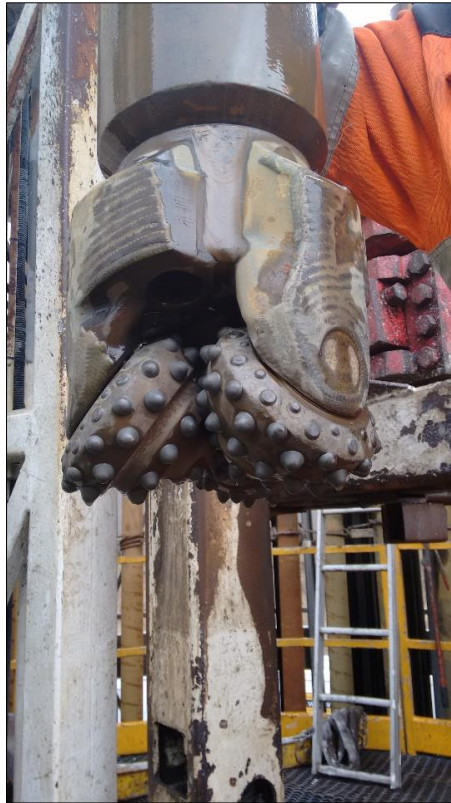
**Figure 10.** *Drill bit back on the surface in good condition on August 27th.*

After being stuck for 48 hours a second temperature log was carried out by ÍSOR’s logging engineers. This log showed the well was around 30°C hotter than 24 hours before, and was now up to 140°C. The hottest part of the well was located above the fill. 1000 L of cold water were pumped down the well at 19 L/s in order to push the heat pulse down to the fill and heat it up more. Then on August 25<sup>th</sup> (workday 37) the pumps were shut off and the driller started jarring and trying to rotate the string at the same time. This worked and the string started rotating at 14:30. For the next few hours the drill bit moved slowly up. When pumping at 25 L/s, the pressure went up to 2,3 bar. At 20:30 the string got completely free and pulling out of hole started. The bit was back at surface in the evening of August 27<sup>th</sup> but pulling out of hole went slowly due to breakdown of the hydraulic system. The bit was in good condition with only modest signs of wear (Figure 10).

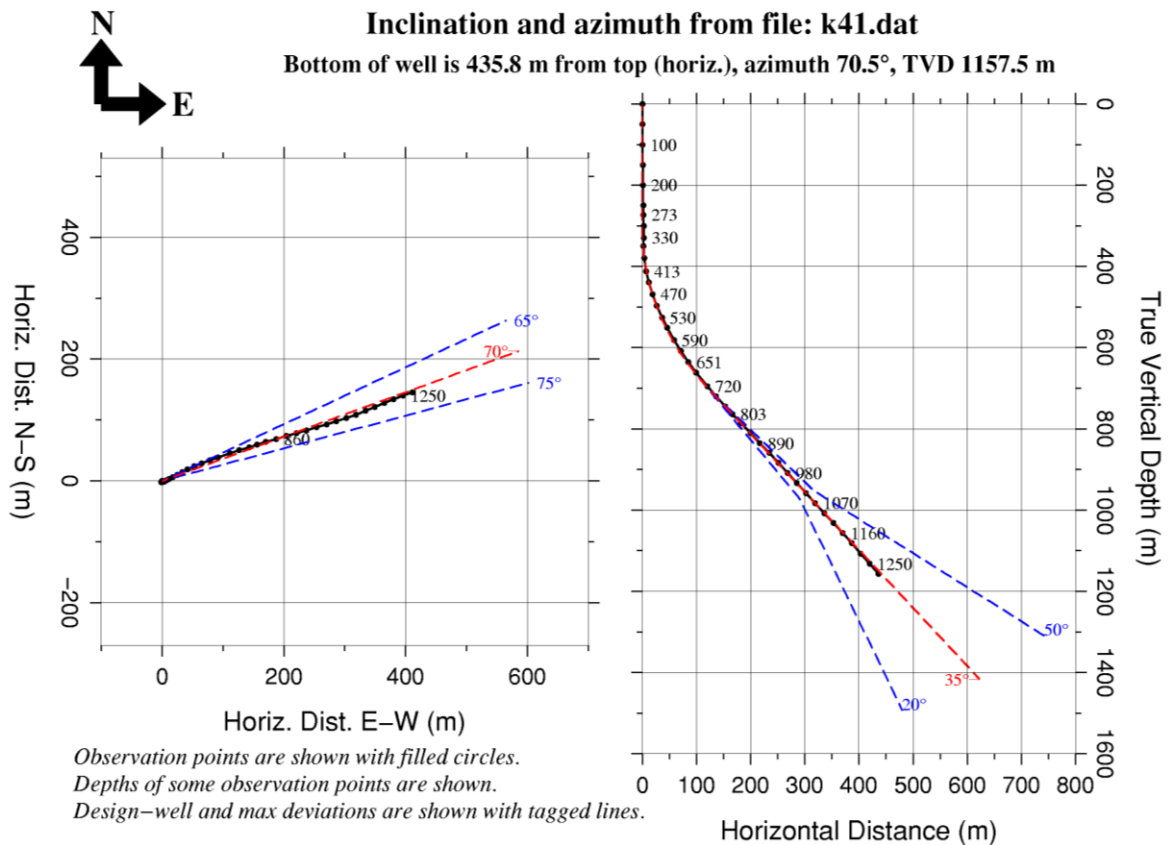
**Figure 17.** Calculated well path from the measured inclination and azimuth data together with the designed well path and corresponding deviation limits.

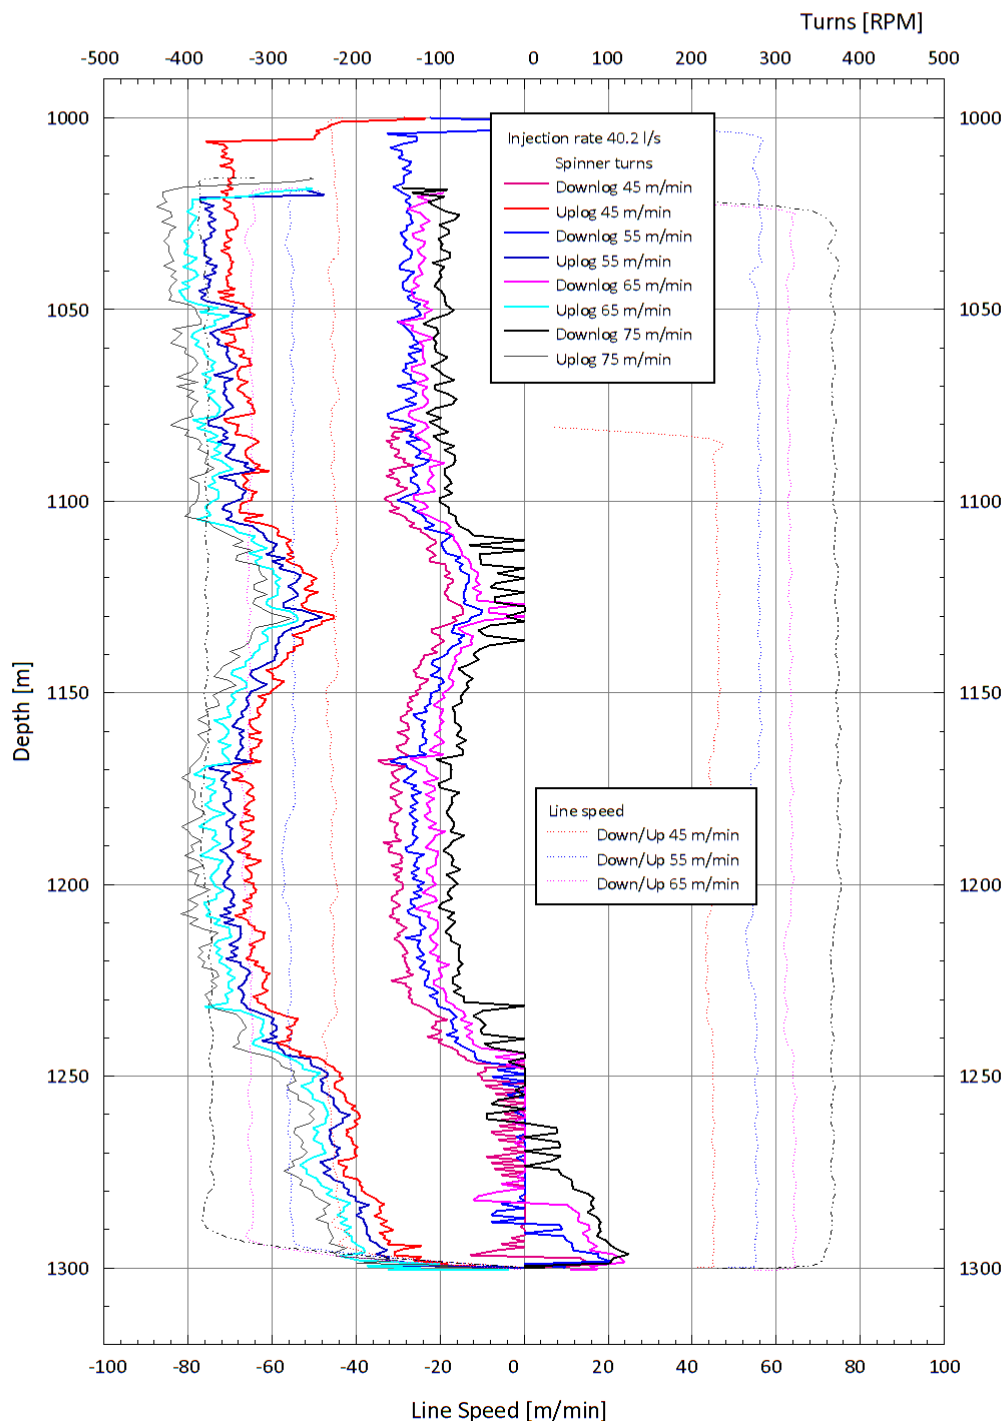
**Figure 39.** The spinner logs run during the second step with 40.2 L/s injection rate.

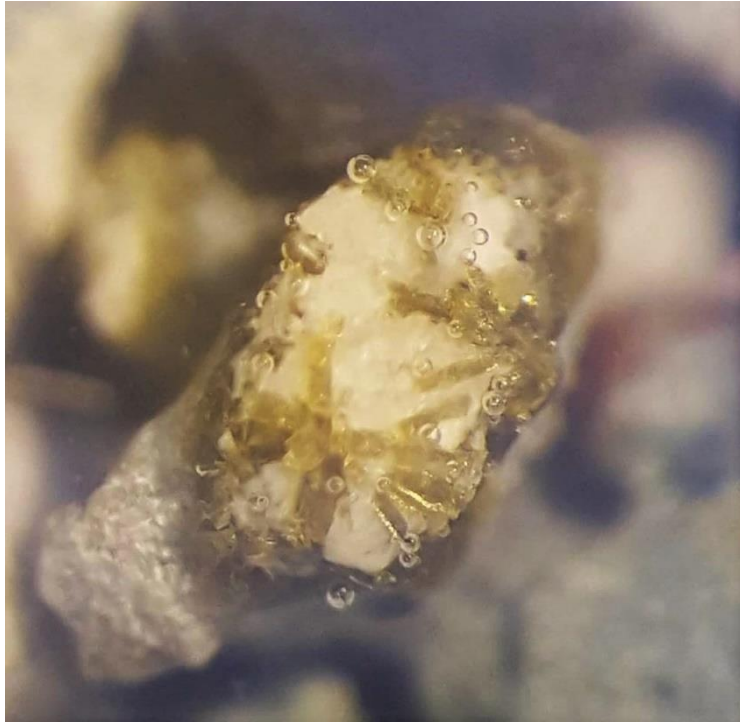
**Figure 2.** *Calcite found over epidote at 996 m. The bubbles form when hydrochloric acid is added to the sample and CO<sub>2</sub> is released.*

Laumontite occurs at 404 m and it appears in few samples below that depth. Epidote can be seen in a short interval at 408-410 m. Then it disappears but comes again into the system at 638 m where it can be found in most samples after that down to 1040 m, indicating more than 230 °C. Wairakite (200-300 °C) appears at 546 m and wollastonite at 976 m (more than 300 °C). However, at 996 m, calcite was found over epidote (Figure 2), which may indicate influx of cooler carbonate rich fluid.

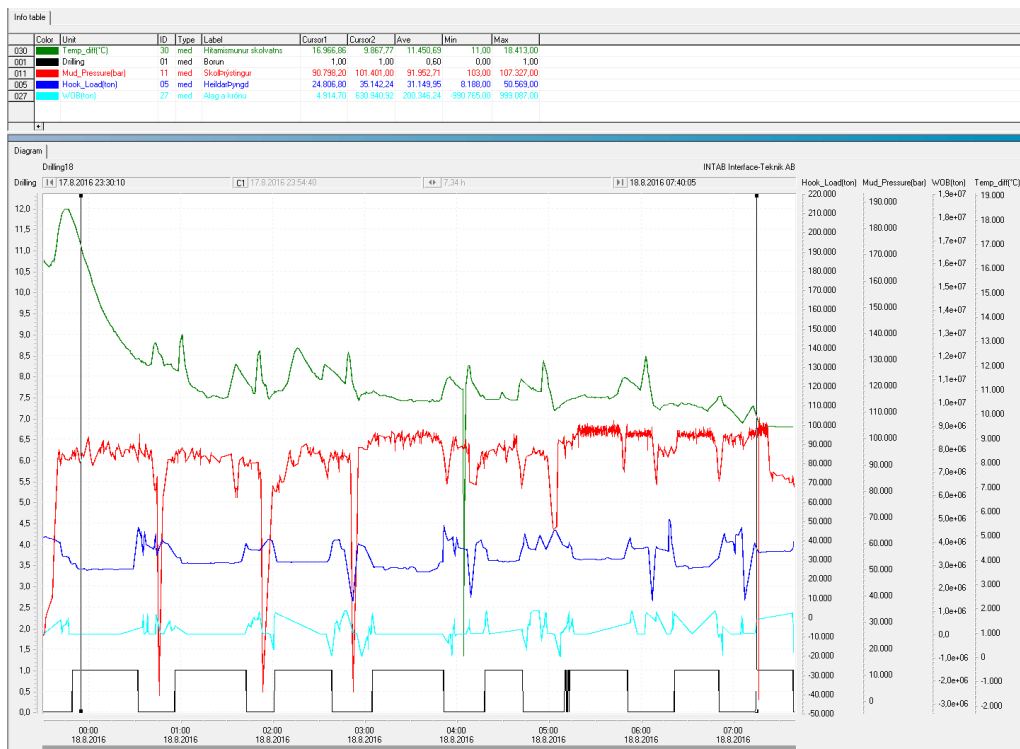
Figure 3. Easy view image from drilling during the night after the gyro survey.

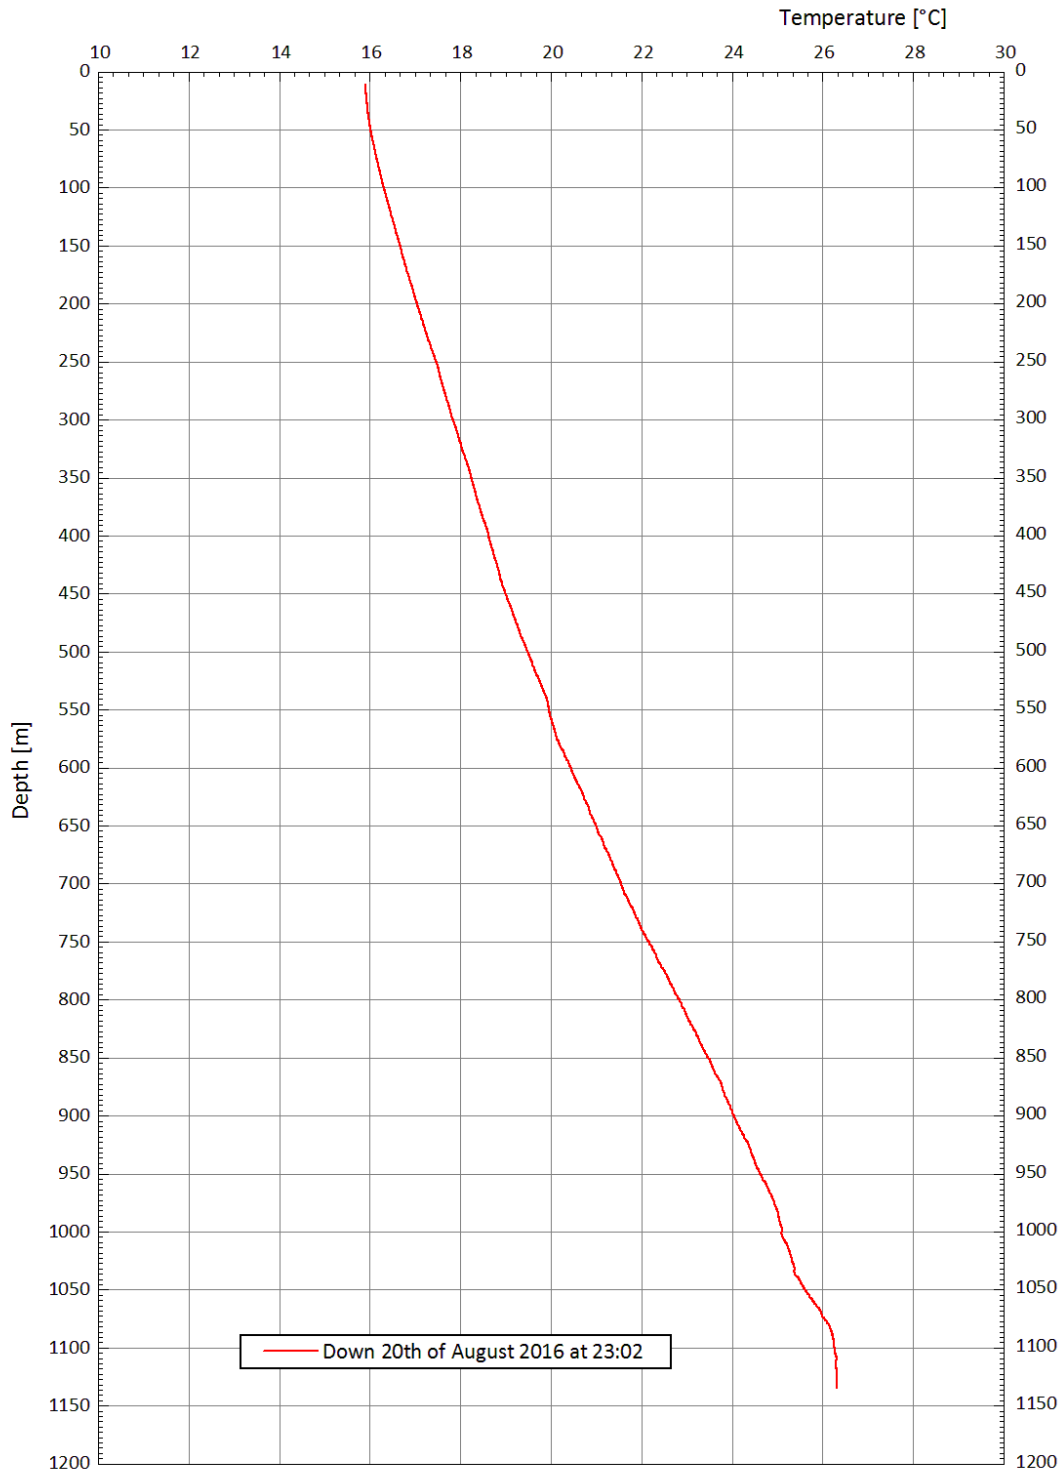
**Figure 1.** Temperature log RIH during 19 L/s injection and total LOC. The probe stopped at 1135 m indicating ~ 7 m bottom fill. All injected fluid seems to exit the well somewhere below 1135 m.

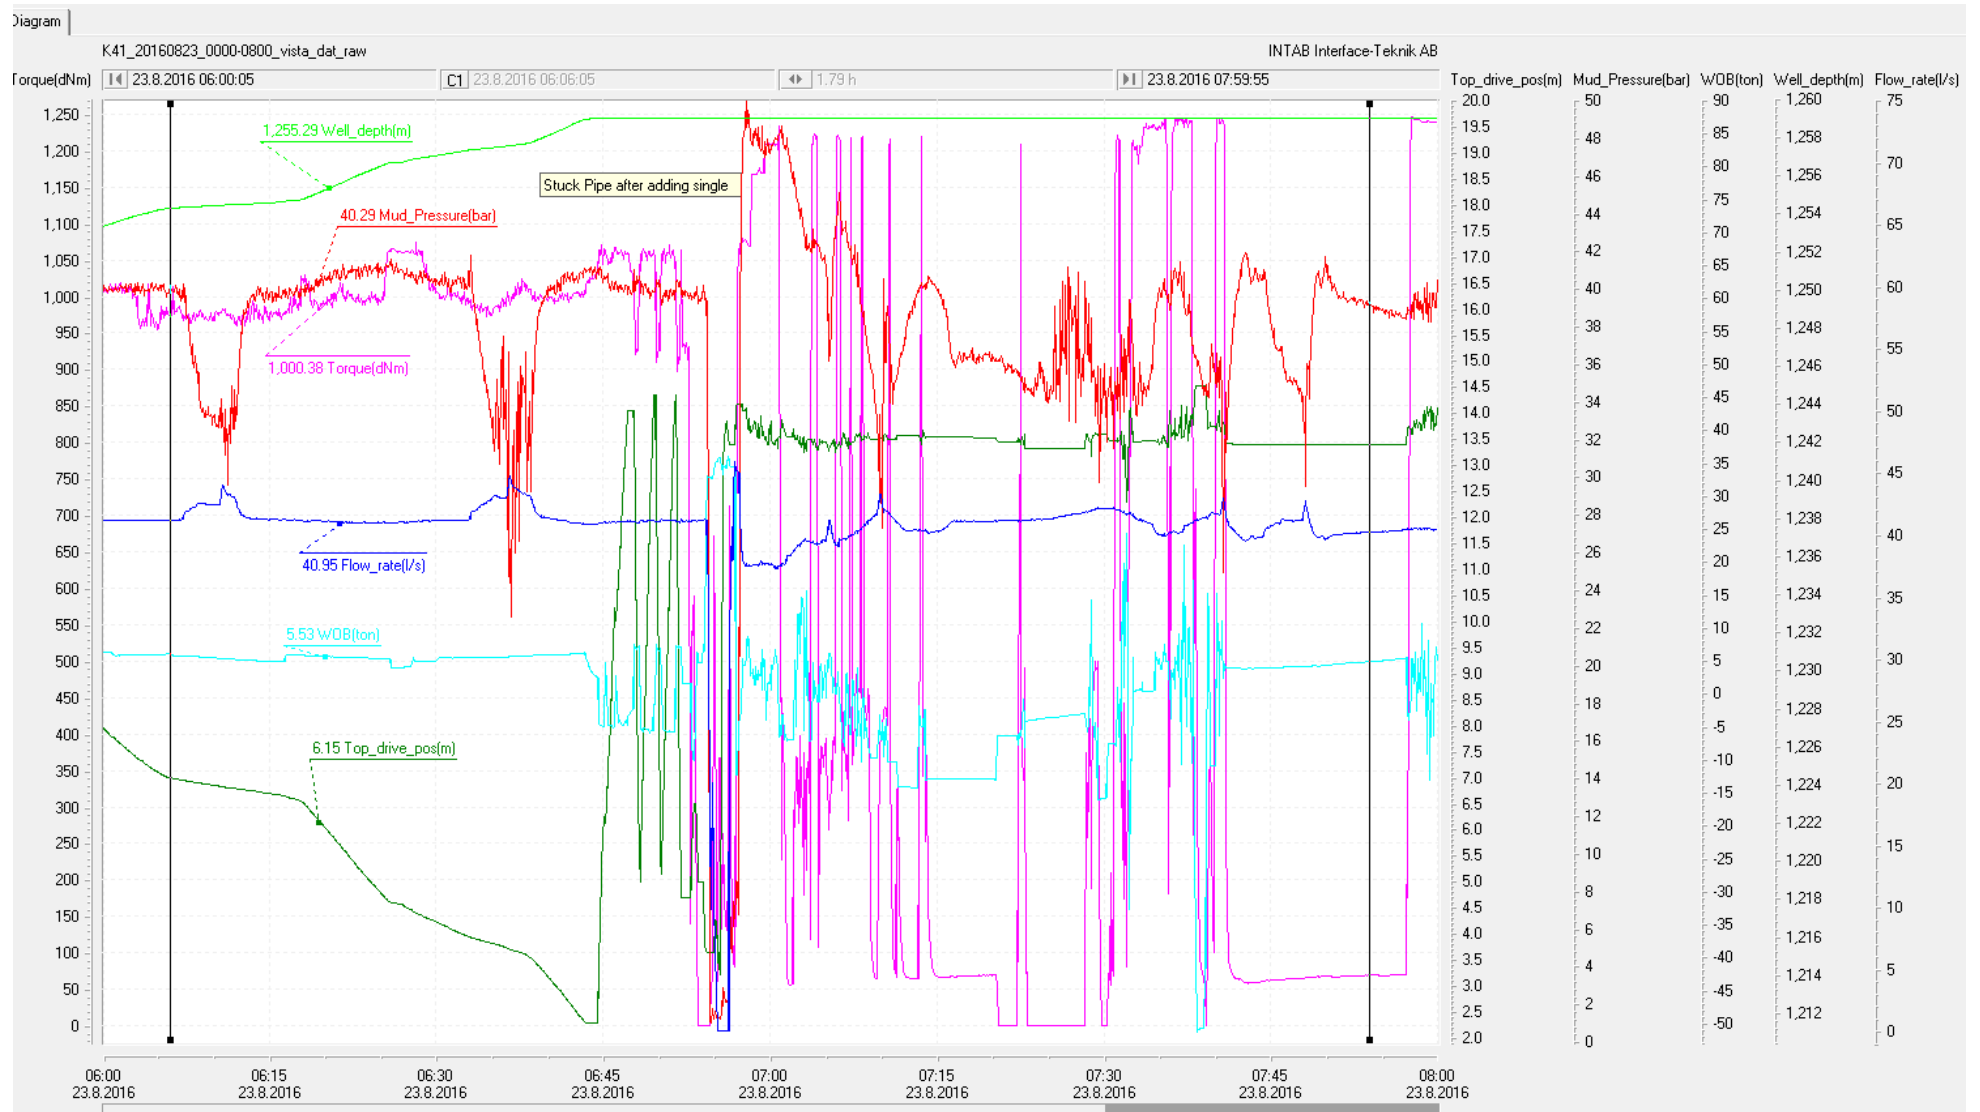
Figure 3. Key parameters during this morning's "stuck-pipe" event.

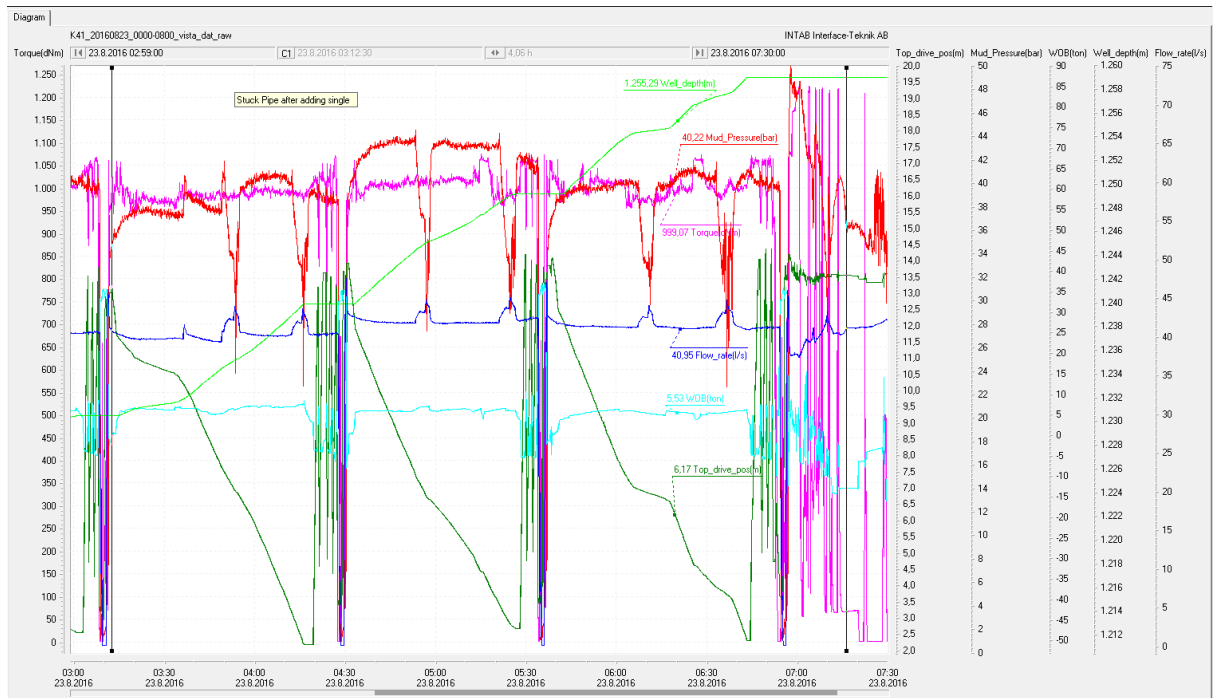
**Figure 1.** The string got stuck at 07:00 at 1259 m MD.

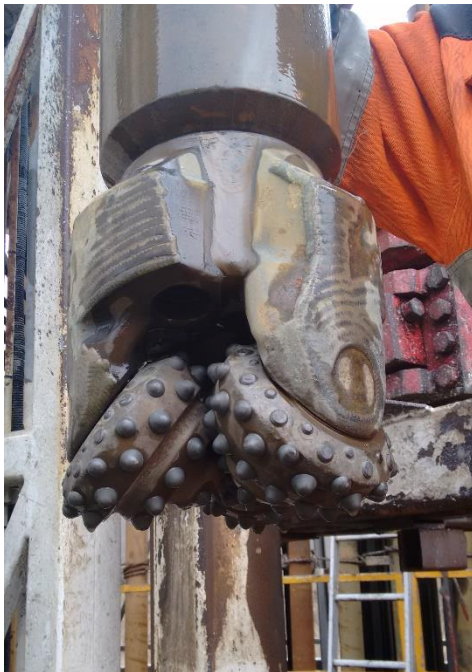
**Figure 1.** Drill-bit back on the surface late yesterday afternoon. The bit looks pretty good with only modest signs of wear.

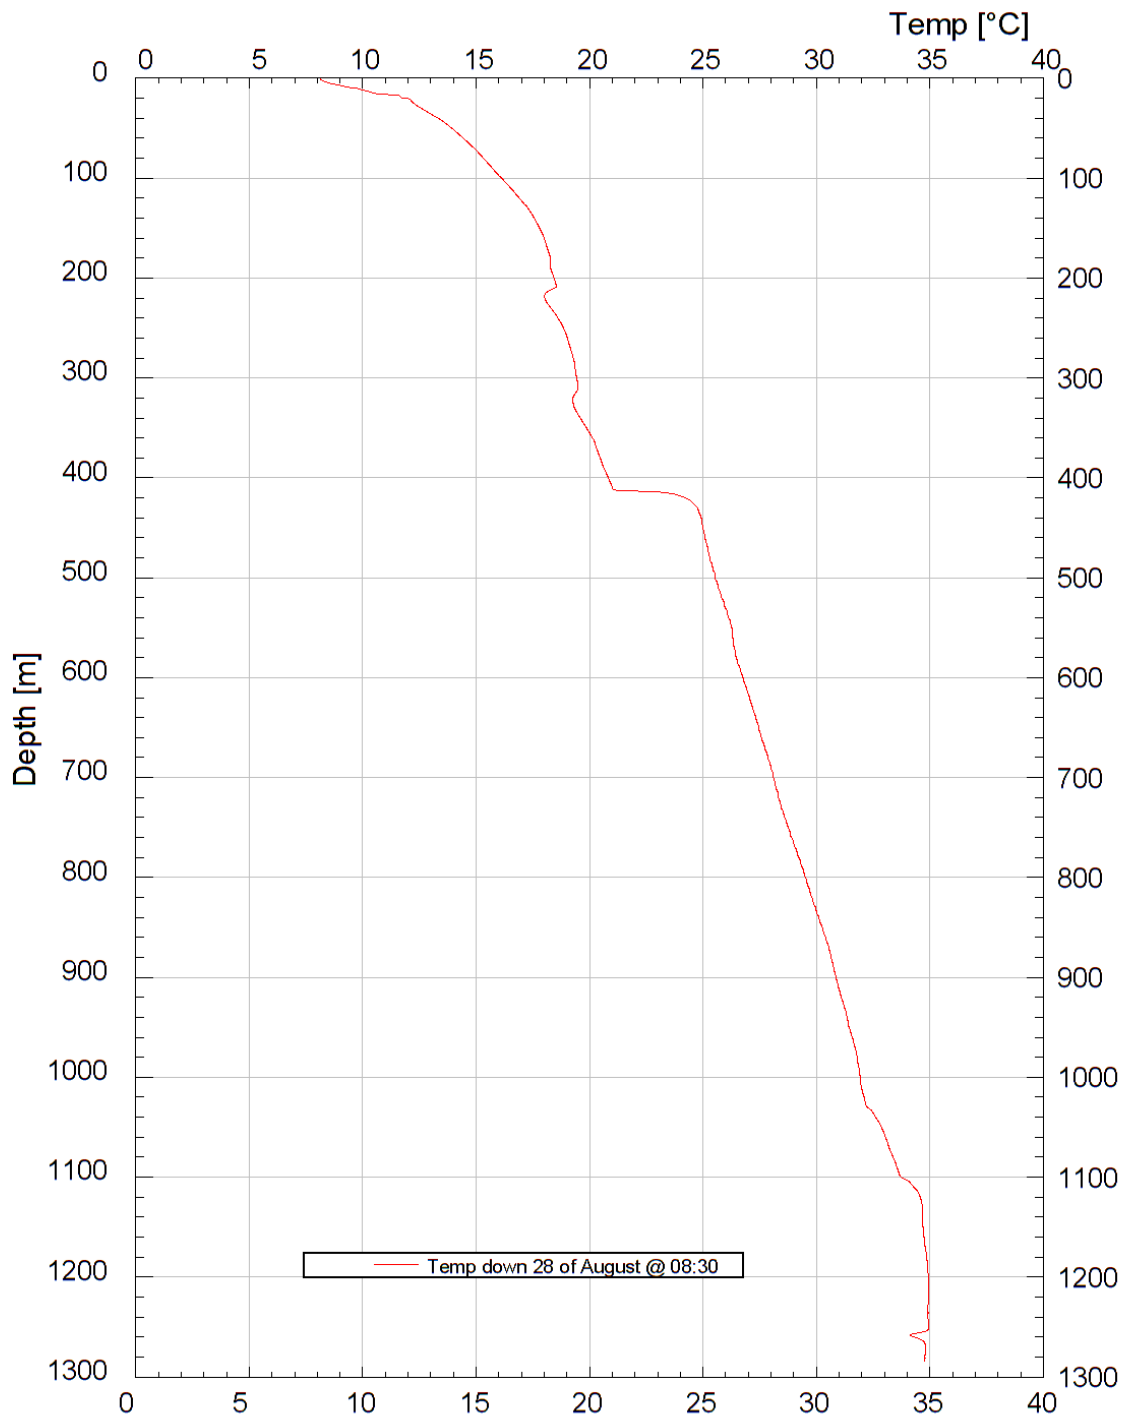
**Figure 2.** Temperature log inside drill-string this morning carried out prior to running in with the gyro tool. The bit is at 1302 m (MD), the tool logged down to 1285 m.  $Q = 19$  L/s on kill line no pumping on string. Note cooling points: i) at end of casing ~1030 m (change of well diameter at 1040 m); ii) at ~1100 m; and iii) at 1260 m. Note also that the well is receiving water below ~1260 m (MD).
